**2004 Operations, Maintenance,  
and Monitoring Report**

**BRADY CANAL HYDROLOGIC  
RESTORATION**

State Project Number TE-28  
Priority Project List 3

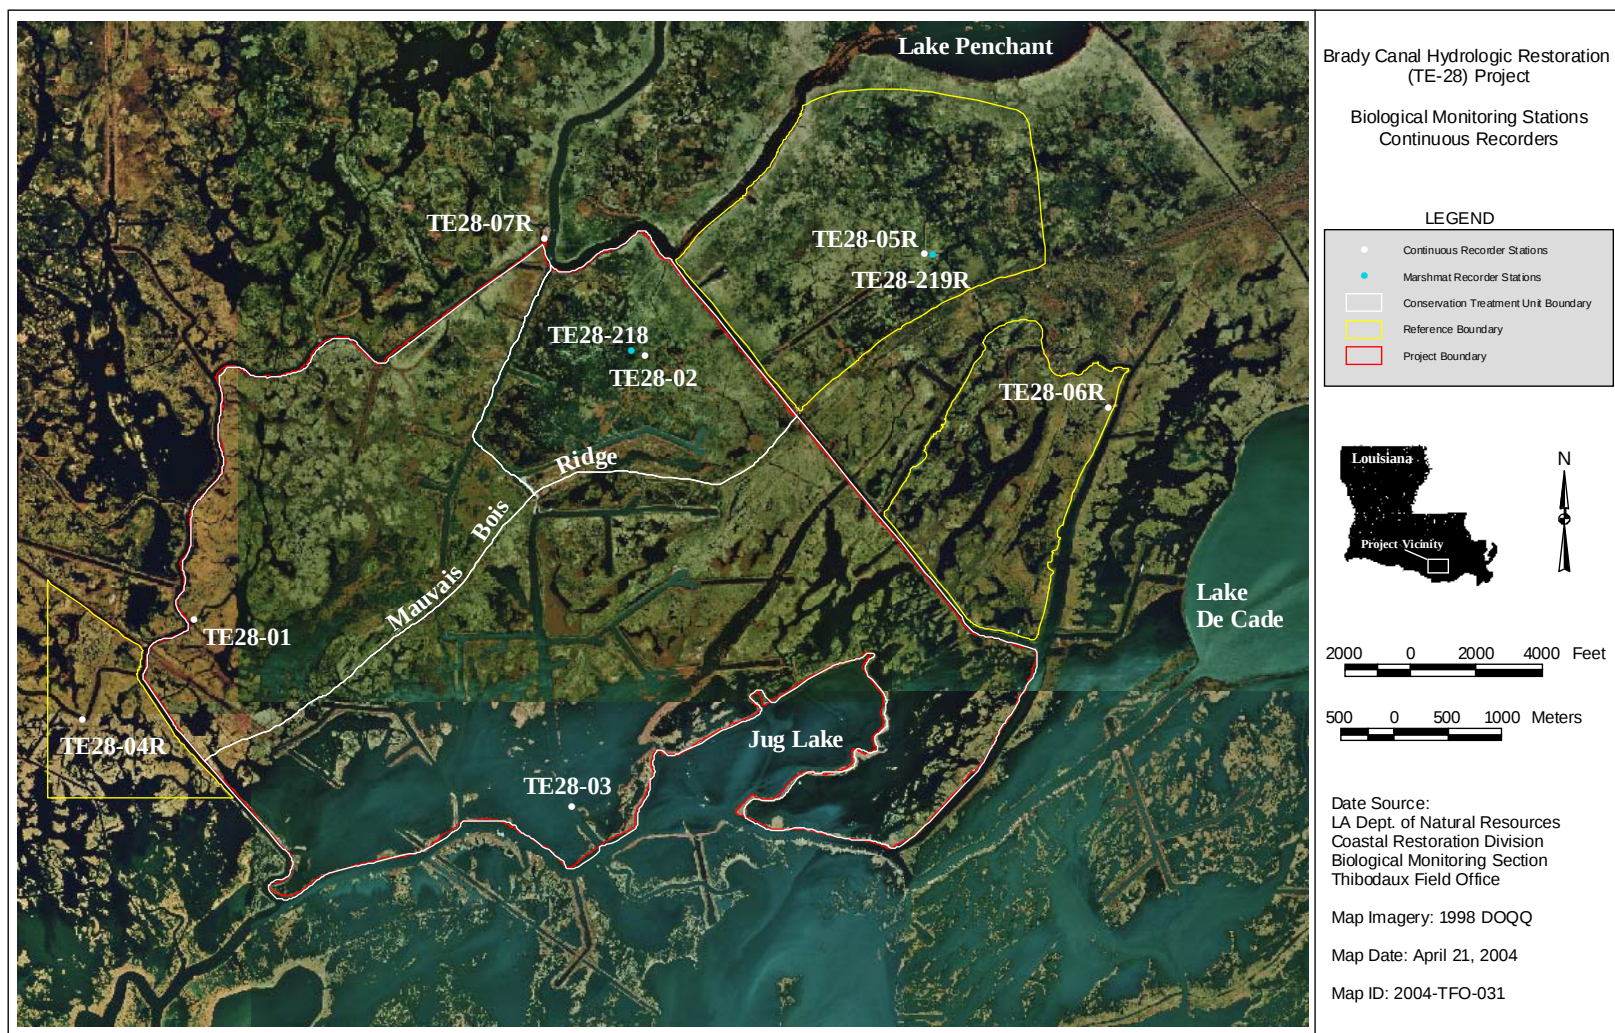
Figure 2: Location of continuous salinity and water level recorders in the Brady Canal Hydrologic Restoration (TE-28) project.

To monitor salinities one continuous recorder is located in each CTU and reference area (Figure 2). One additional recorder is located outside the project area on Bayou Penchant where Brady Canal begins near a water control structure. Discrete salinities are measured monthly at five sites within each CTU and reference area. Salinity data has been collected from 1996-2000 (pre-construction) and from 2000-2003 (post-construction), and will continue through 2004.

To monitor water level variability, one continuous recorder is located within each CTU and one recorder is located in each reference area (Figure 2). One additional recorder is located

To monitor marsh mat movement, one continuous recorder is located within CTU #2 and one recorder located in the paired reference area #2 (Figure 2). Mean daily water level variability and duration and frequency of flooding of floating marshes are determined for pre-construction vs. post-construction comparisons and also project vs. reference comparisons. Marsh mat movement data were collected from 1998-2000 (pre-construction) and 2000-2003 (post-construction) and will be collected through 2004 (post-construction).

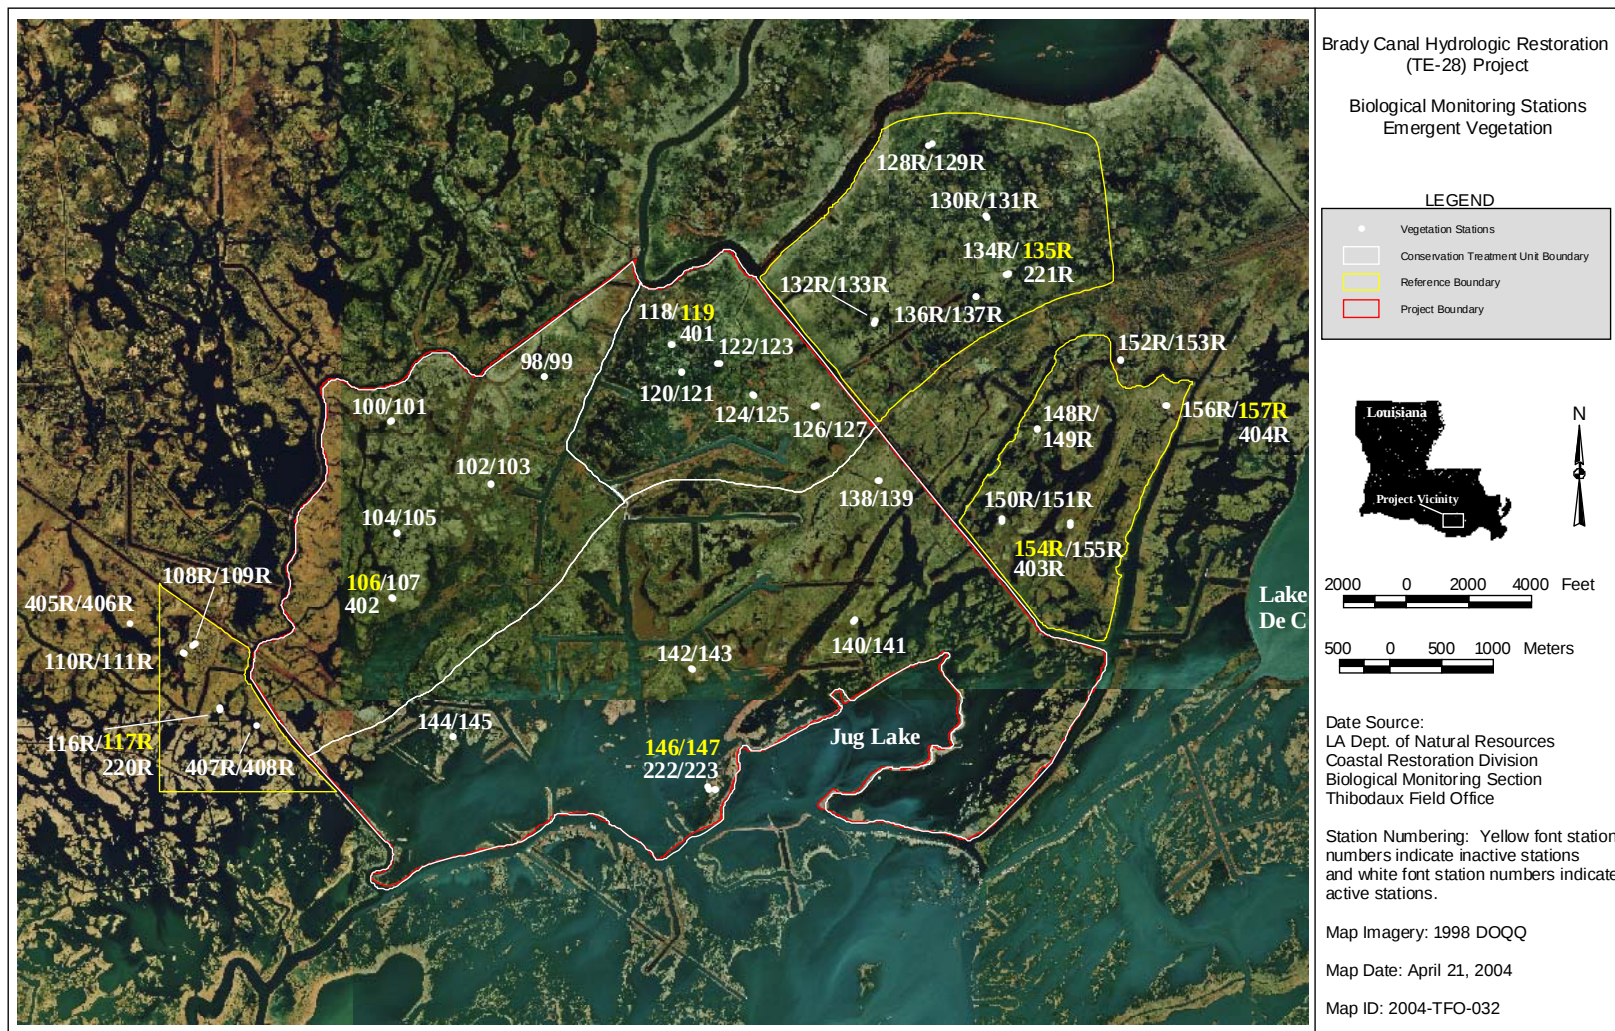
Figure 3: Location of emergent vegetation stations for the Brady Canal Hydrologic Restoration (TE-28) project.

Species richness and relative abundance are evaluated in the project and reference areas using the Braun-Blanquet method (Mueller-Dombois and Ellenberg 1974). Five stations were chosen within each CTU and reference area and replicate samples are collected at each station (Figure 3). Relative abundance will be documented in permanent plots to allow revisiting over time. Sites were sampled once in 1996 (pre-construction), 1999 (as-built), and in 2002 (post-construction) and will be sampled in 2004, 2006, 2009, 2012, and 2015 (post-construction).

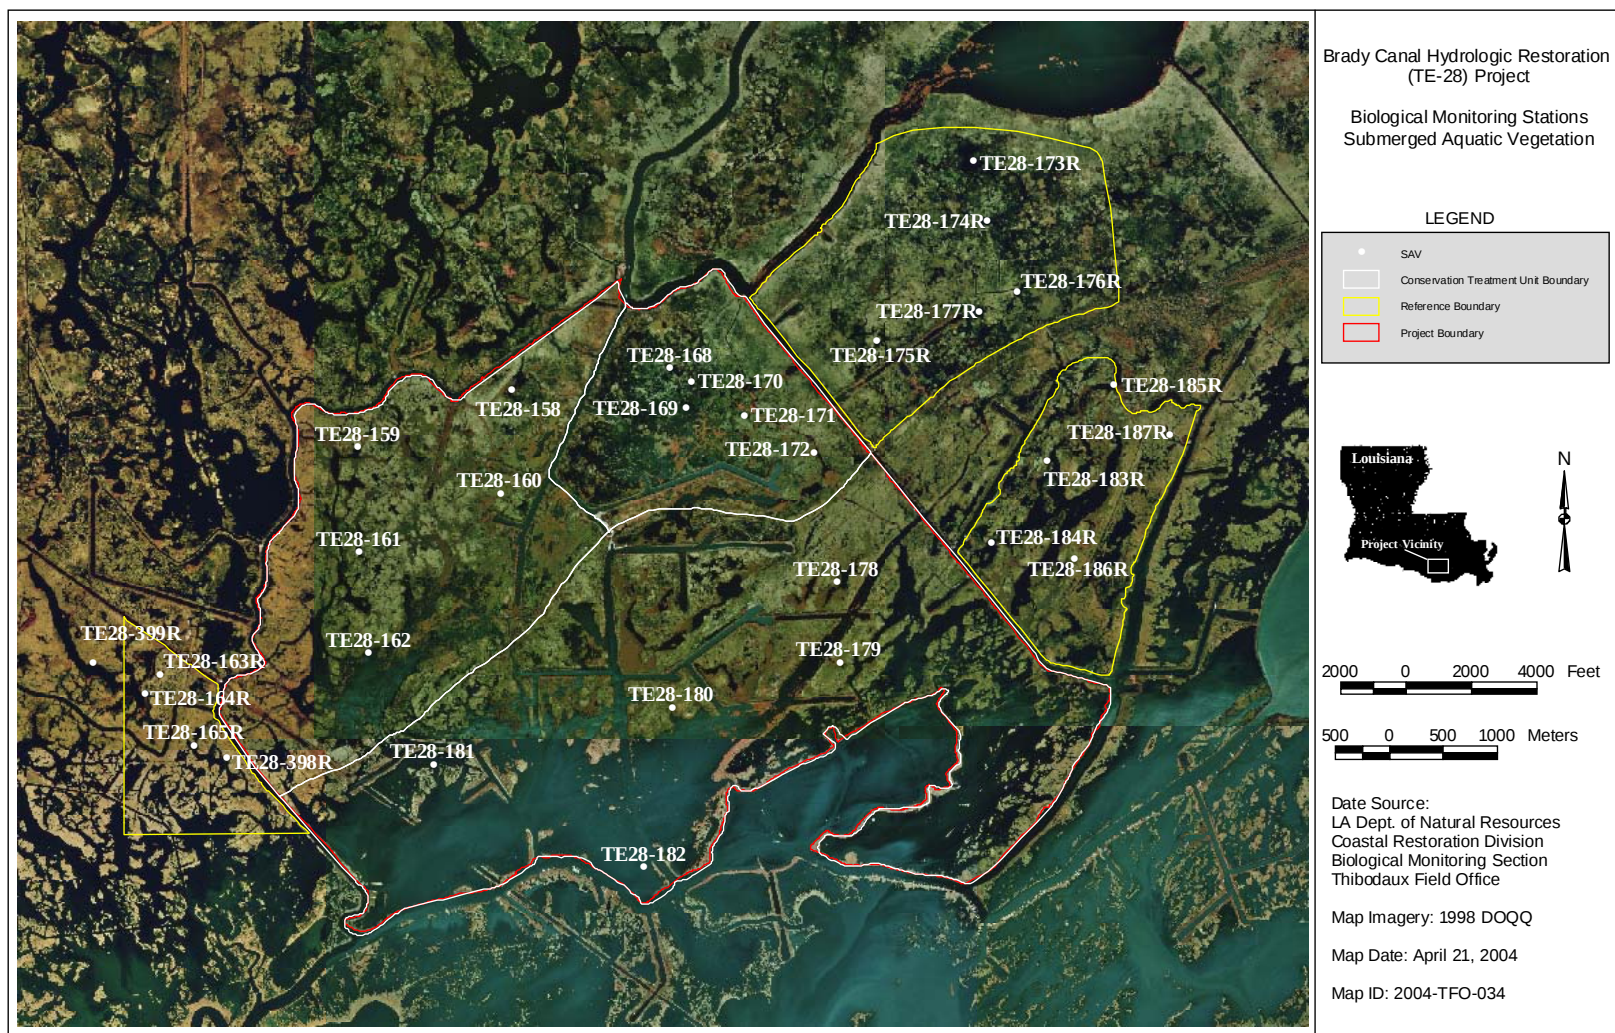
Figure 5: Location of submerged aquatic vegetation stations for the Brady Canal Hydrologic Restoration (TE-28) project.

The frequency of occurrence of SAV was compared between project and reference areas. Within the project (by CTU) and reference areas (Figure 5), 5 ponds were sampled during the Fall (October or November) in 1996 and 1999 (pre-construction) and in 2002 (post-construction) and will be sampled in 2006, 2012, and 2015 (post-construction). Methods described in Nyman and Chabreck (in press) will be used to determine the frequency of occurrence of SAV. Within each pond sampled, the presence/absence of SAV is determined at a minimum of 20 random points. Frequency of occurrence is determined for each pond from the number of points at which SAV occurred and the total number of points sampled. When SAV occurs at a point, the species occurring will be listed.
