**2005 Operation, Maintenance, and  
Monitoring Report**

**La. Highway 384  
Hydrologic Restoration**

State Project Number CS-21  
Priority Project List 2

June 2005  
Cameron Parish

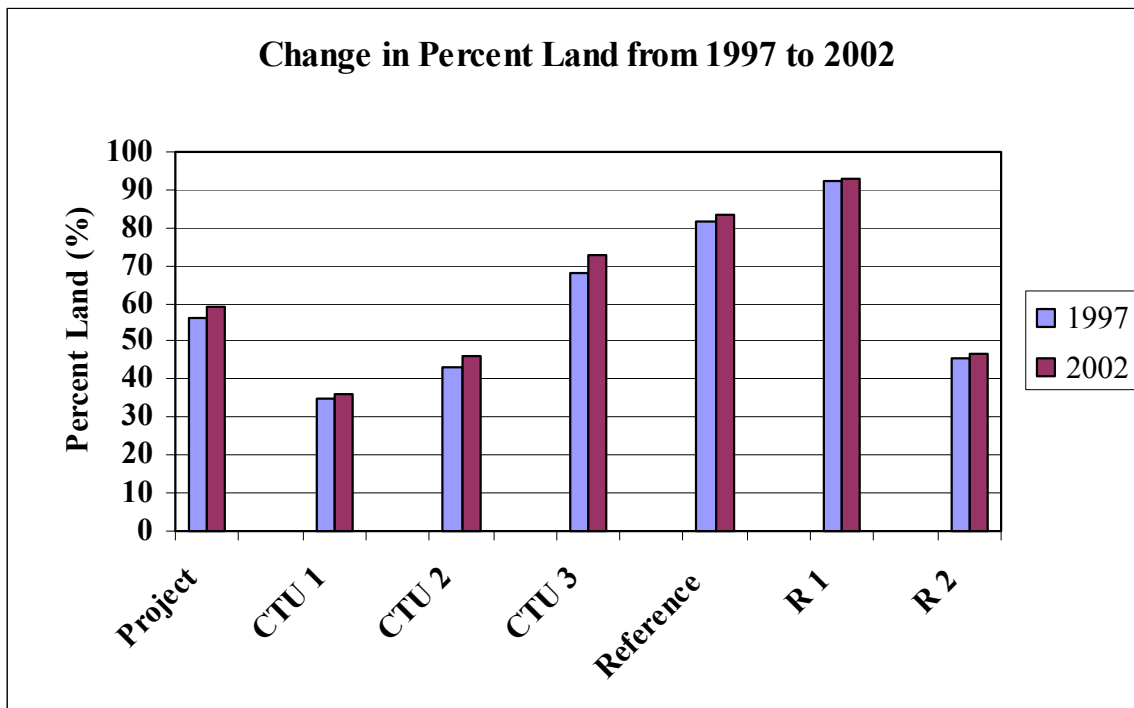
**Figure 5.** Percent of land area in 1997 and 2002 from aerial photography of each project CTU and the reference areas.

Photography of the project area was obtained by USGS in 1997 and 2002 (figures 3 and 4). The two flights showed a modest increase in the percentage of each area that can be considered land (table 1, figure 5). The greatest increase in land was in CTU 3, where there was an increase of 4.2%. The total increase for the project areas combined was 3.4%, while the reference areas collectively increased by 1.7%. Percent land increased in both the project and reference areas. The increases were small in both the project and reference areas, although they were larger in the project areas. The 1997 percent land was subtracted from the 2002 percent land for each unit, and project units were compared to reference units with a t-test. The test revealed that there was no significant difference between the project and reference in percent land increase ( $F_{1,4}=3.79$ ,  $p=0.1469$ ).

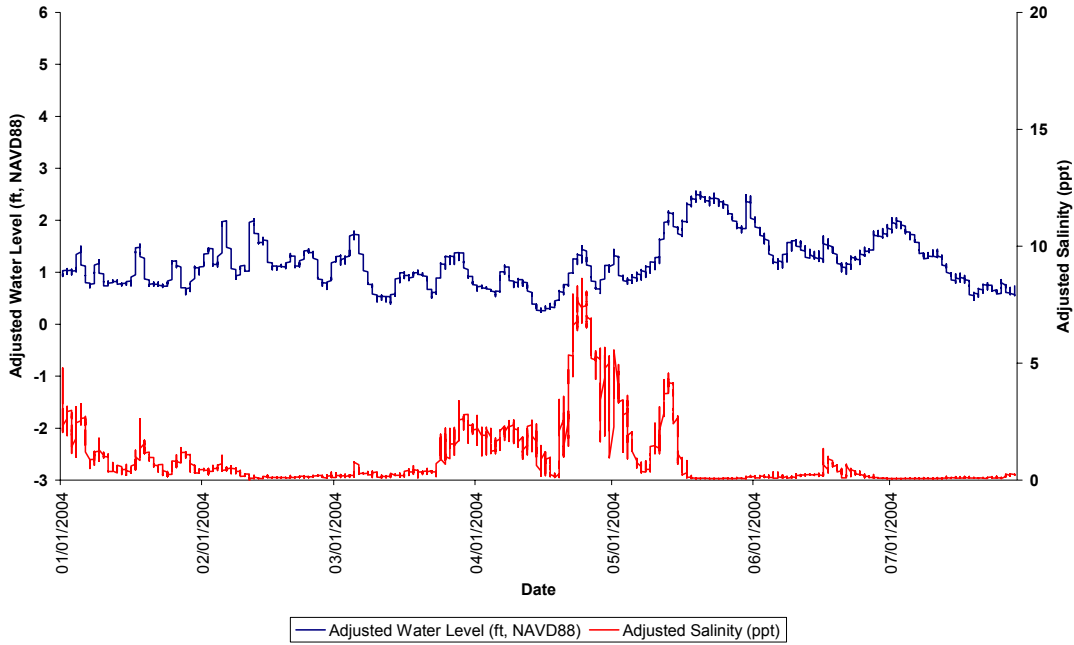
**Highway 384 Hydrologic Restoration (CS-21)  
Station CS21-98 (01/01/04 - 07/28/04)**

**Highway 384 Hydrologic Restoration (CS-21)  
Station CS21-29 (01/01/04 - 07/28/04)**

**Figure 7.** Water level and salinity data from stations CS21-98 (top) and CS21-29 (bottom), shown in feet.

Water level and salinity data from January 1, 2004, to June and July, 2004, at all four stations are presented below (figures 6 and 7). Mean monthly salinity data reveal that salinity was highest in the reference area throughout the year and that mean salinities were within the target range for salinity each month ( $\leq 10$  ppt CTU 1,  $\leq 5$  ppt CTUs 2 and 3) (figure 8). Mean monthly water levels were below the marsh surface in the project area from January to April 2004. The marsh in the project areas was flooded during the early summer in May and June 2004 (figure 9).

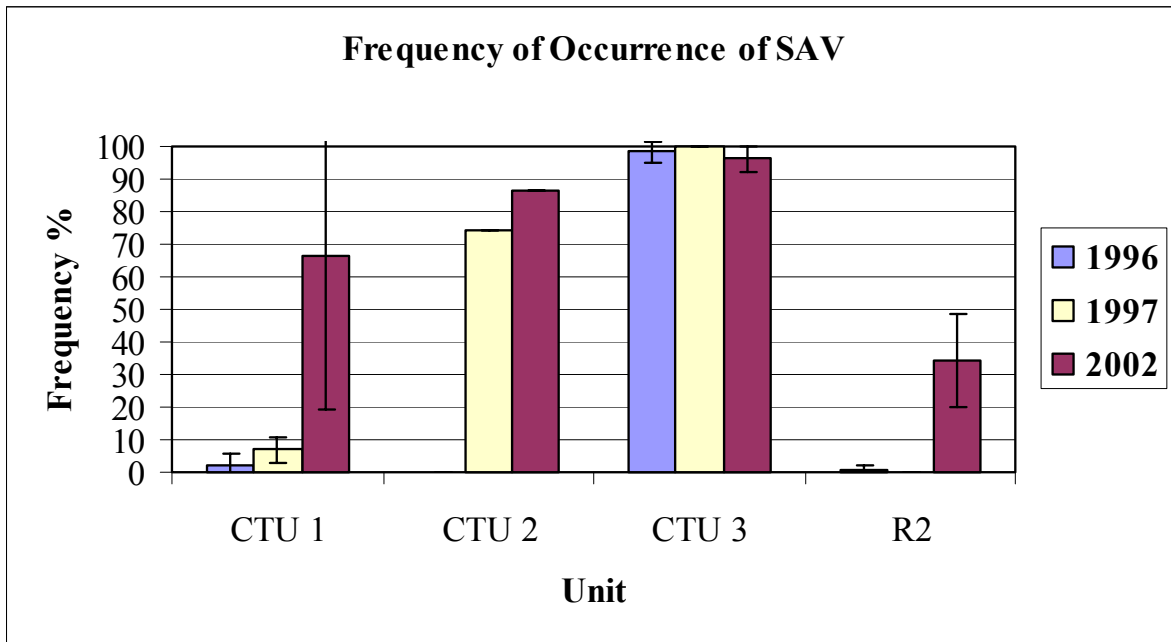
**Figure 10.** Total % cover of SAV species in the CS-21 project and reference area R2 for sampling years.

The project goal for SAV was to increase frequency of occurrence of SAV in the three project areas relative to the SAV reference unit, R2. SAV was sampled twice pre-construction (1996 and 1997) and once post-construction. There was little cover in any unit in 1996 except for CTU 3, which had 11 species present and nearly 100% cover, and a small amount of algae in CTU 1 (table 2, figure 10). 1997 saw near-total cover in CTU 3 with nine species present, 79% algae in CTU 2, and 5% more algae in CTU 1. Post-construction in 2002, cover had increased to 66% in CTU 1, all of it being *Ruppia maritima* (widgeongrass). Cover remained high in CTU 2 and SAV switched from mostly algae to being dominated by *Ruppia maritima*. Cover remained near 100% in CTU 3 with 10 species present. The reference area (R2) had nearly 34% cover in 2002, mostly *Ruppia maritima*.

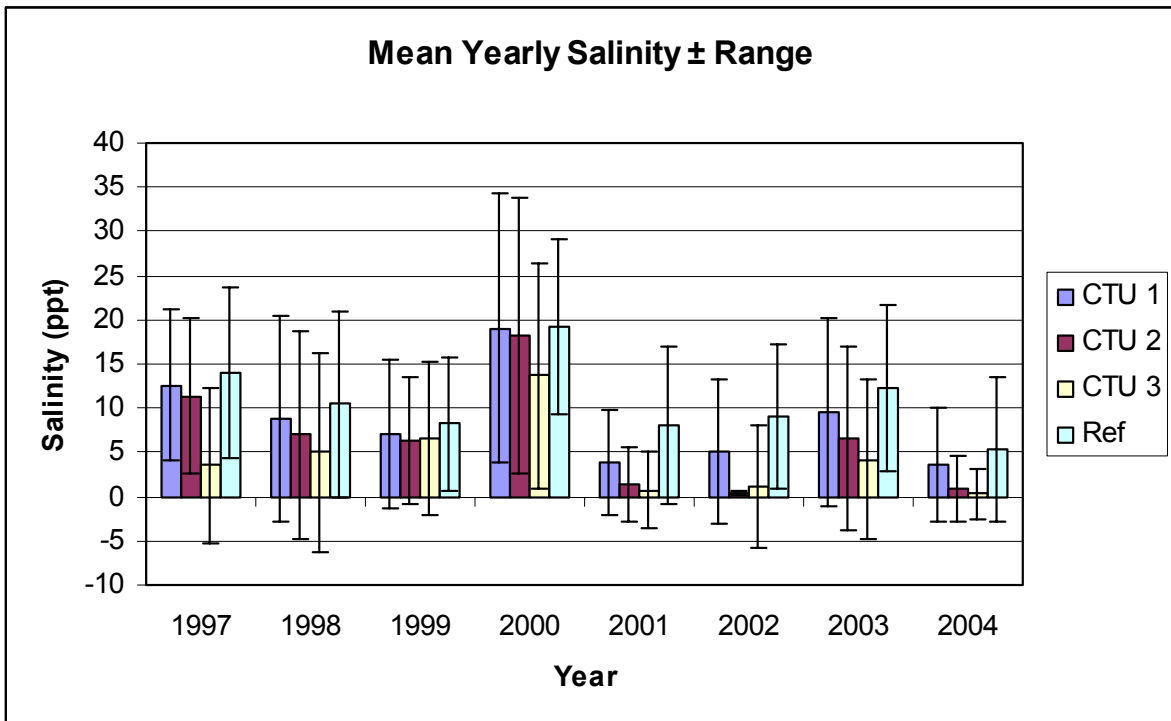
**Figure 11.** Mean salinity for each year the data sondes were deployed. All data were included even when data were missing from one sonde but not another. Error bars represent range of data for that year.

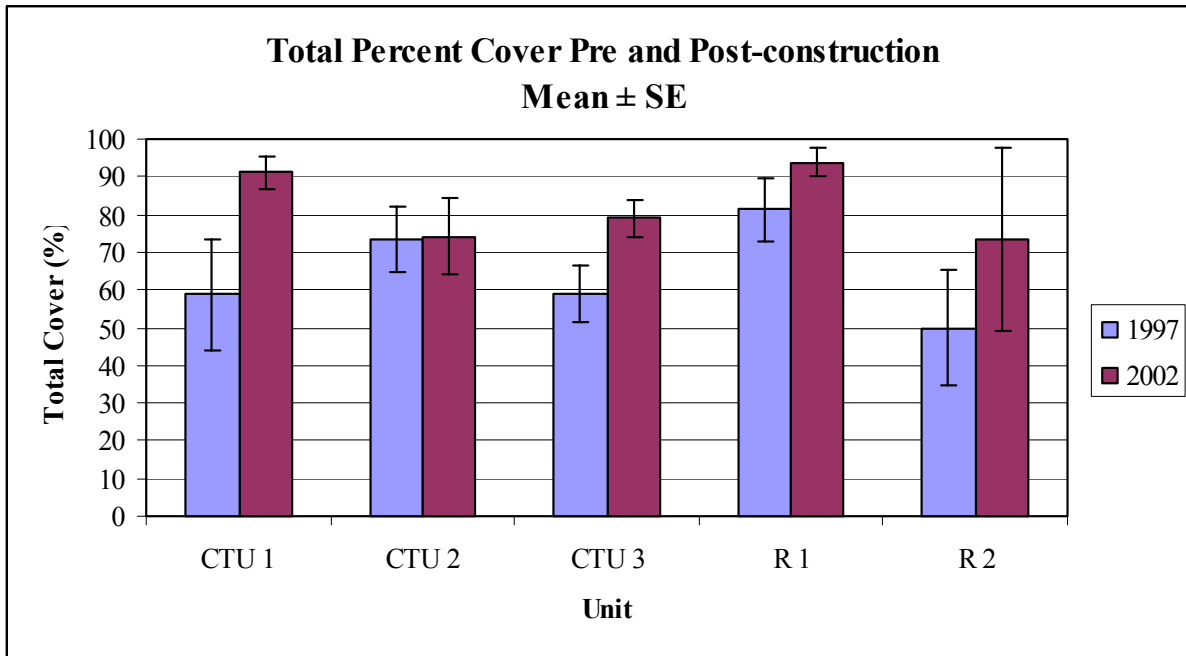
**Figure 12.** Total % cover in vegetation plots at the CS-21 La. Highway 384 Project pre- and post-construction, in 1997 and 2002, respectively.

The project goal for emergent vegetation was to increase cover in shallow open water areas within the project area. This goal specifically refers to increasing cover of intermediate marsh in CTU 2, maintaining intermediate conditions in CTU 3, and increasing cover of brackish marsh in CTU 1. According to surveys performed pre-construction in 1997, CTU 1 was primarily dominated by *Juncus roemerianus* (needlegrass rush), with some *Spartina patens* (marshhay cordgrass) and some more-saline species present, including *Spartina alterniflora* (smooth cordgrass) and *Distichlis spicata* (seashore saltgrass). The 2002 survey showed an increase in *Spartina patens* and the presence of *Schoenoplectus robustus* (sturdy bulrush). Total percent cover increased post-construction from 58.8 % to 91.3% (figure 12).

CTU 3 was dominated by *Spartina patens*, *Schoenoplectus californicus* (California bulrush), and *Sagittaria lancifolia* (bulltongue) in 1997. By 2002, the unit was dominated by *Spartina patens*, *Typha latifolia* (cattail), and *Juncus roemerianus*, species richness had increased from 6.6 to 10.5 species per plot, and total cover had increased from 59% to 79% (figure 12). These results are consistent with the project goals of increasing the cover of intermediate marsh.

Reference areas 1 and 2 showed little change from 1997 to 2002, being dominated by *Juncus* and *Spartina patens*. *Spartina alterniflora* began to emerge and *Distichlis spicata* decreased post-construction in R1. Total cover increased in both units (figure 12), and species richness slightly decreased in R2 from 3.3 to 2.7 species per plot.
