**2004 Operation, Maintenance,  
and Monitoring Report**

**Highway 384 Hydrologic  
Restoration**

State Project Number CS-21  
Priority Project List 2

May 2004  
Cameron Parish

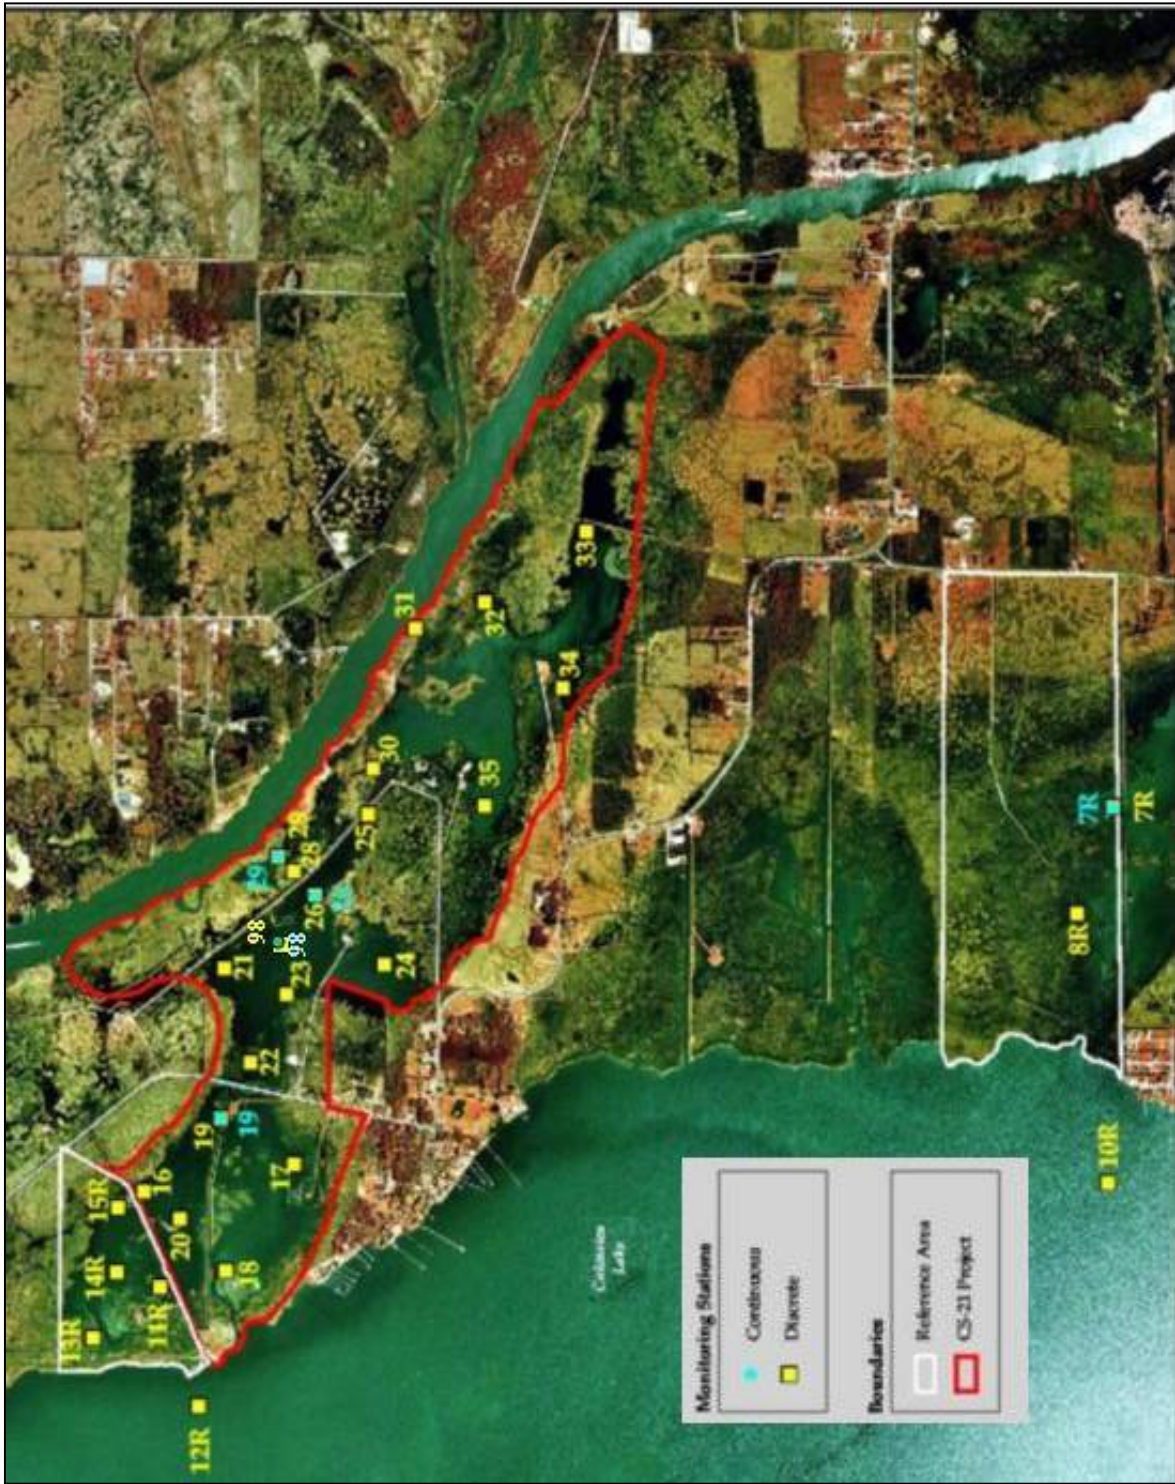
**Figure 2.** Location of continuous recorders and discrete water quality stations for Highway 384 Hydrologic Restoration (CS-21).

Water salinity was monitored monthly at 29 discrete sampling stations within the project and reference areas and at four continuous recorders in each of the project areas (CTUs 1-3) and reference areas R1 and R2 (figure 2). The recorders were deployed in May 1997 to log hourly salinity.

Water level was monitored monthly at the same discrete sampling stations as salinity and at staff gauges installed inside and outside of the project area near the two CS-21 project water control structures. The four continuous data recorders that were deployed in May 1997 to recorded hourly water level in the three project areas and in R1. These data are available in raw and graphic formats. To document the frequency, magnitude, and duration of head differences conducive to freshwater introduction into the project from the GIWW, the data recorders in CTU 2 & 3 were deployed near the freshwater introduction structure, one on each side of the structure (figure 2). All four recorders were surveyed to NAVD 88.

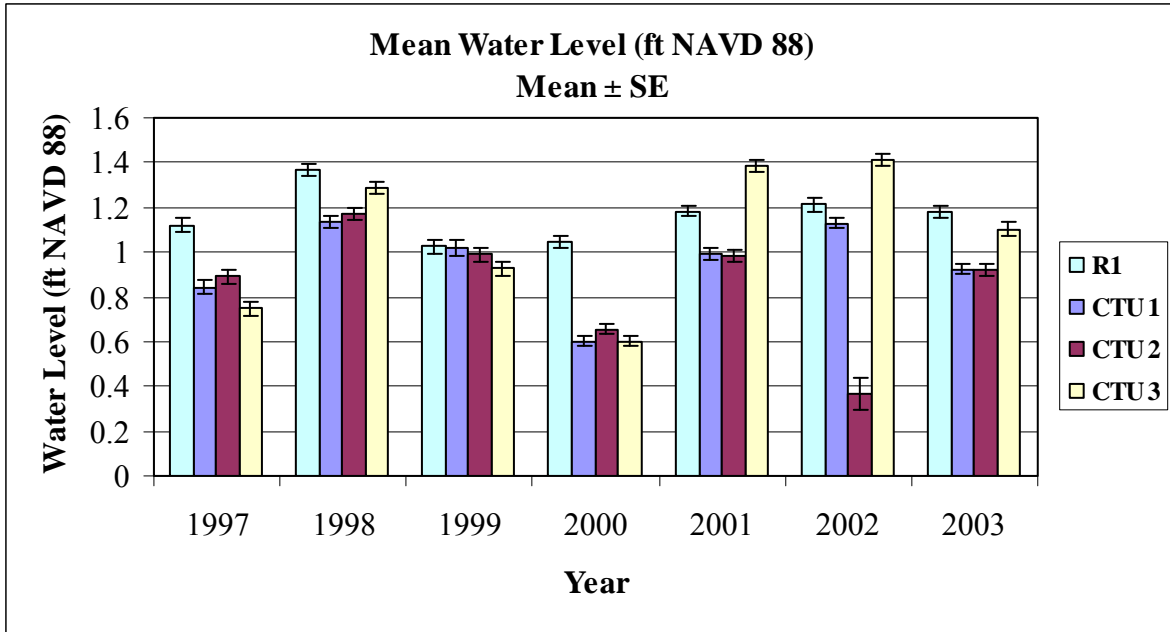
**Figure 9.** Yearly means of daily mean water level (ft NAVD 88) in the CS-21 Hwy 384 Project Area from 1997 to 2003.

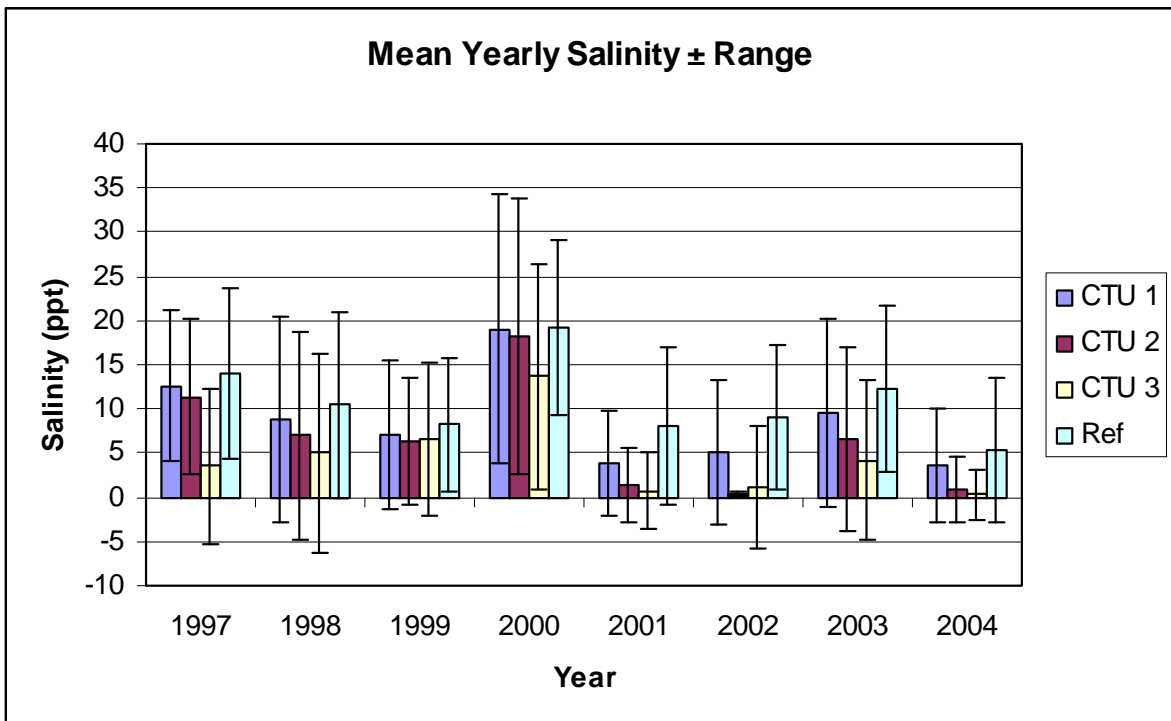
**Figure 11.** Mean salinity for each year the data sondes were deployed. All data was included even when data was missing from one sonde but not another. Error bars represent range of data for that year.

due to the fact that the two transects in CTU 3 were so different post-construction with one transect having 100% cover and the other with 33% cover. CTU 2 was not significantly different from R2 either ( $F_{1, 1}=0.1705$ ,  $p=0.6968$ ). Frequency pre-construction was near zero in R2 and 37% in CTU 2. Post-construction, cover increased in both units, to 34% in R2 and to 86% in CTU 2. The magnitude of the change was statistically the same in each unit so differences were not statistically different. CTU 3 was significantly different from R2 pre and post-construction ( $F_{1, 1}=46.083$ ,  $p<0.0001$ ). The difference in CTU 3 and R2 was due to the fact that cover remained near 100% in CTU 3 while it increased from near zero to 34% in R 2. Frequency of occurrence of SAV increased in all areas post-construction and, although the total cover of SAV was higher in the project units, the increase in SAV in R2 over the course of the project caused increases in project units to be statistically insignificant. It is likely that SAV in the entire project responds more to yearly weather and salinity trends more than to the CS-21 project itself. Or, if the differences in SAV are project effects, perhaps the reference area is impacted by the project also. CTU 3 has had lower salinities throughout the life of the project (figure 11).
