**2005 Operations, Maintenance,  
and Monitoring Report**

**Sabine Structure Replacement**

State Project Number CS-23  
Priority Project List 3

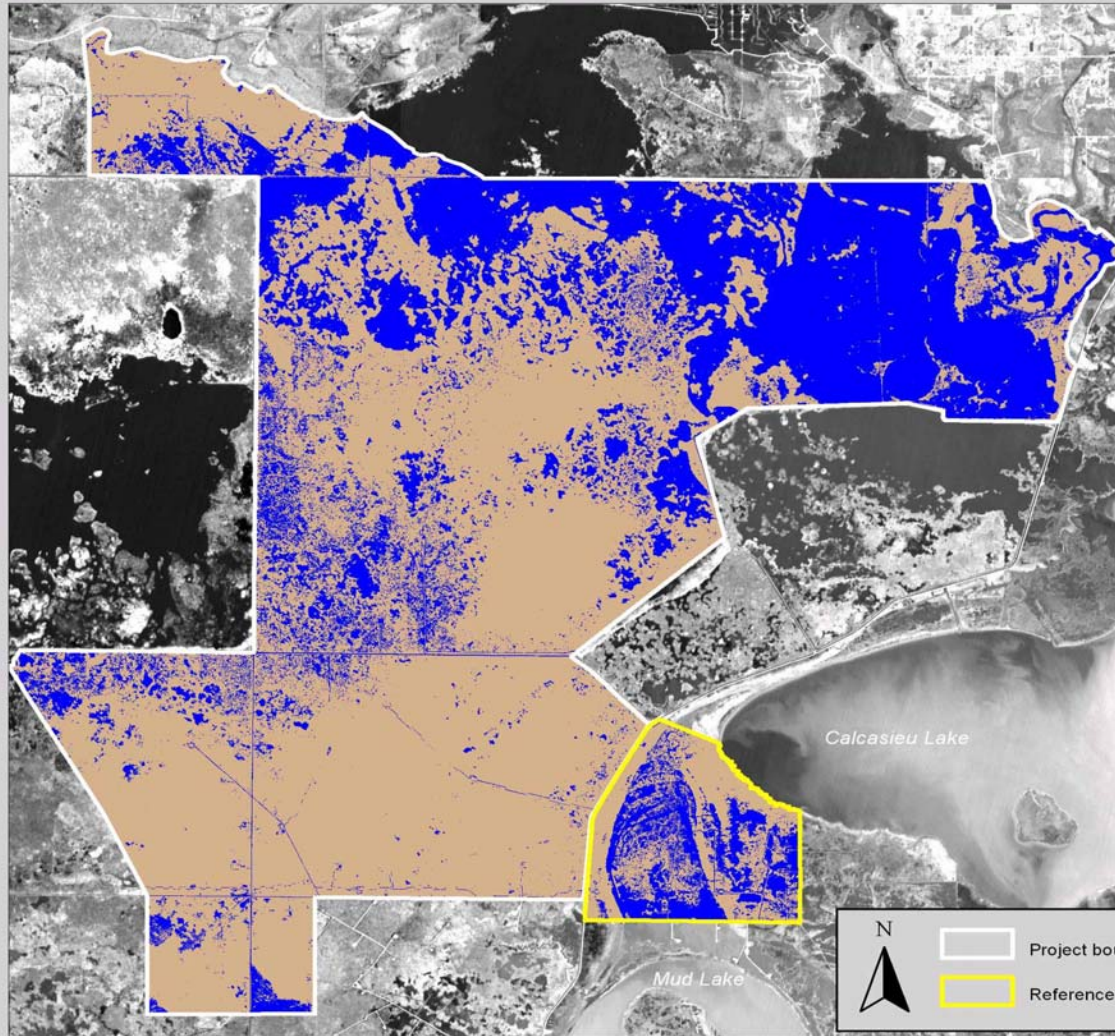
**Replace Sabine Refuge Water Control Structures at Headquarters Canal, West Cove Canal, and Hog Island Gully (CS-23)**  
 Coastal Wetlands Planning, Protection and Restoration Act  
 2000 Land-Water Analysis

Class	Project Acres	Reference Acres
Land	28146.8	1695.5
Water	13572.1	1233.5
<b>Total</b>	<b>41718.9</b>	<b>2929.0</b>

Source:  
 The land-water data were acquired from 1:24,000 color infrared photography shown here at 1:120,000 scale. The photography was obtained on November 27, 2000. The data were overlaid on a 1998 Digital Ortho Quarter Quadrangle.

**Figure 2.** Land/water analysis of the Sabine Structure Replacement (CS-23) project for the project and reference areas from photography obtained November 27, 2000.

Near-vertical color-infrared aerial photography (1:24,000 scale) was used to measure land to water ratios for the project and reference areas (figure 2). The photography was obtained in November 2000 prior to project construction and post-construction in 2004. The original photography was checked for flight accuracy, color correctness, and clarity, and was subsequently archived. Aerial photography was scanned, mosaicked, and georectified by U.S. Geological Survey/National Wetlands Research Center (USGS/NWRC) personnel according to standard operating procedures (Steyer et al. 1995, revised 2000), (figure 3). The photography will be obtained after construction in 2009, and 2018.

Aerial photography was acquired in November 2000 for a land:water analysis (figure 2). Results indicate that the project area had a ratio of 67.5% land to 32.5% water, while the reference area consisted of 57.9% land to 42.1% water. Post-construction photography was collected in 2004 and is currently being processed.

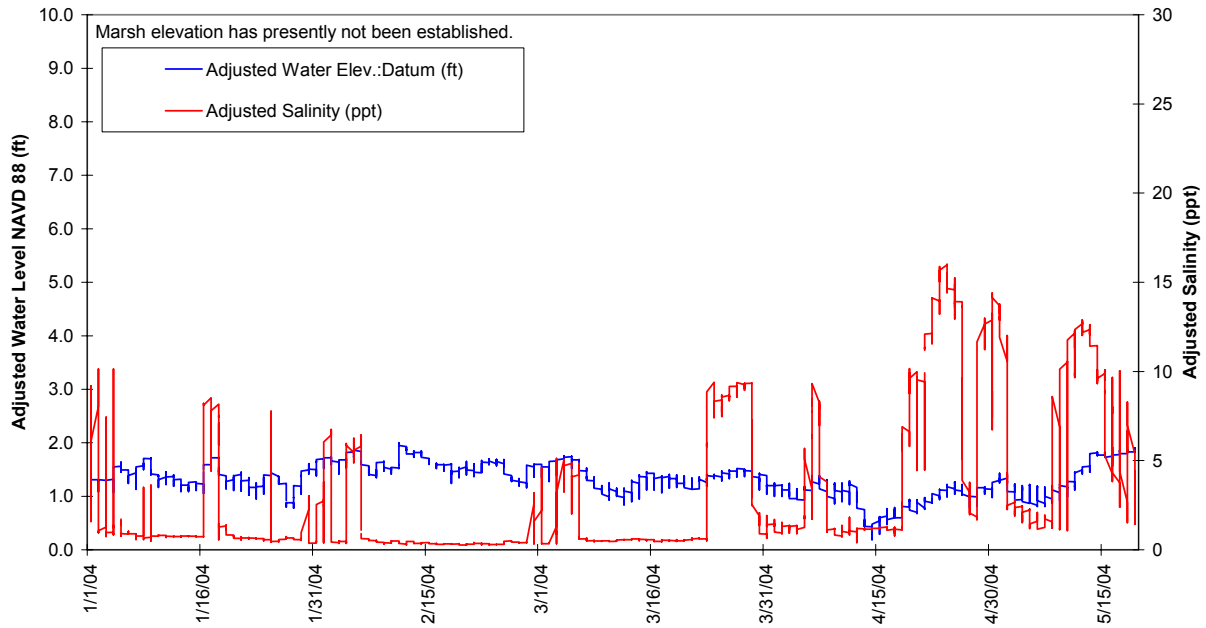
**Station CS23-01 (1/1/04 – 05/19/04)**  
**Salinity and Water Level Data**

**Figure 5.** Hourly salinity and water level at station CS23-01 in the Sabine Structure Replacement (CS-23) project area. No marsh elevation was established due to the close proximity of a ridge and shell road.

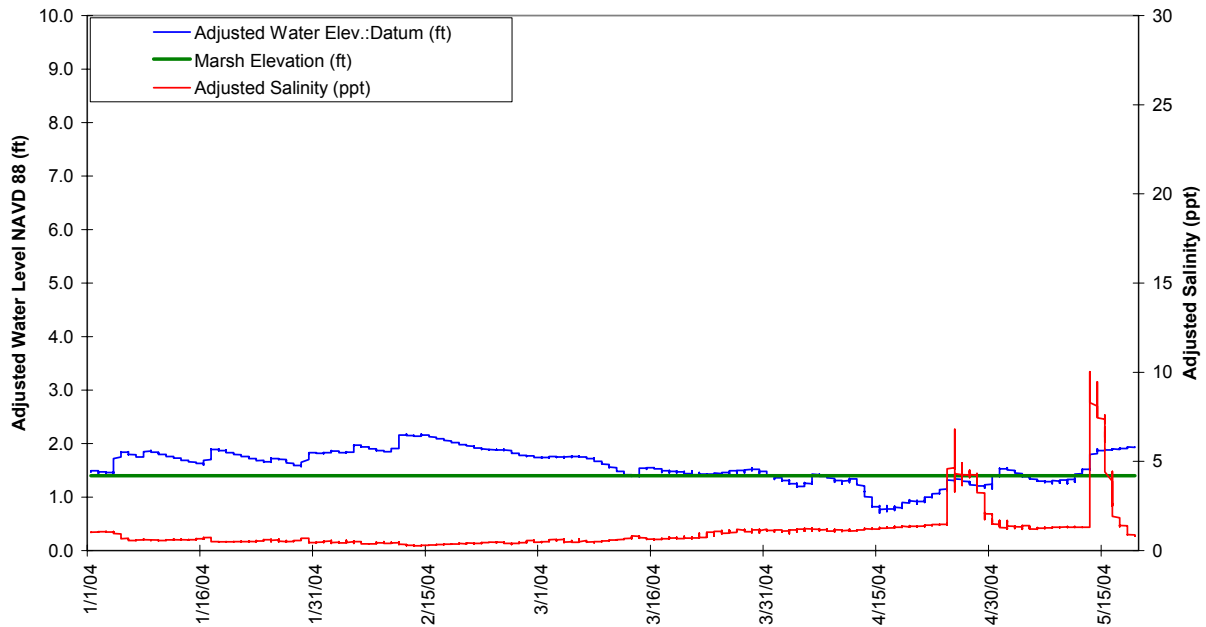
**Station CS23-02 (01/01/04 – 05/19/04)  
Salinity and Water Level Data**

**Figure 6.** Hourly salinity and water level at station CS23-02 in the Sabine Structure Replacement (CS-23) project area. A water level reading above marsh elevation indicates that the marsh is flooded.

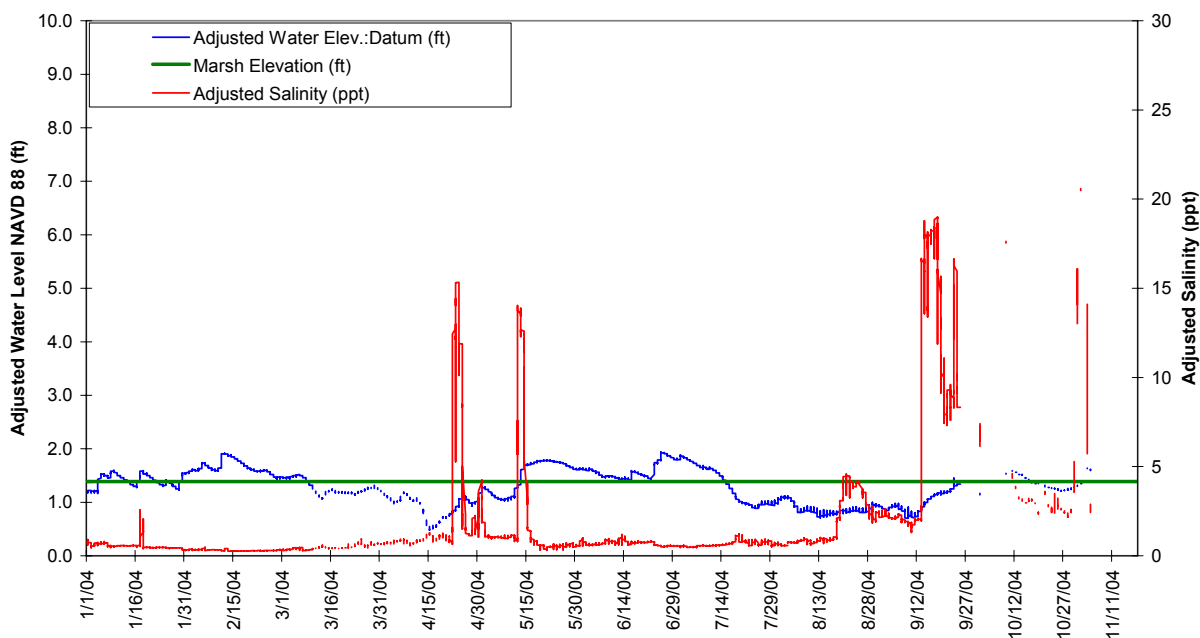
### Station CS23-03 (1/1/04 – 11/18/04) Salinity and Water Level Data

**Figure 7.** Hourly salinity and water level at station CS23-03 in the Sabine Structure Replacement (CS-23) project area. A water level reading above marsh elevation indicates that the marsh is flooded.

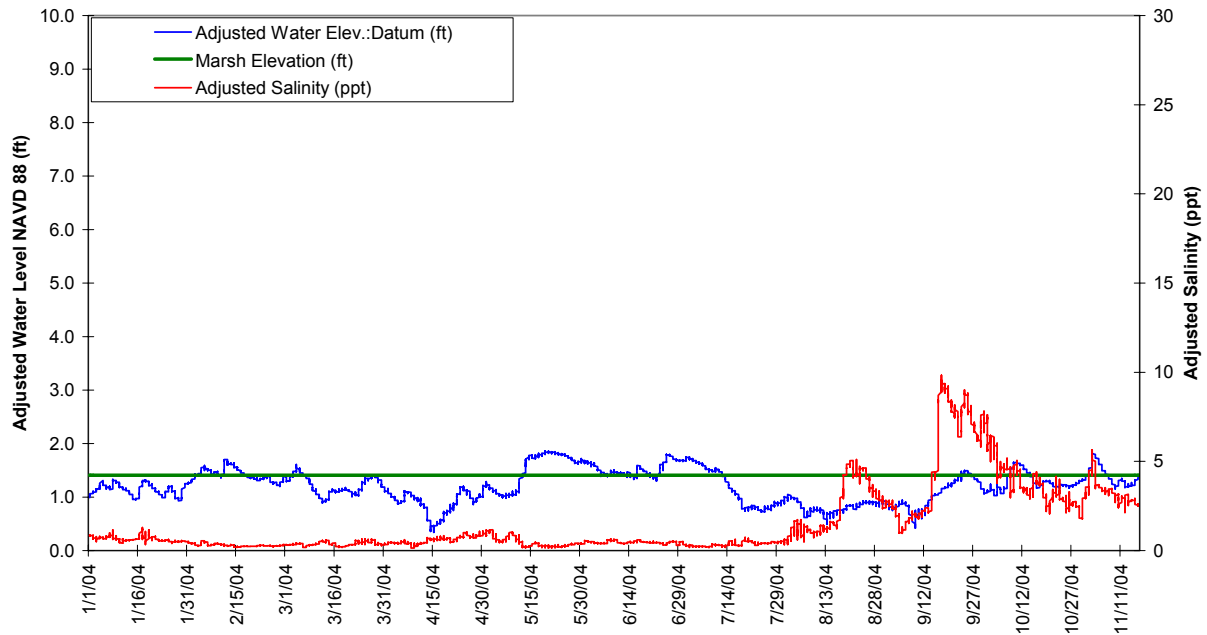
# Station CS23-05 (01/01/04 – 11/16/04) Salinity and Water Level Data

**Figure 8.** Hourly salinity and water level at station CS23-05 in the Sabine Structure Replacement (CS-23) project area. A water level reading above marsh elevation indicates that the marsh is flooded.

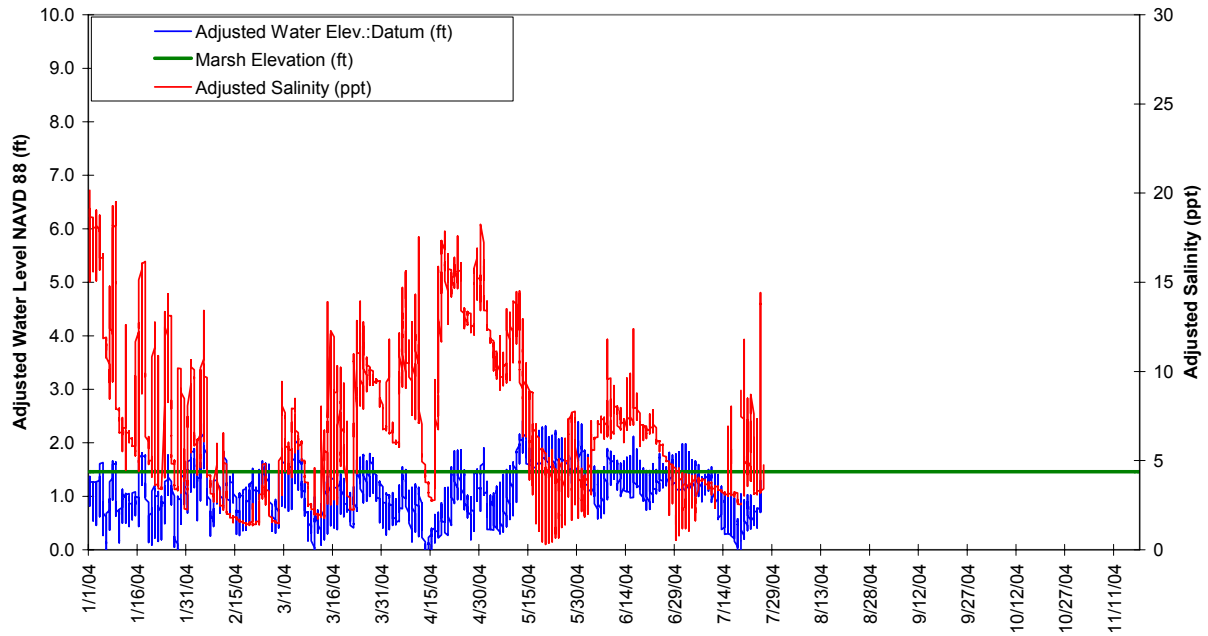
**Station CS23-01R (01/01/04 – 11/18/04)  
Salinity and Water Level Data**

**Figure 9.** Hourly salinity and water level at station CS23-01R in the Sabine Structure Replacement (CS-23) project area. A water level reading above marsh elevation indicates that the marsh is flooded.

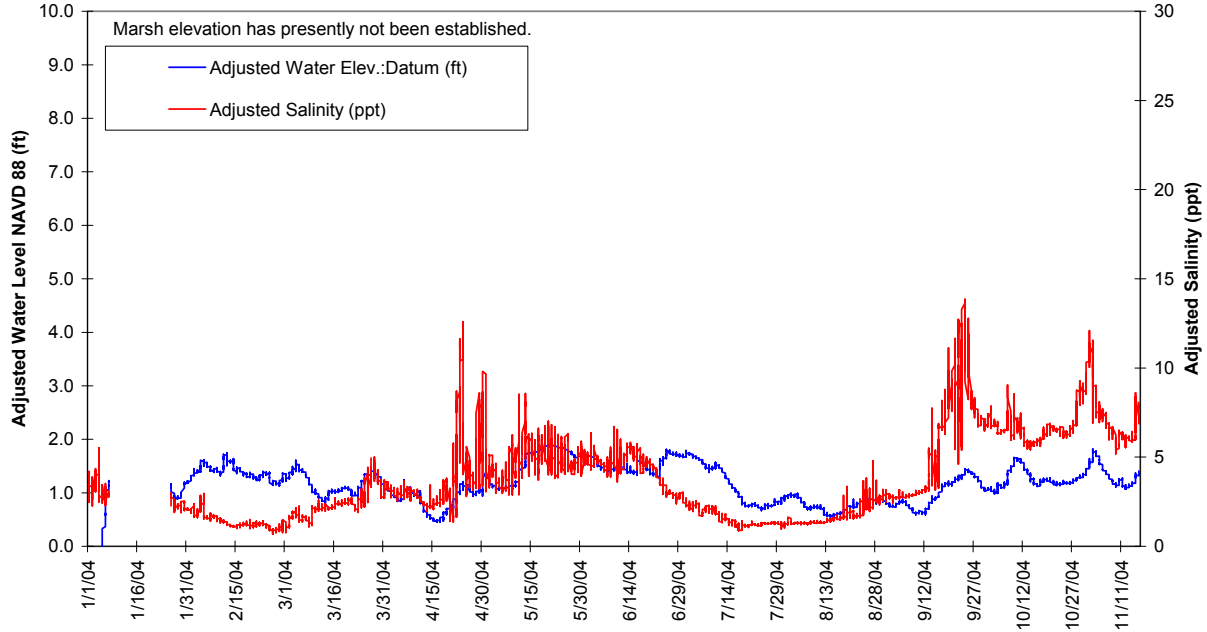
### Station CS02-05 (01/01/04 – 11/16/04) Salinity and Water Level Data

**Figure 10.** Hourly salinity and water level at station CS02-17 in the Sabine Structure Replacement (CS-23) project area. A water level reading above marsh elevation indicates that the marsh is flooded.

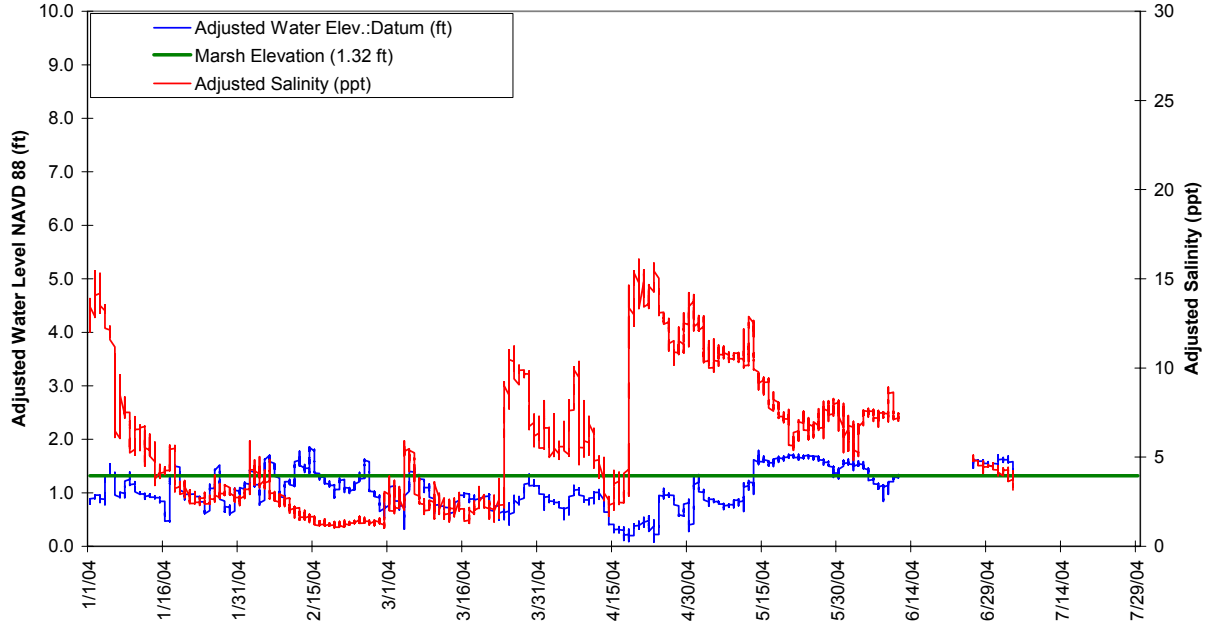
**Station CS02-17 (01/01/04 – 07/30/04)**  
**Salinity and Water Level Data**

**Figure 11.** Hourly salinity and water level at station CS02-17 in the Sabine Structure Replacement (CS-23) project area. A water level reading above marsh elevation indicates that the marsh is flooded.

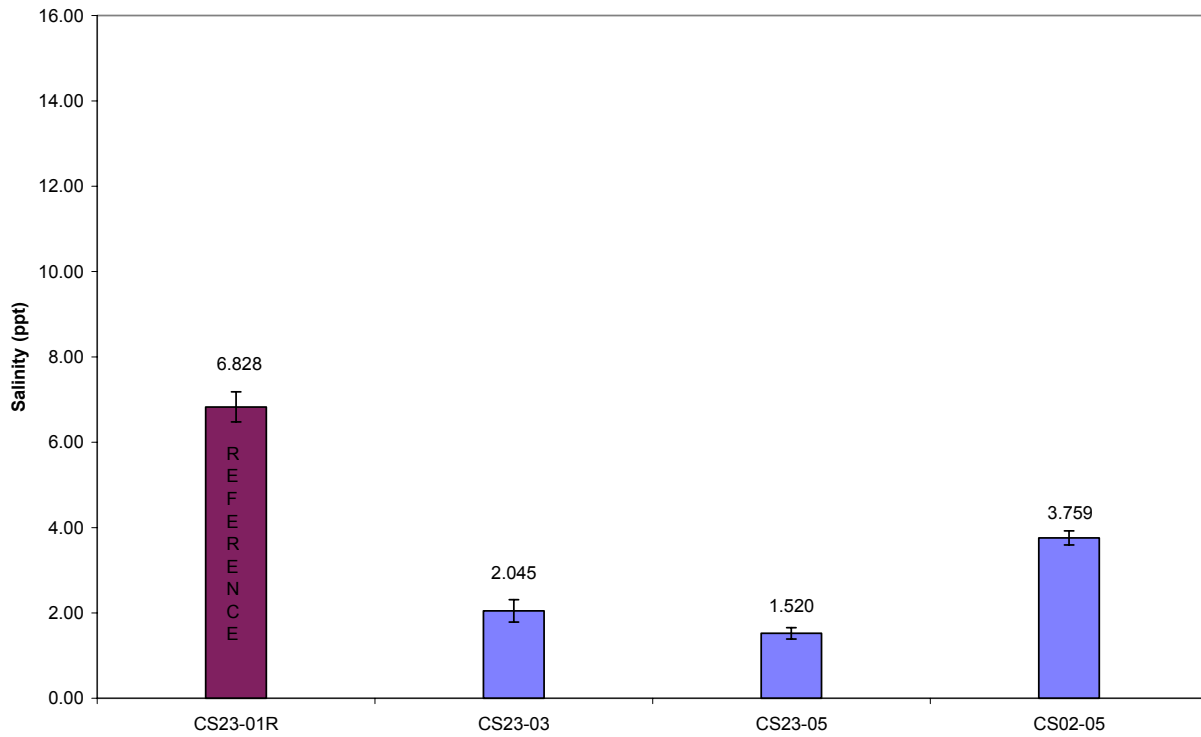
Project vs. Reference (47 weeks)

**Figure 12.** Yearly means derived from weekly means of salinity (ppt) at four continuous recorder stations located in the Sabine Structure Replacement (CS-23) project and reference areas for the period 01/01/04 – 11/16/04.

Hourly data were combined at each station to derive yearly mean values. Analysis of Variance (ANOVA) was conducted on yearly salinity means for 2004. Stations had significantly different salinities for 2004 ( $F_{3,3} = 159.4814$ ;  $P = 4.0001$ ). Post-ANOVA contrasts of each project station compared against the reference station revealed that all stations were significantly different from the reference station at the  $P < 0.05$  level ( $p < 0.0001$ ) (figure 12).

Electrical problems caused the electric motors to overheat on the Hog Island Gully and West Cove structures after the initial installation, and the structures are not fully operational at this time. Due to the inability to operate the structures correctly, salinity and water level spikes have occurred, although less frequently than during pre-construction. Yearly mean salinities derived from the weekly means were also lower within the project area when compared to the reference area (figure 12).

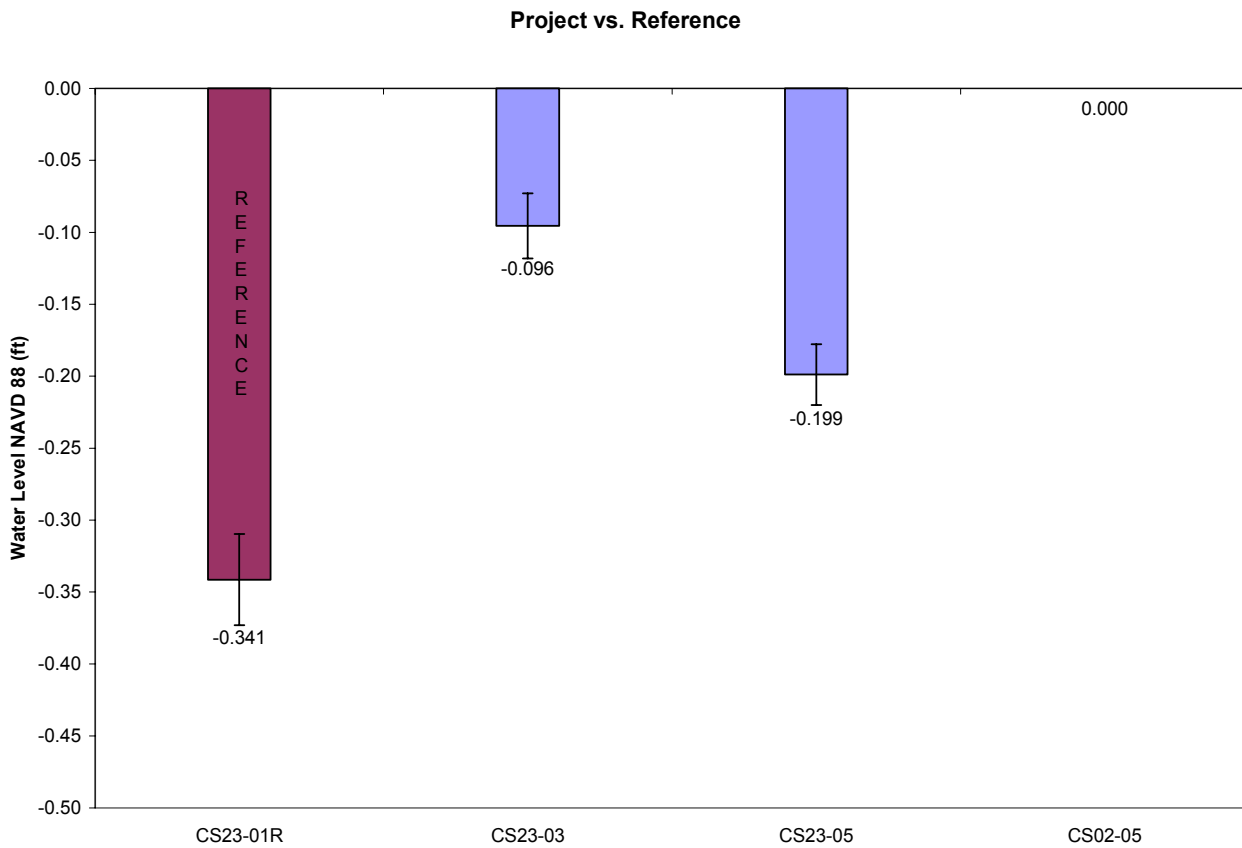
**Figure 14.** Yearly means derived from weekly means of water levels relative to marsh elevation (ft, NAVD 88) at four continuous recorder stations located in the Sabine Structure Replacement (CS-23) project and reference areas for the period 1/1/04 – 11/18/04.

Water levels relative to marsh elevation (ft, NAVD 88) were collected hourly at four stations associated within the CS-23 project and reference areas. Water circulation patterns relative to incoming tidal flows are depicted in figure 13. Hourly data were combined at each station to derive yearly mean values. ANOVA was conducted on yearly means of adjusted water level to marsh (ft) for 2004. Stations were significantly different from each other ( $F_{2,2} = 30.8$ ;  $P < 0.0001$ ). Post-ANOVA contrasts revealed that both stations CS23-03 (-0.096) and CS23-05 (-0.199) were significantly different from the reference CS23-01R (-0.341) station. However, water levels relative to marsh remained below the average marsh elevation of 1.41 ft (0.43 m) for the January 1–November 26, 2004, period (figure 14).

Water levels remained below the average marsh elevation of 1.41 ft (0.43 m) for the January 1-November 18, 2004 period (figure 14).
