# Holly Beach Sand Management (CS-31)

## Coastal Wetlands Planning, Protection, and Restoration Act

### 2005 and 2009 Land-Water Classifications

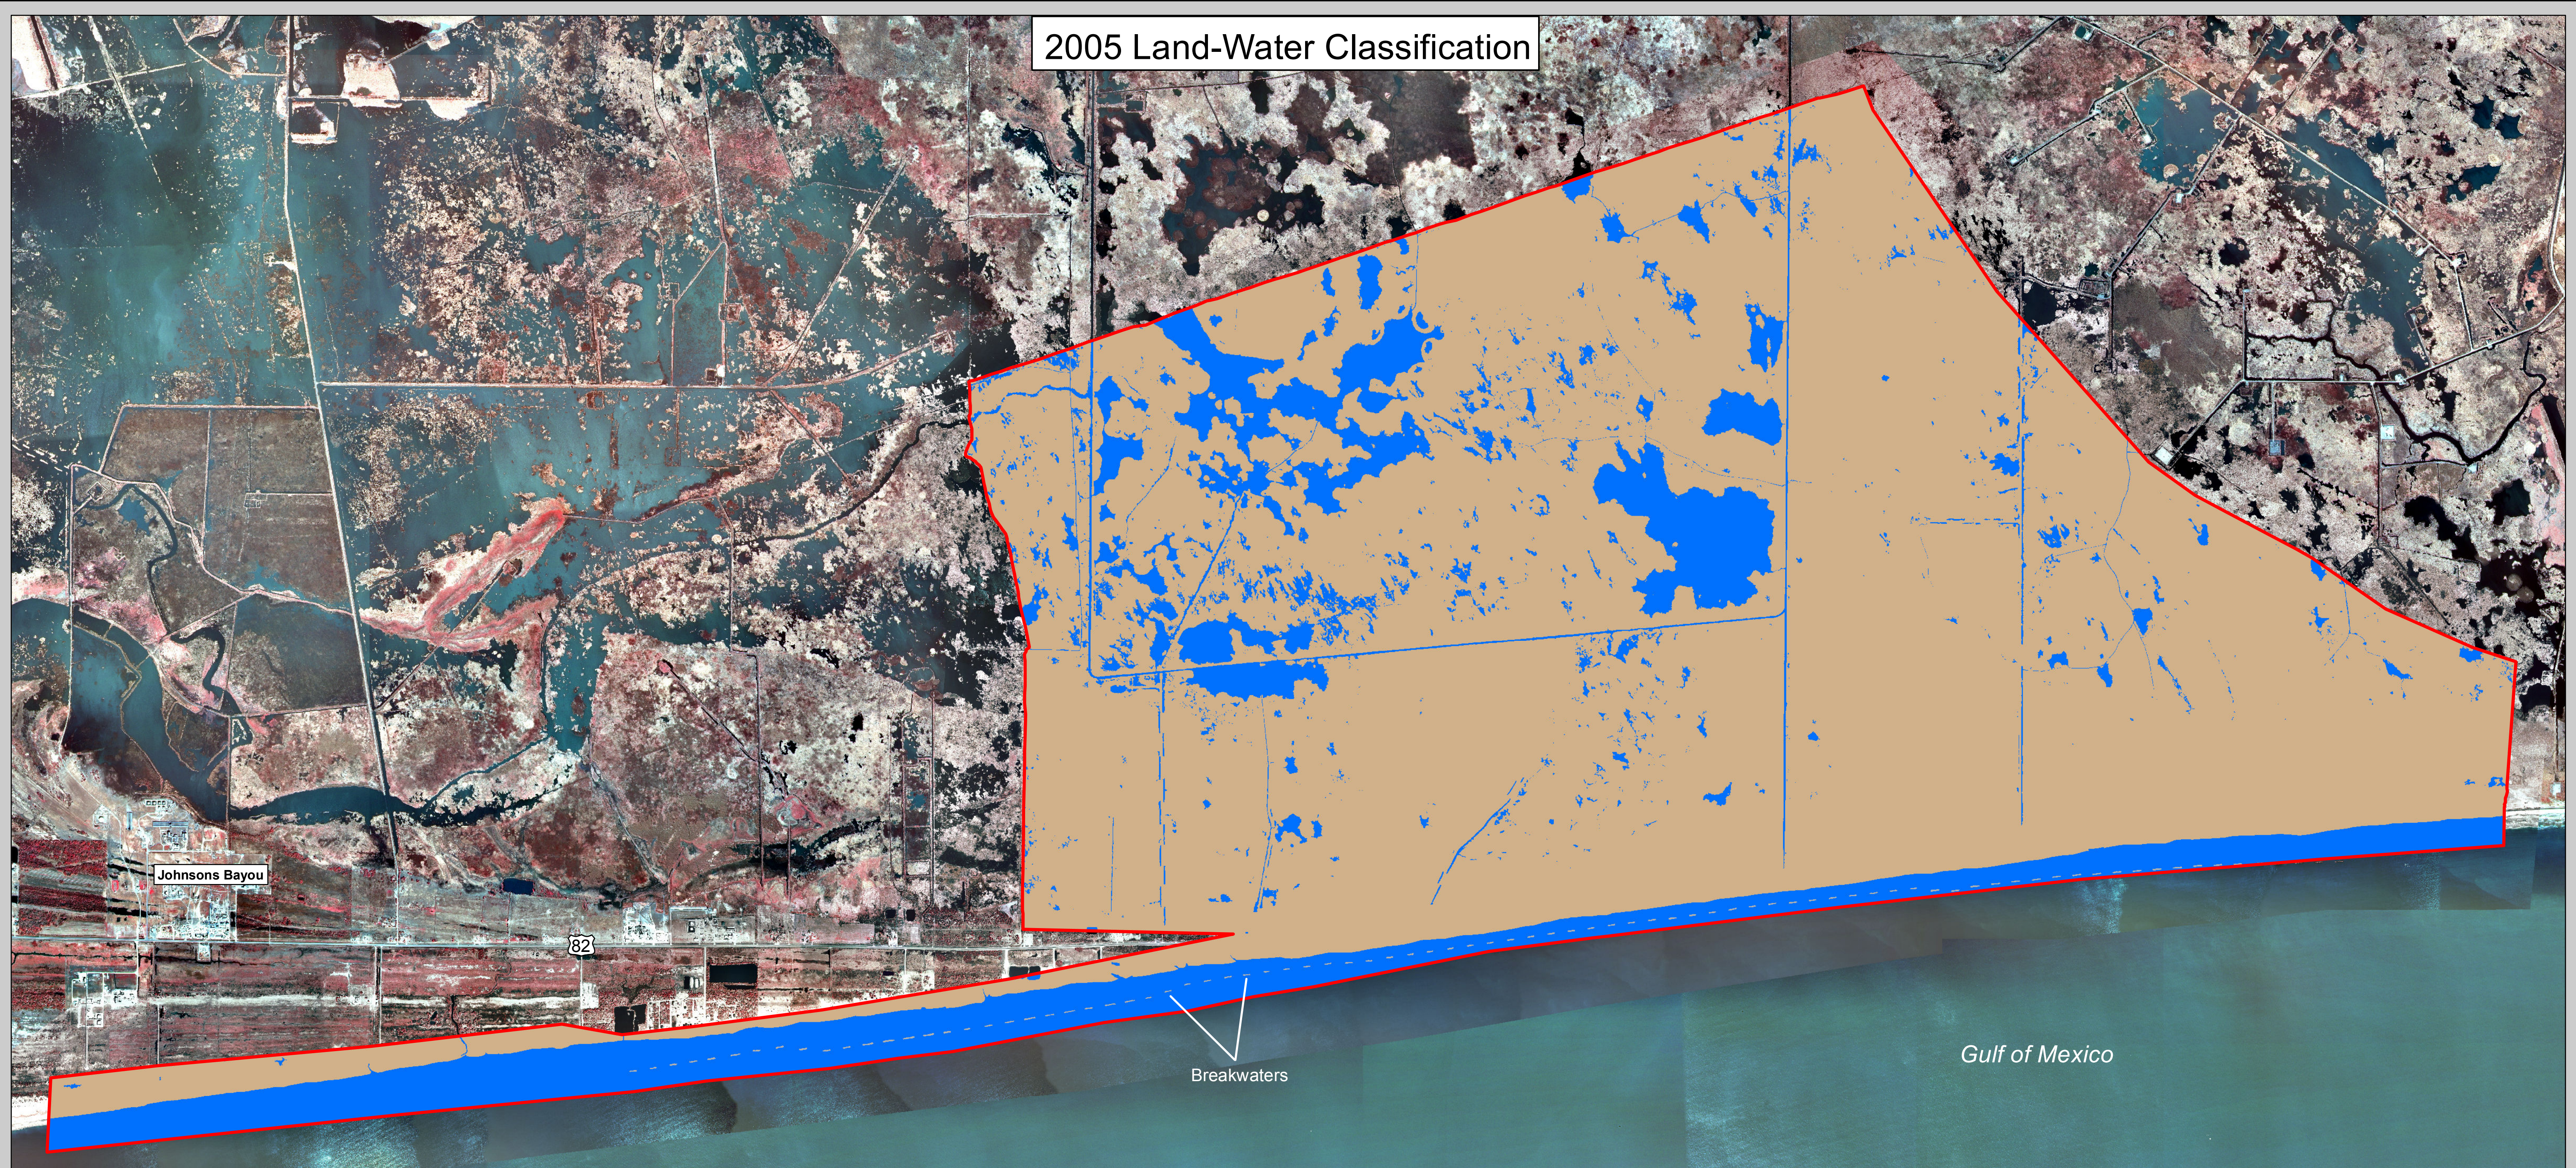
Class	2005 Project Acres	2009 Project Acres
Land	8,897	8,849
Water	1,894	1,946
Breakwaters	10	6
<b>Total</b>	<b>10,801</b>	<b>10,801</b>

**Land-Water Classification:**  
To conduct the land-water classification, aerial photographs were scanned, and classified into land and water categories. All areas characterized by emergent marsh, scrub-shrub, upland, and dunes that are not affected by tide were classified as land. Areas characterized by open water, aquatic beds, and mud flats were classified as water. Shoreline was established based on the line between regularly and irregularly flooded water regimes. Regularly flooded regimes are tidewaters that alternately flood and expose land surfaces at least once daily, while irregularly flooded regimes are tidewaters that flood land surfaces less often than daily.
