# **E C O L O G I C A L   R E V I E W**

**Raccoon Island Shoreline Protection/Marsh Creation, Phase A**  
CWPPRA Priority Project List 11  
State No. TE-48

September 16, 2004

Karim Belhadjali  
Restoration Technology Section  
Coastal Restoration Division  
Louisiana Department of Natural Resources

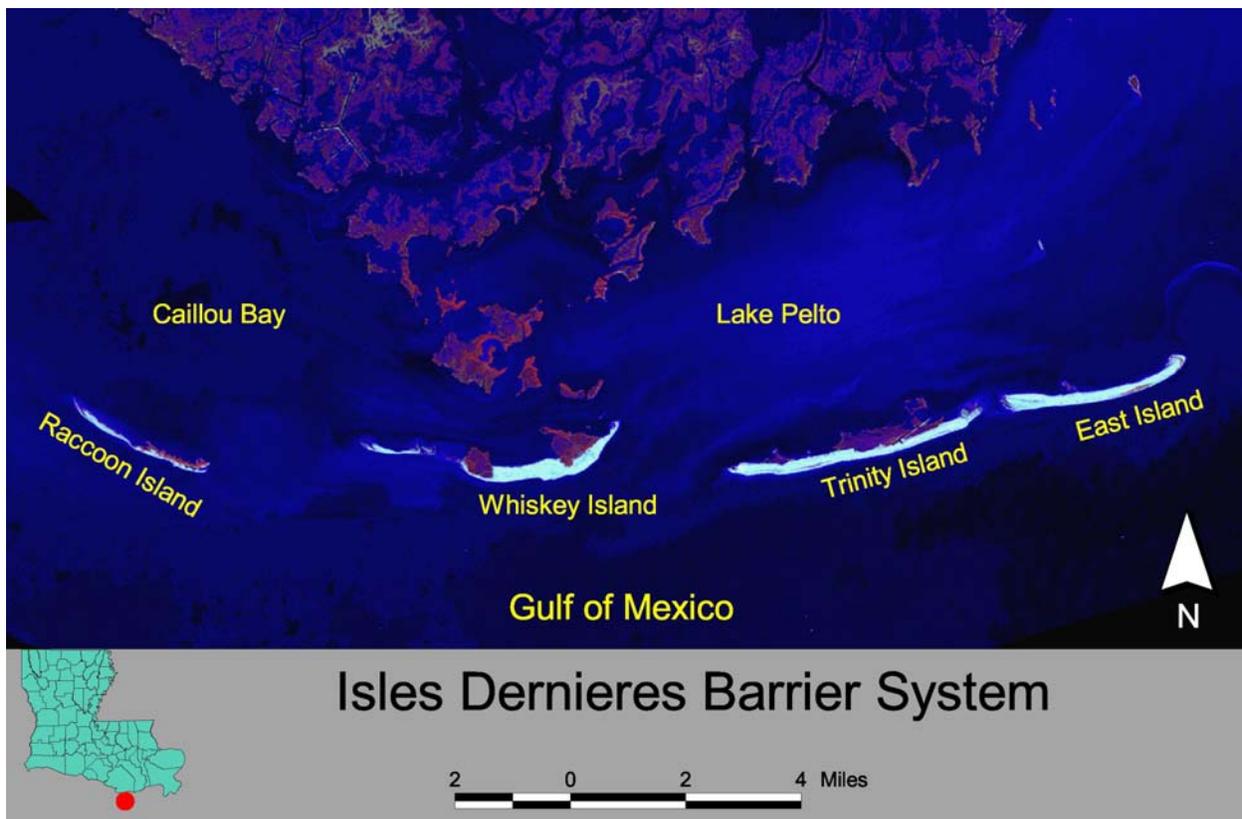
Figure 1: Isles Dernieres, Louisiana.

The Raccoon Island Shoreline Protection/Marsh Creation project is located in Terrebonne Parish, approximately 50 miles south of Houma, Louisiana. Raccoon Island is part of the Isles Dernieres, a 20 mile long island arc composed of four islands: Raccoon Island, Whiskey Island, Trinity Island and East Island (Figure 1). Raccoon Island is currently a part of the Louisiana Department of Wildlife and Fisheries' Isle Dernieres Barrier Islands Refuge, and exhibits some of the highest species richness and abundance of nesting colonial water birds in the state. One of the most important brown pelican and roseate spoonbill nesting colonies in Louisiana is found on Raccoon Island. It is also one of the few nesting sites in Louisiana for the reddish egret. Other species that nest there in large numbers include, but are not limited to, the great egret, white ibis, black skimmer, least tern, sandwich tern, royal tern and gull-billed tern (Mike Carloss, Natural Resources Conservation Service, Personal Communications, June 18, 2004).

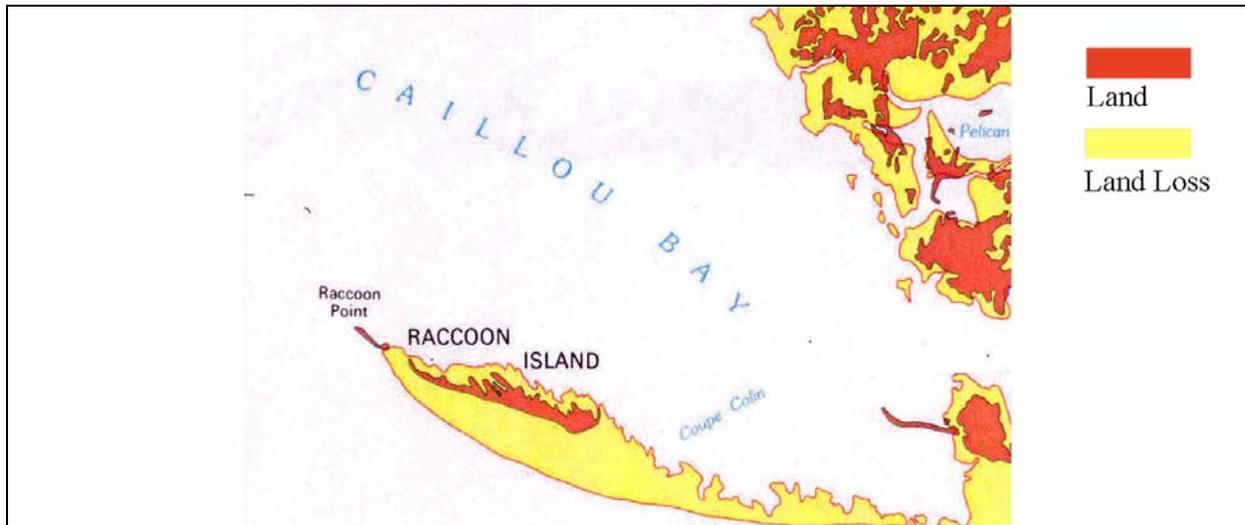
Figure 2: Historical shoreline change at Raccoon Island from the 1890's to 1988 (modified from McBride et al. 1992).

Raccoon Island is experiencing landward migration, area loss, bayside erosion and island narrowing due to an interaction of several factors such as subsidence, eustatic sea level rise, wave processes, storm impacts, inadequate sediment supply and human disturbances (McBride and Byrnes 1997). The average width of Raccoon Island has changed from 2,736 feet in the 1890's to 813 feet in 1988 (McBride et al. 1992) (Figure 2).

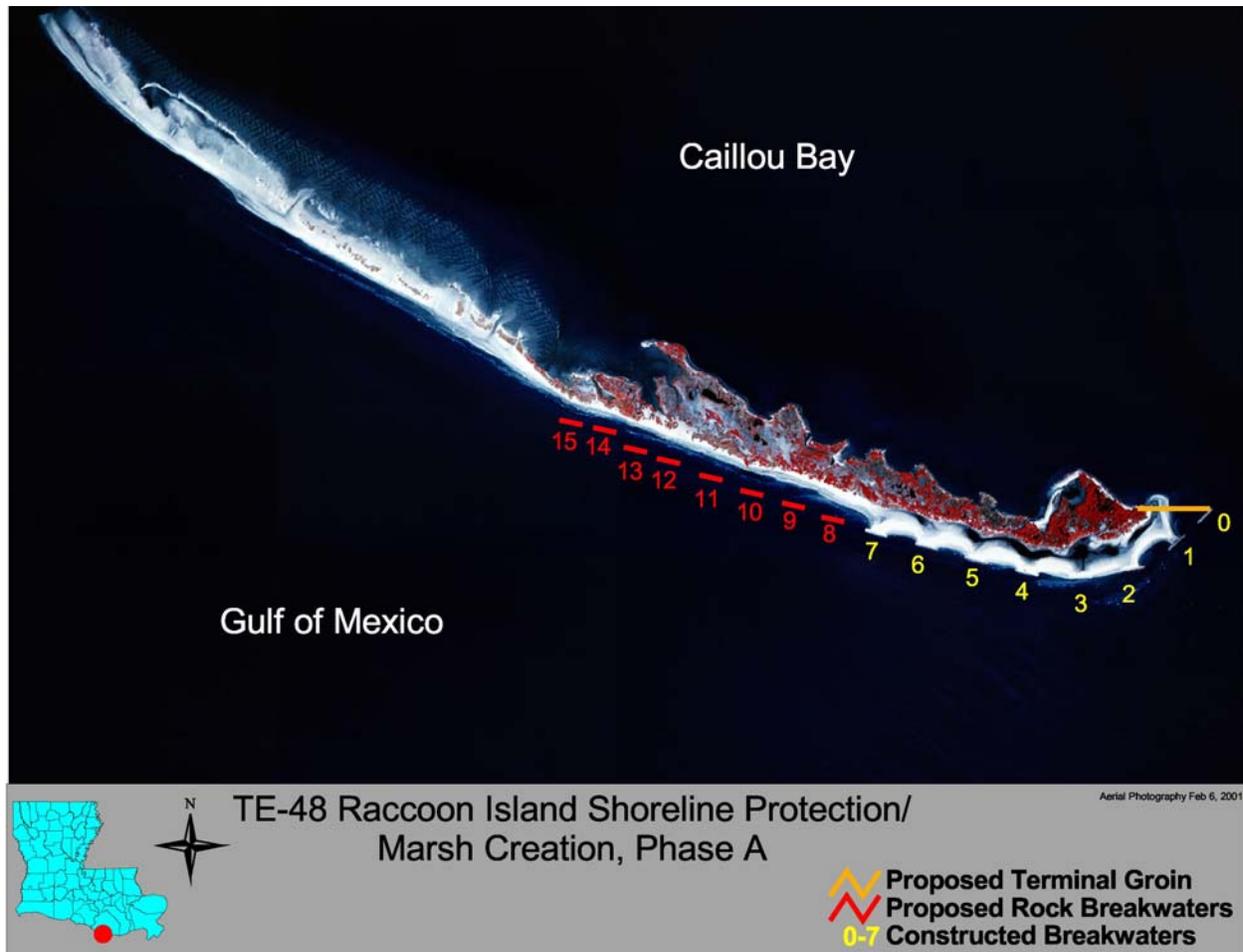
Figure 3: TE-48, Phase A, project features.

The Raccoon Island Shoreline Protection/Marsh Creation project is co-sponsored by the Natural Resources Conservation Service (NRCS) and the Louisiana Department of Natural Resources (LDNR) (Figure 3). The project is designed to reduce the rate of gulf shoreline retreat through the construction of rock breakwaters and to create over 60 acres of marsh as new habitat for avian species, through the direct placement of dredged material (NRCS and LDNR 2001). Restoring and maintaining the Isles Dernieres barrier island chain was recommended by Coast 2050 as regional ecosystem strategies [Louisiana Coastal Wetlands Conservation and Restoration Task Force and the Wetlands Conservation and Restoration Authority (LCWCRTF&WCRA) 1999]. This strategy would restore the barrier island chain to a “condition suitable for maintaining the integrity of the estuarine system” (LCWCRTF&WCRA 1998).

In order to test the effectiveness of segmented breakwaters in mitigating shoreline erosion along the Louisiana barrier islands and to evaluate their potential role in future barrier island restoration projects, the Raccoon Island Breakwaters Demonstration (TE-29) project was constructed along the eastern gulf shoreline of Raccoon Island in June and July of 1997. Eight segmented breakwaters, labeled 0-7, were deployed approximately 300 feet off the southeastern shoreline of Raccoon Island and their effects on shoreline retreat were monitored (Figure 3).

The project is anticipated to reduce the rate of shoreline erosion by approximately 60% through the construction of eight segmented breakwaters as a westward continuation of the Raccoon Island Breakwaters Demonstration (TE-29) project, and construction of a terminal groin at the eastern end of the breakwater field (Figure 3).
