West Hackberry Vegetative Planting Demonstration (CS-19)

Project Status

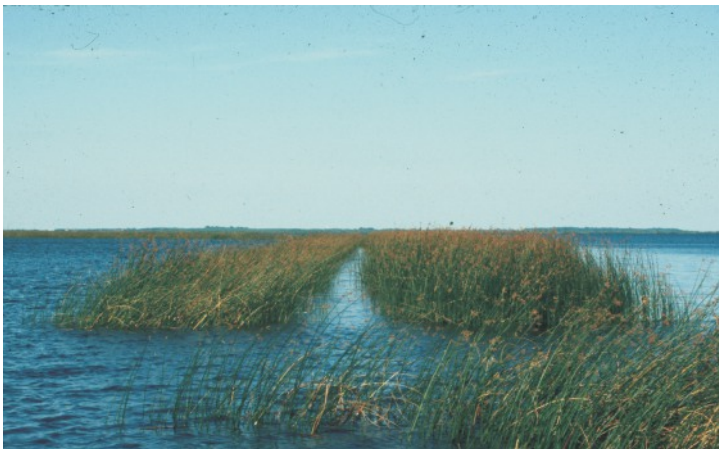
California bulrush plantings after prolonged exposure to elevated salinity levels.

California bulrush plantings were initially successful, creating 4.3 acres of emergent vegetation that formed an effective wave buffer. However, following droughts in 1996 and 1999-2000, less than 1.2 acres survived. During the drought of 1996, salinity levels rarely fell below 20 parts per thousand (ppt) for six weeks, and salinity levels averaged 15 to 20 ppt for the period of drought in 1999 to 2000. Prolonged exposure to these extreme conditions exceeds the typical salinity tolerance of California bulrush. Nevertheless, some plants did manage to survive the droughts and eventually showed gain in lateral spread, although thinning within the plots was noted.

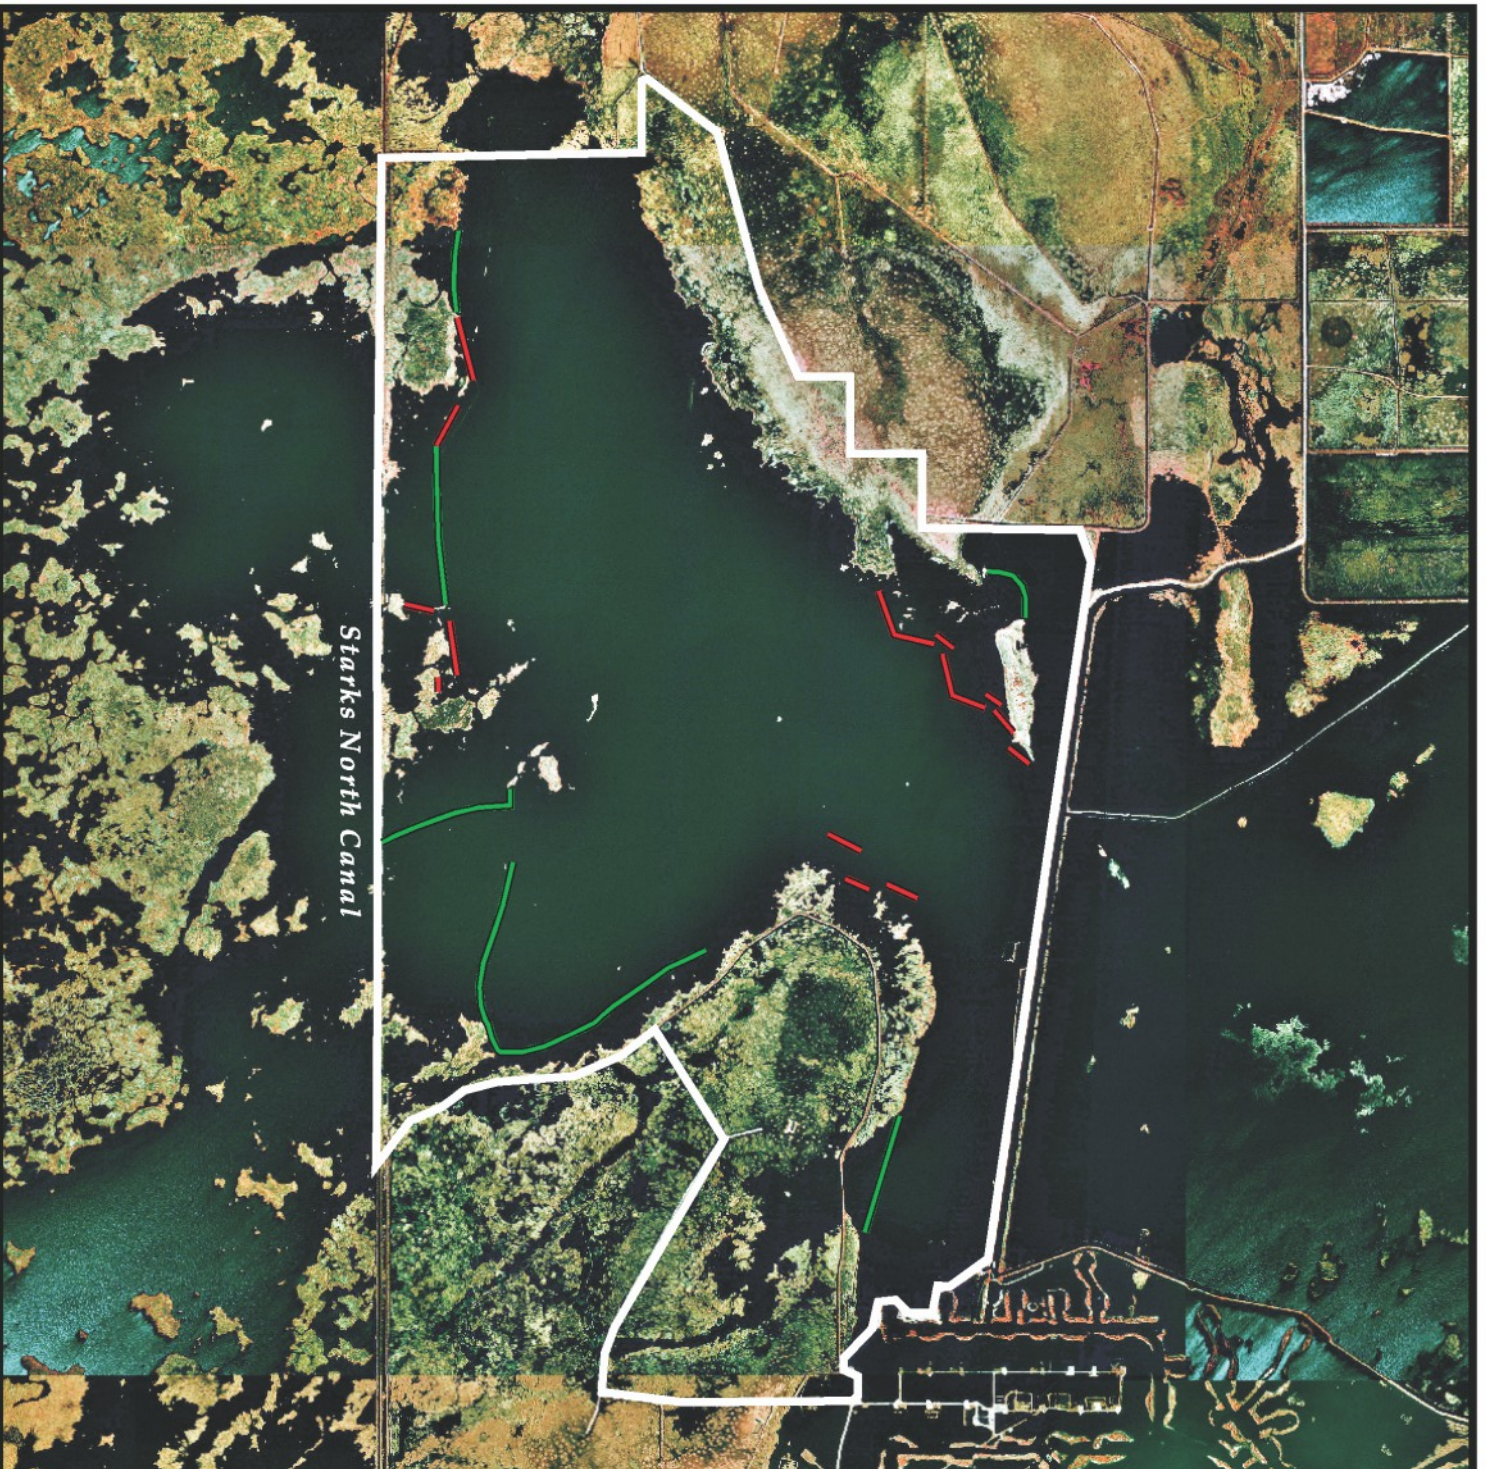
West Hackberry Vegetative Planting Demonstration (CS-19)

Vegetative Planting
 	Sediment Fence
 	Project Boundary

In April 1994, 6,000 linear feet of hay-bale fencing segments were constructed parallel to the project area shorelines in an effort to reduce erosion from wind-induced wave energy, and increase the amount of sediment deposition.

In June 1994, 4,750 California bulrush (*Schoenoplectus californicus*) plants were installed along 11,875 linear feet of marsh shoreline to protect against wave erosion.
