# West Hackberry Vegetative Planting Demonstration (CS-19)

## Project Status

**Approved Date:** 1991      **Project Area:** 0 acres  
**Approved Funds:** \$0.25 M      **Total Est. Cost:** \$0.25 M  
**Net Benefit After 20 Years:** 0 acres  
**Status:** Completed March 1994  
**Project Type:** Demonstration: Vegetative Planting and Sediment Trapping

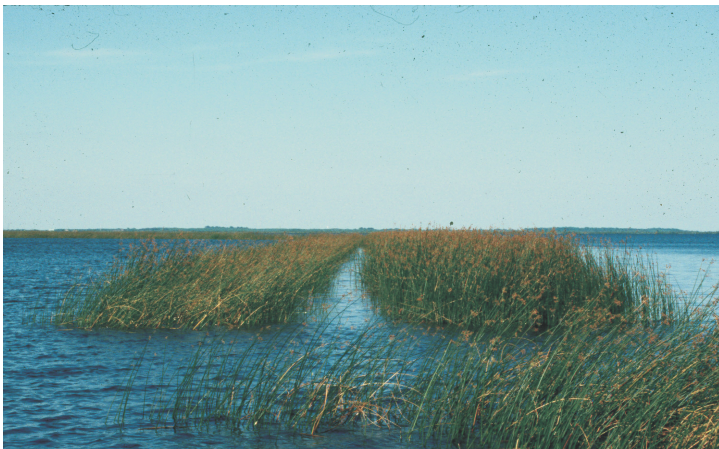
California bulrush plantings after prolonged exposure to elevated salinity levels.

California bulrush plantings were initially successful, creating 4.3 acres of emergent vegetation that formed an effective wave buffer. However, following droughts in 1996 and 1999-2000, less than 1.2 acres survived. During the drought of 1996, salinity levels rarely fell below 20 parts per thousand (ppt) for six weeks, and salinity levels averaged 15 to 20 ppt for the period of drought in 1999 to 2000. Prolonged exposure to these extreme conditions exceeds the typical salinity tolerance of California bulrush. Nevertheless, some plants did manage to survive the droughts and eventually showed gain in lateral spread, although thinning within the plots was noted.

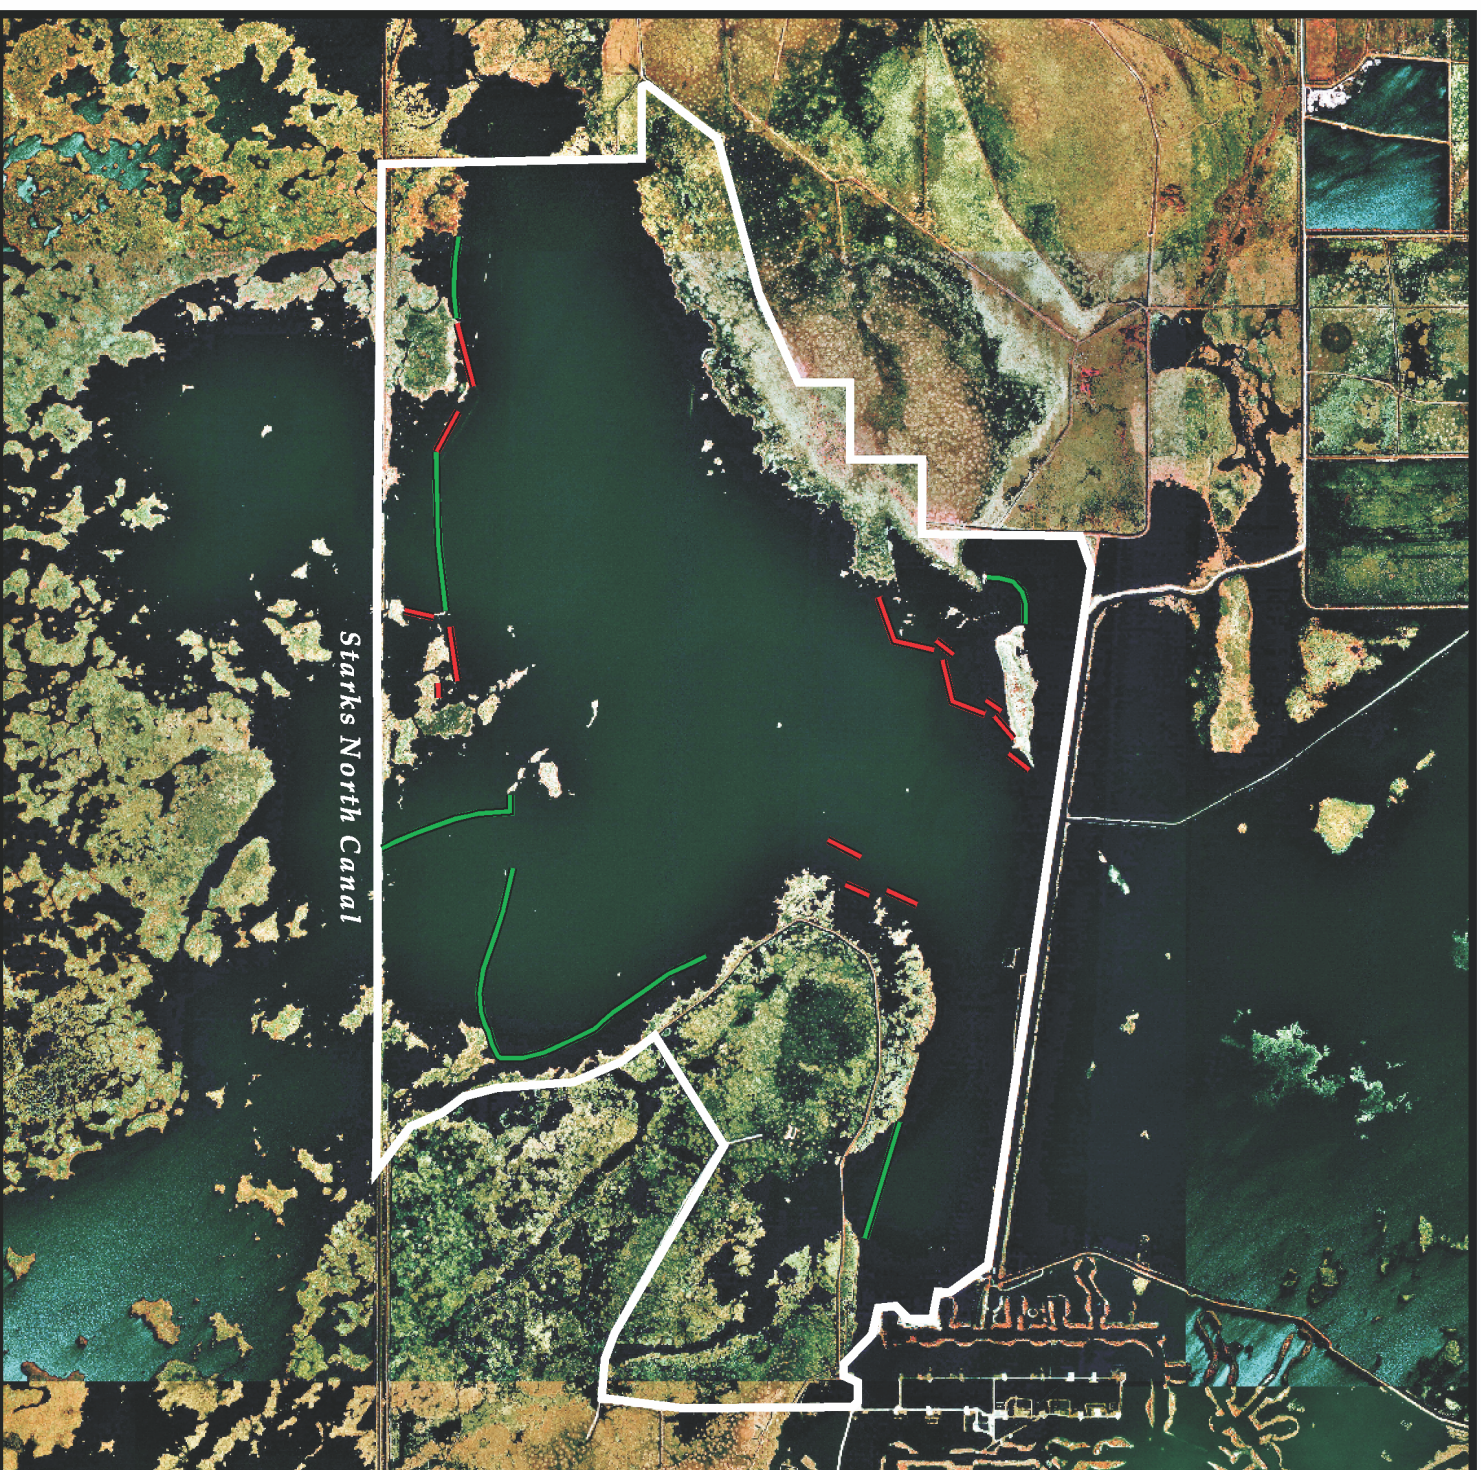
Vegetative Planting
-

Sediment Fence
-

Project Boundary

In April 1994, 6,000 linear feet of hay-bale fencing segments were constructed parallel to the project area shorelines in an effort to reduce erosion from wind-induced wave energy, and increase the amount of sediment deposition.

In June 1994, 4,750 California bulrush (*Schoenoplectus californicus*) plants were installed along 11,875 linear feet of marsh shoreline to protect against wave erosion.
