**2012/2013 Annual Inspection
Report**

**CAMERON PRAIRIE REFUGE
PROTECTION PROJECT
(ME-09)**

State Project Number ME-09
Priority Project List 1

June 12, 2013
Cameron Parish

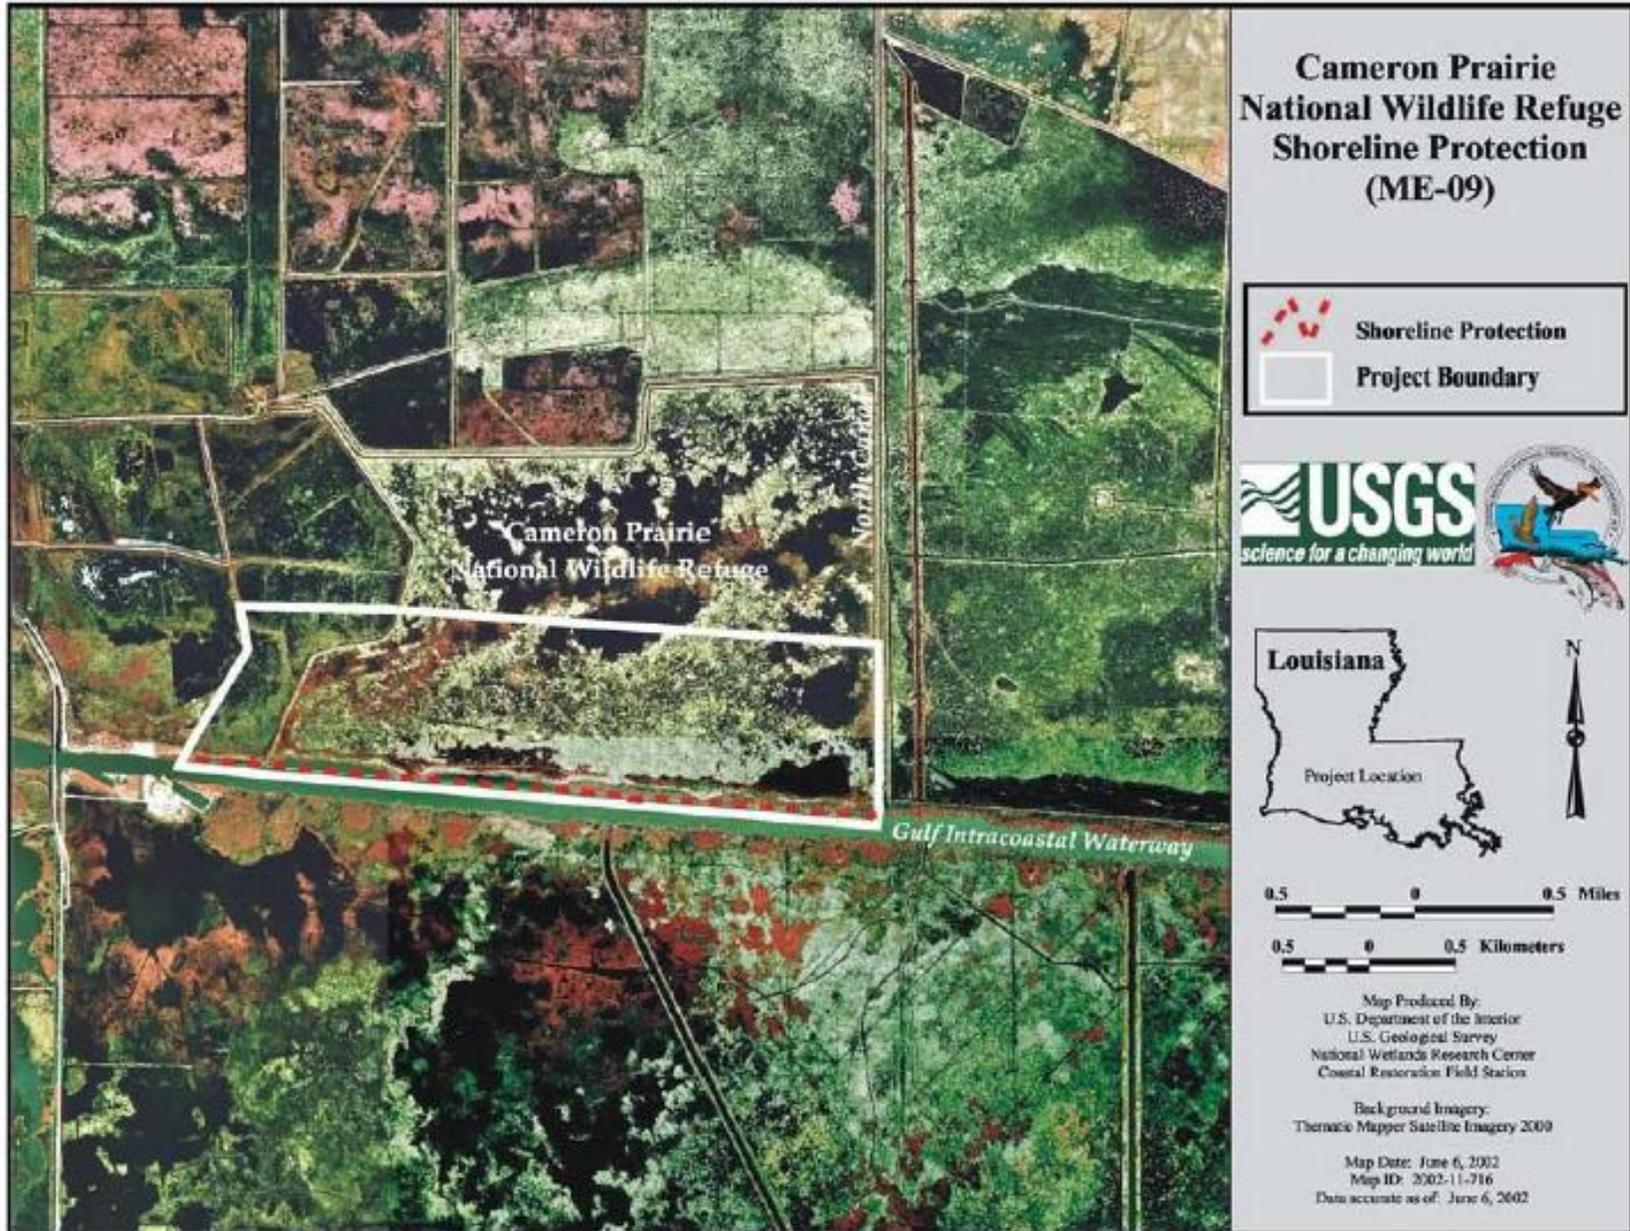
Appendix A
Project Features Map

- Approximately 13,200 linear feet of foreshore rock dike along the northern bank of the GIWW.
