2010 Operations, Maintenance, and Monitoring Report

GIWW (Gulf Intracoastal Waterway) to Clovelly Hydrologic Restoration (BA-02)

State Project Number BA-02
Priority Project List 1

December 2010
Lafourche Parish

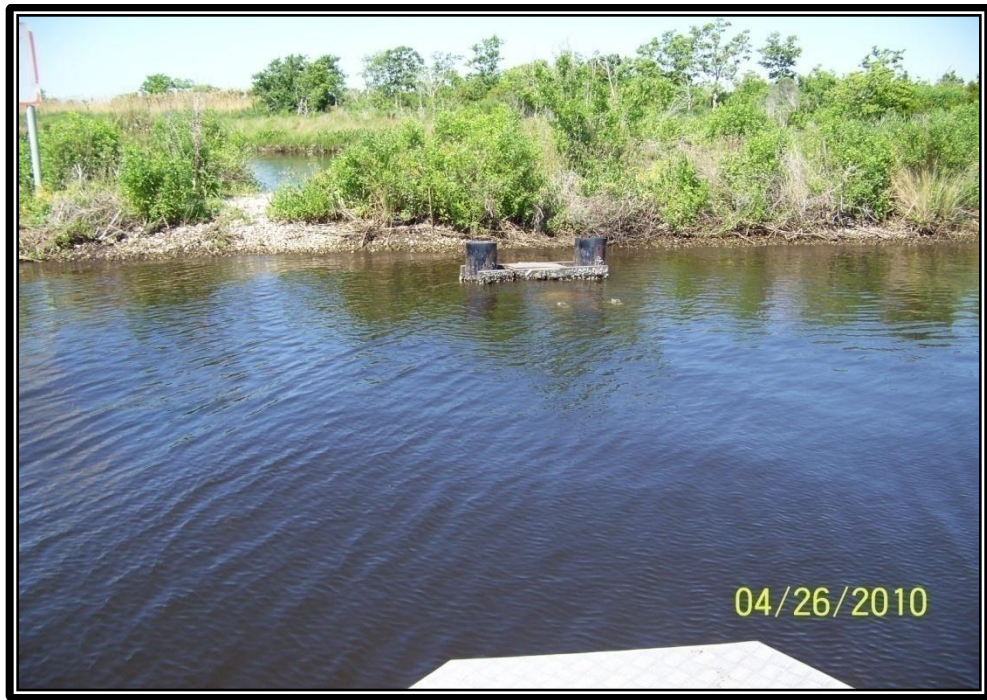
The rock plug structure with flap-gate appeared to be in good condition with no indication of settlement or washouts around embankment tie-ins of the structure. The culvert, flap gate, signs,

Photo No. 12 – view of rock plug (Structure 91) with corrugated culvert and flap gate through the embankment.

The rock plug was in good condition with no obvious settlement or erosion around the bank tie-ins. However, we did identify minor maintenance which included severe corrosion of the metal caps covering the butts of the timber piles supporting the culver and flap gate. To prevent rotting of the timber pile heads, the metal sheeting on the top the timber piles will be replaced. As preventative maintenance, we will also be removing the flap gate attached to the culvert for inspection and cleaning, if required.

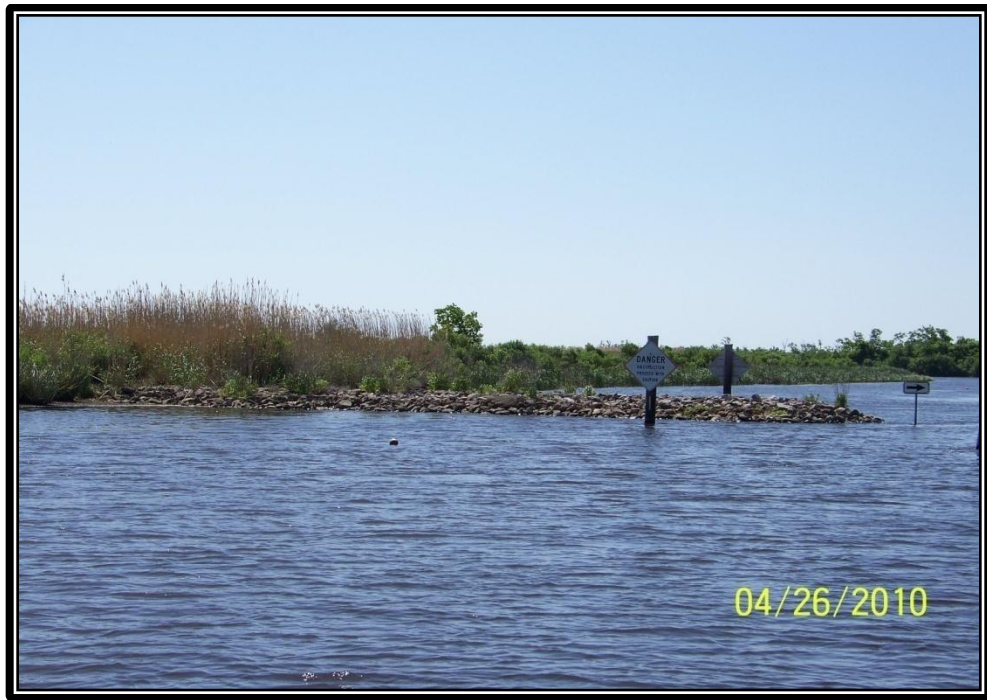
Photo No. 14 – view of the rock dike section and bank tie-in on the west side of Structure No.1 looking north.

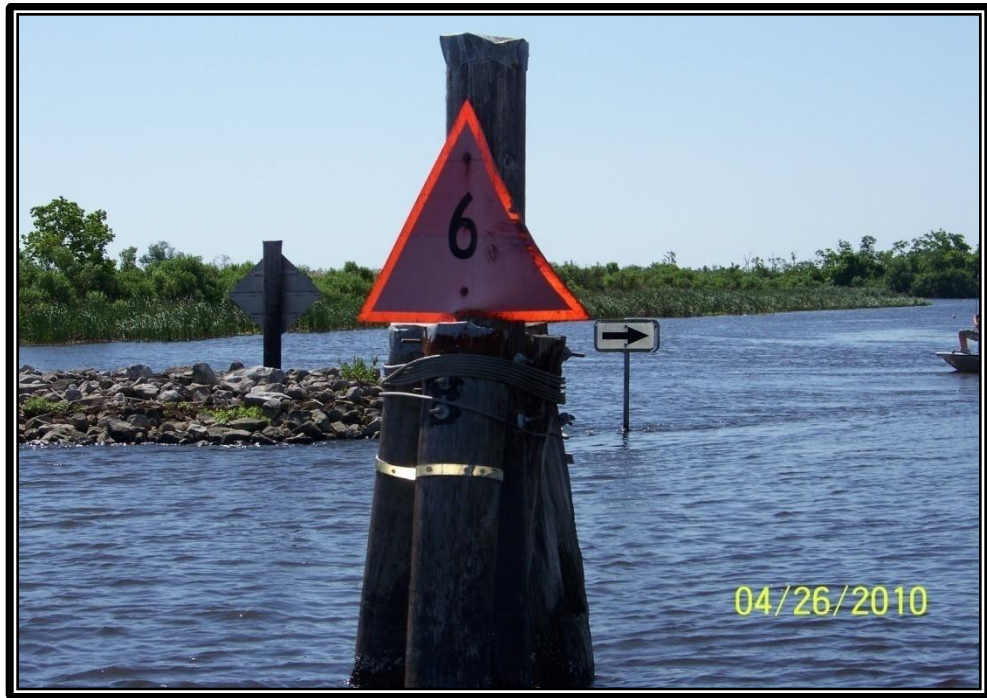
The deficiencies at Structure No.1 were limited to the four (4) timber cluster piles near the entrance of the barge bay. The timber structure on the southwest side of the barge bay was completely destroyed and not longer exists and the other three (3) cluster piles were severely damaged with large splits down the middle of the piles, the batter piles were off center and the surface of all the timbers were worn or scarred from marine vessels rubbing the timbers while accessing the barge bay. Under the 2010 Maintenance Project, all four (4) timber pile clusters will be removed and replaced with new material including hardware, cables and signage. With concurrence from NRCS, we are also recommending that the new structures be relocated slightly outwards (6" to 1') to allow additional clearance for barge vessels to move through the barge opening without interference.

Photo No.15 – view of timber pile dolphin on the northeast side of the barge bay entrance of Structure No.1.

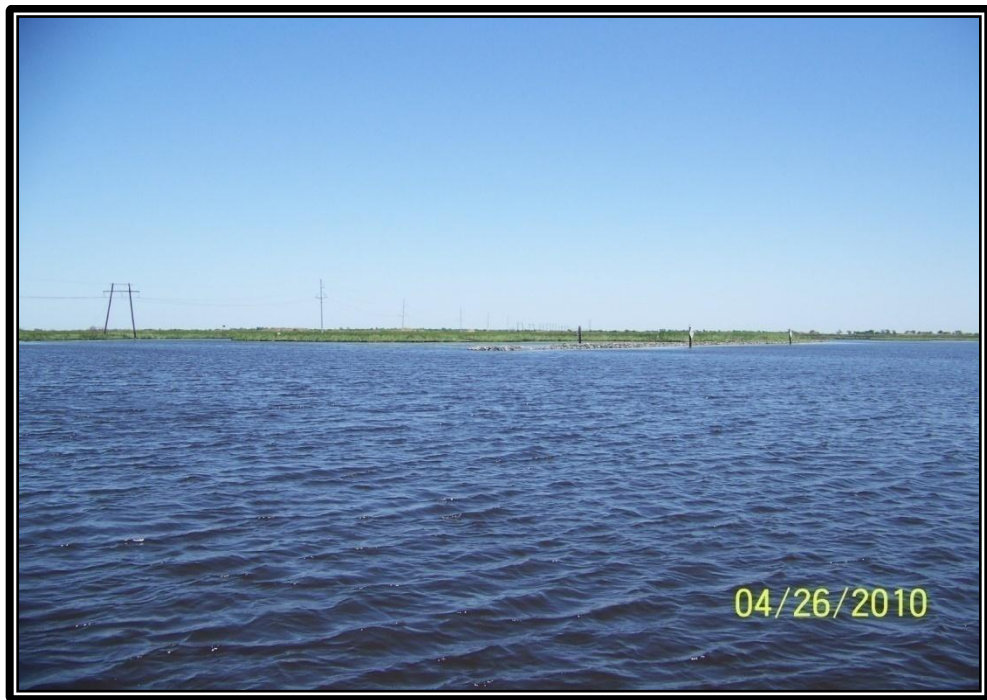
The rock plug structures appeared to be in poor condition with substantial settlement ranging between 1.5' to 2.0'. The critical area of concern associated with this structure is large breach that has developed on the south side of the structure resulting from the 2008 storms. The marsh on the south side of the structure is completely gone with very little shoreline remaining to facilitate a breach closure by extending the structure. Considering the size of the breach and the vulnerability of the interior marsh in this area, we have included a rock dike extension in the 2010 Maintenance Project that consist of refurbishing Structures 4A & 4B to the original design elevation and extending the rock plug across the breach opening and along the existing shoreline approximately 1,500 linear feet, creating a closure with Structure 4.

Photo No.18 – view of rock plug (Structures 4A & 4B) along the west shoreline of Bay L' Ours.

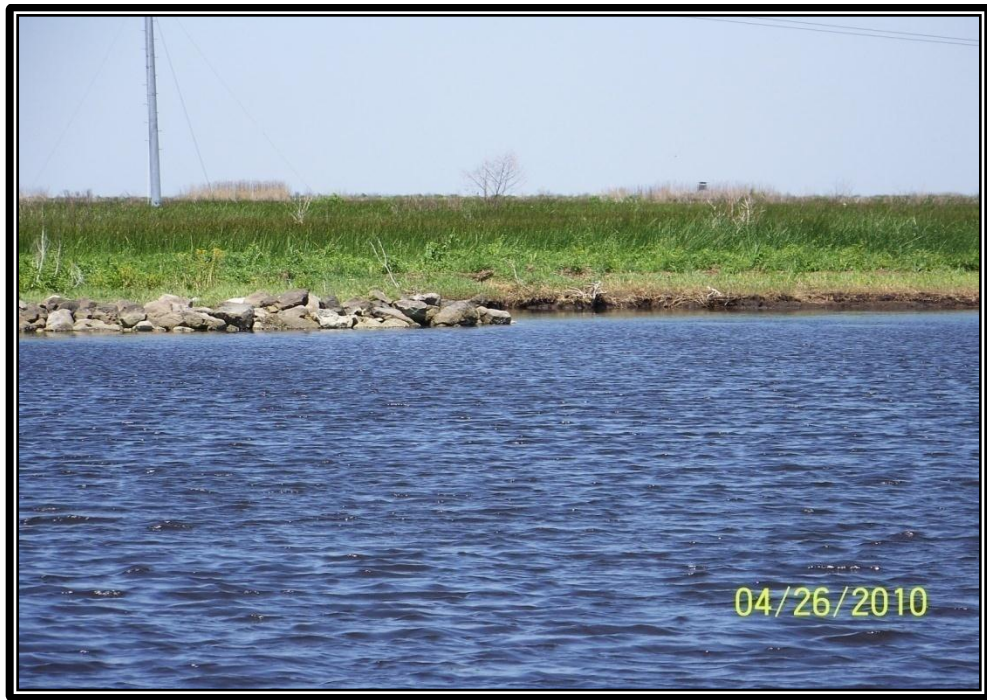
Photo No.20 – view of the north side of the rock plug (Structures 4A & 4B) and the adjacent marsh tie-in.

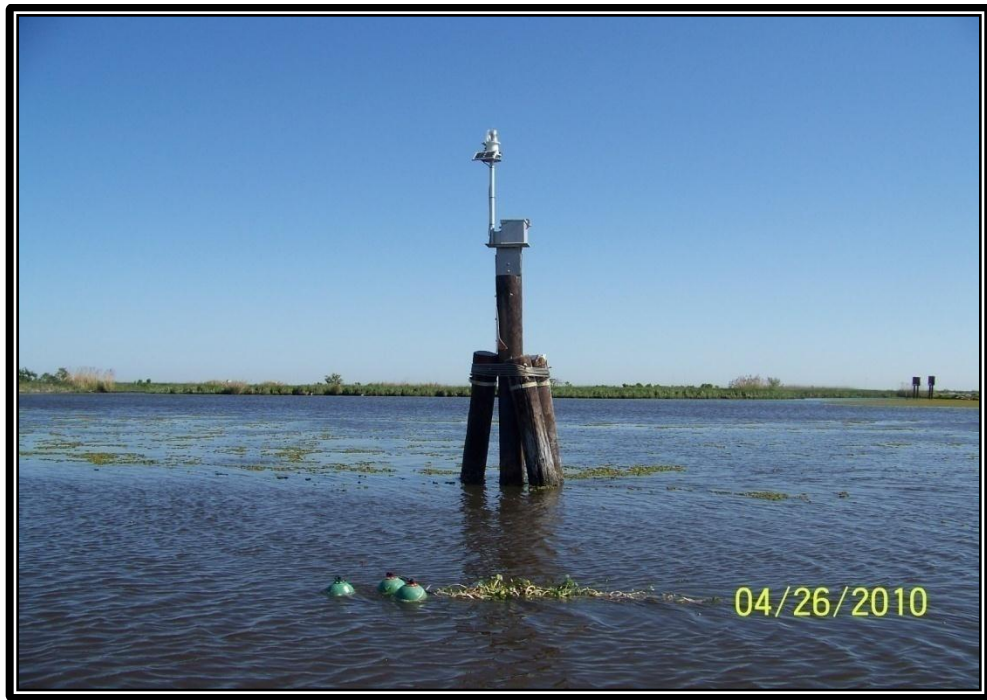
Structure No.14A was in fair to good condition with significant damage to the timber cluster piles supporting the navigational aids and severe settlement and scour of the rock pad below the barge bay opening. We believe that the strong currents moving through the barge bay opening may be responsible for the excessive scour of the rock pad beneath the barge bay. To reduce the scour, we are recommending that the existing scour pad be replaced with a larger stone under the 2010 Maintenance Project. We will also be replacing three (3) of the four (4) timber pile clusters supports for the navigational aid lights as well.

Photo No.22 – view of timber dolphin support structure and navigational aid on the northwest side of Structure No. 14A.

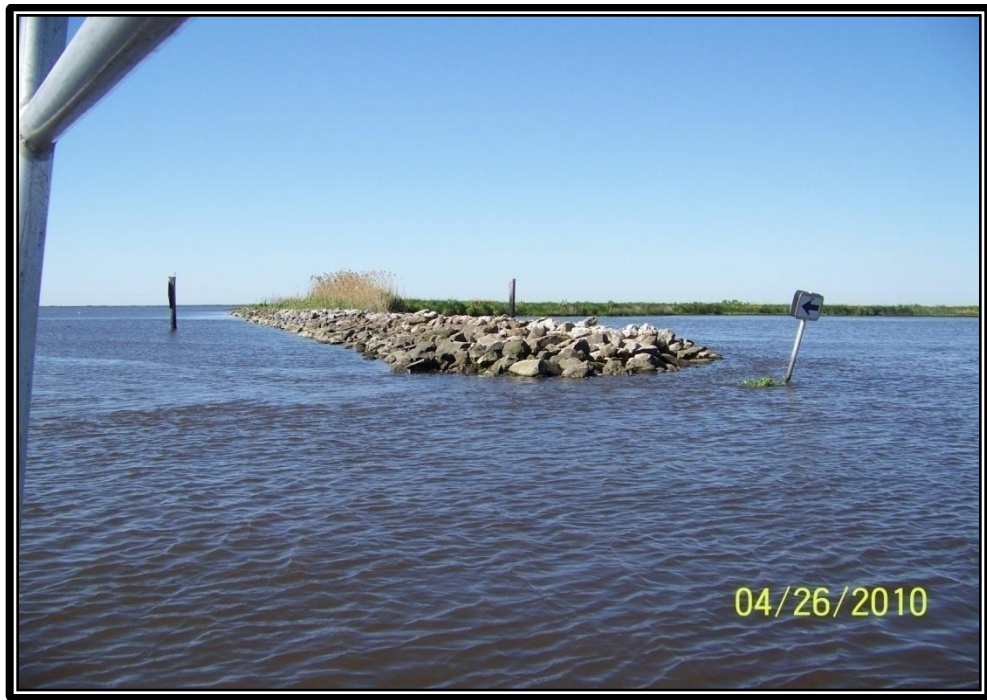
Photo No.24 – view of rock dike section near the barge bay of Structure 14A looking south.

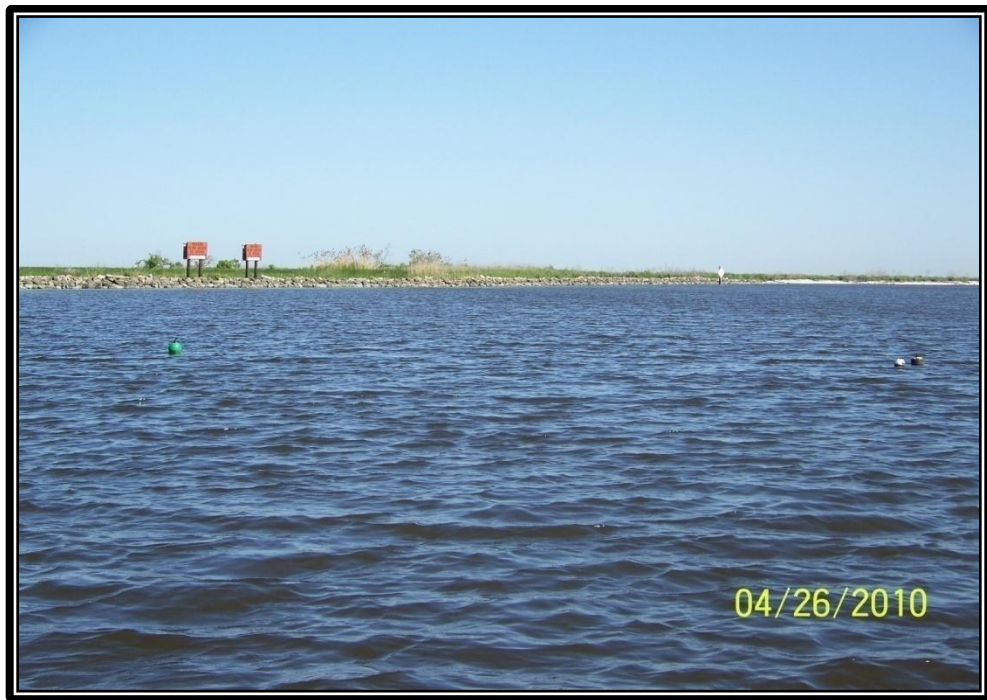
Photo No.26 – view of rock dike section of Structure 14A north of the barge bay.

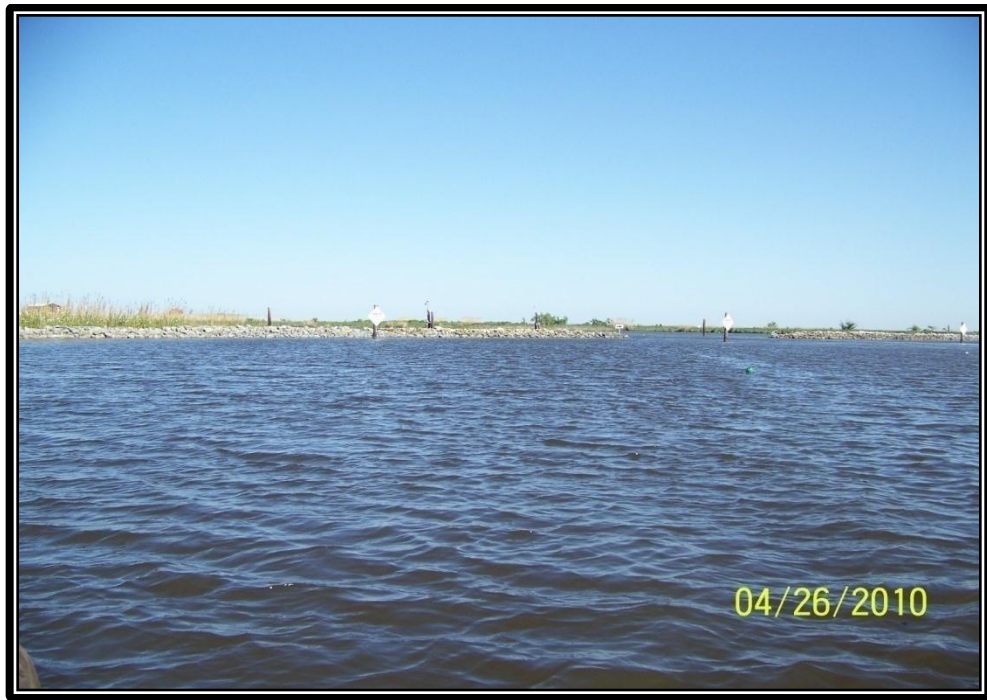
Photo No.28 – view of rock dike section and barge bay of Structure 14A looking northwest.

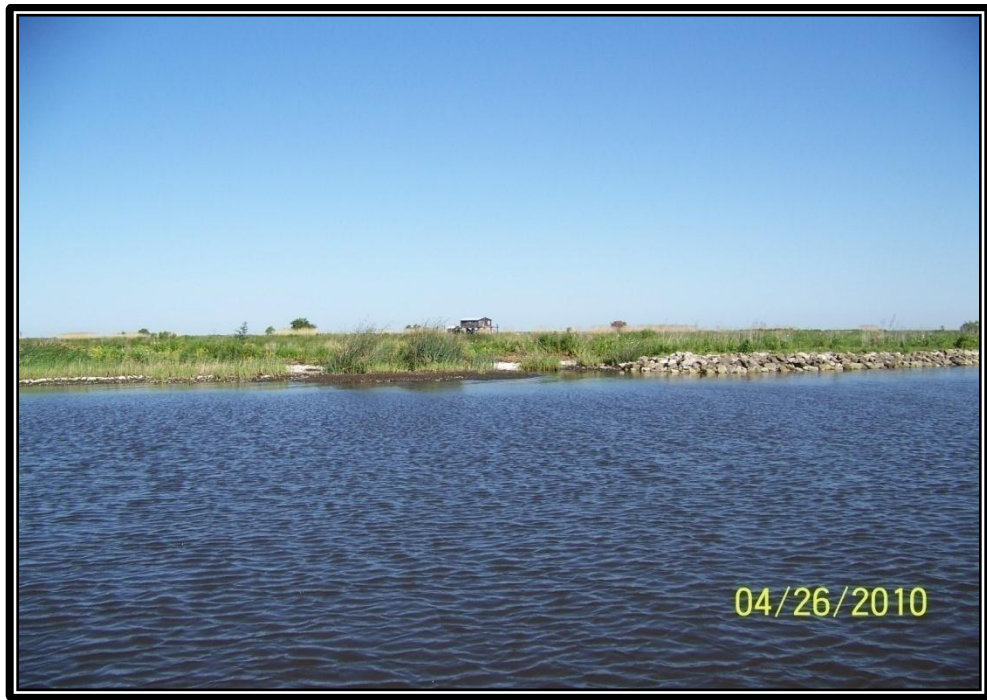
Photo No. 30 – view of the rock dike tie-in to the shoreline on the south side of Structure 14A.

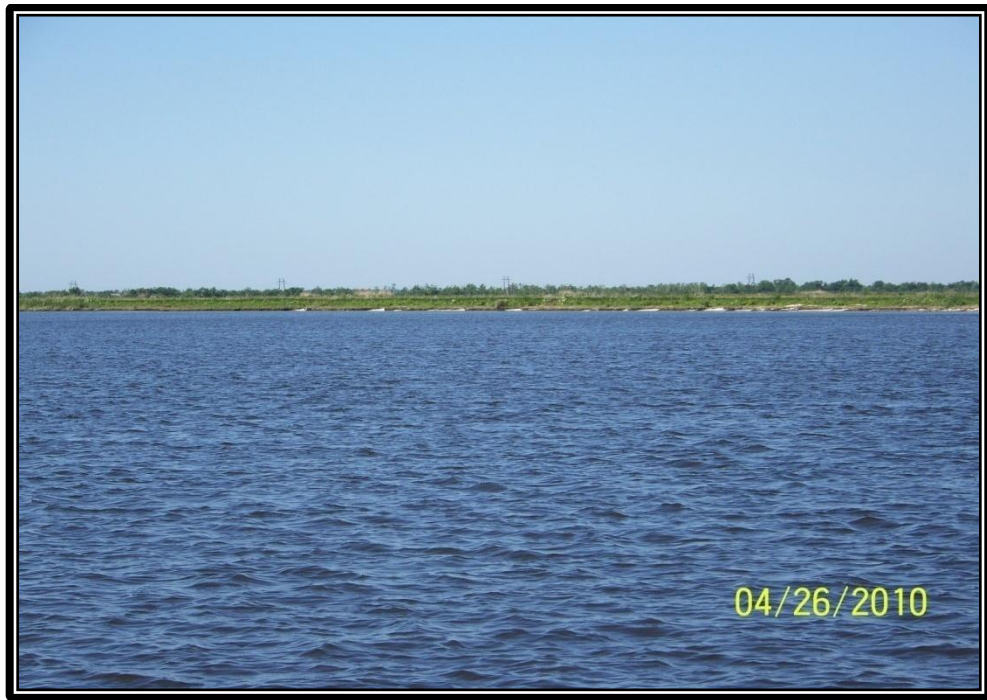
Photo No.32 – view of shell midden along the shoreline of Little Lake south of Structure 14A

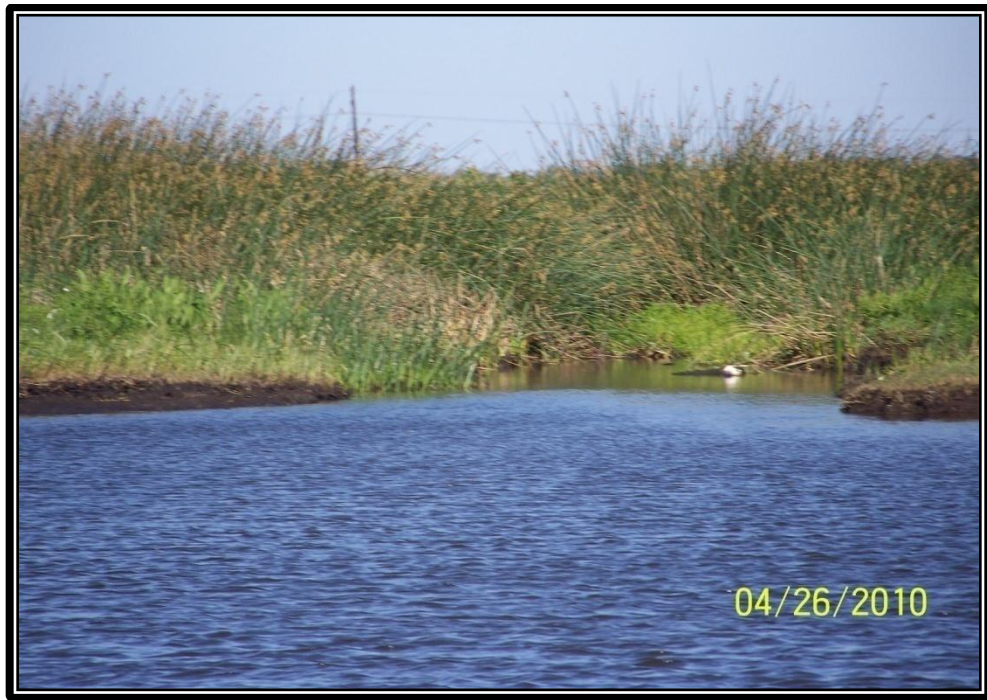
In all, five (5) breaches ranging from 10' to 30' wide were identified within the southern portion of the project area that is included in the 2010 Maintenance Project. Breach locations are shown in the Work Plan Map of Appendix D. The method of repair for breach closures consist of utilizing in situ material from adjacent channel bottoms to reconstruct the earthen dike.

Photo No.34 – closer view of breach shown in the previous photograph.

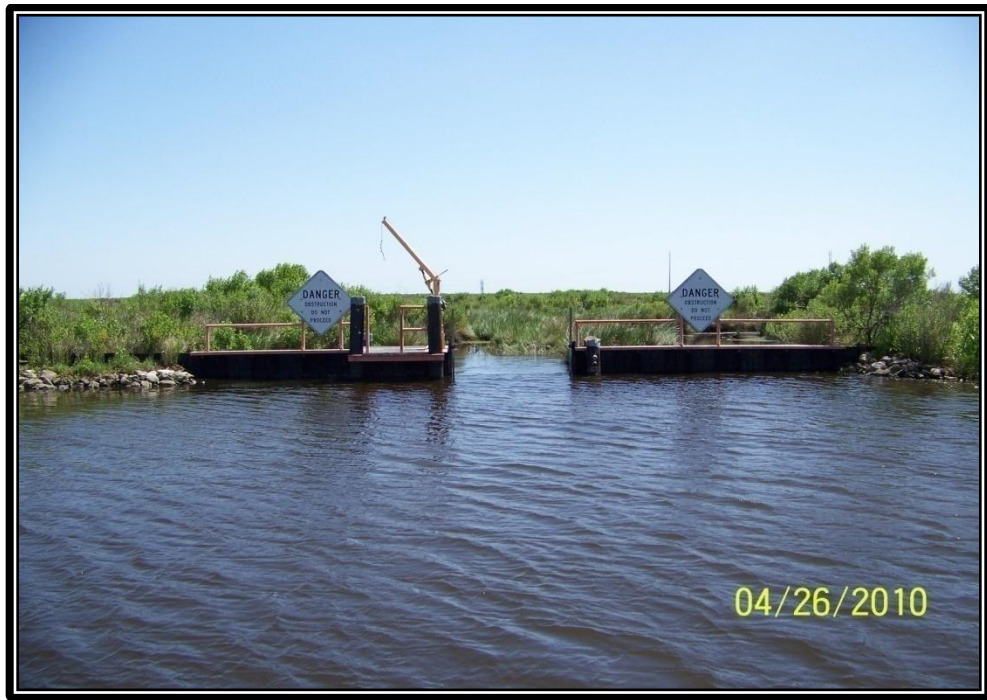
Photo No.36– view of variable crest weir Structure No.35 along north bank of location canal on the east side of Breton Canal.

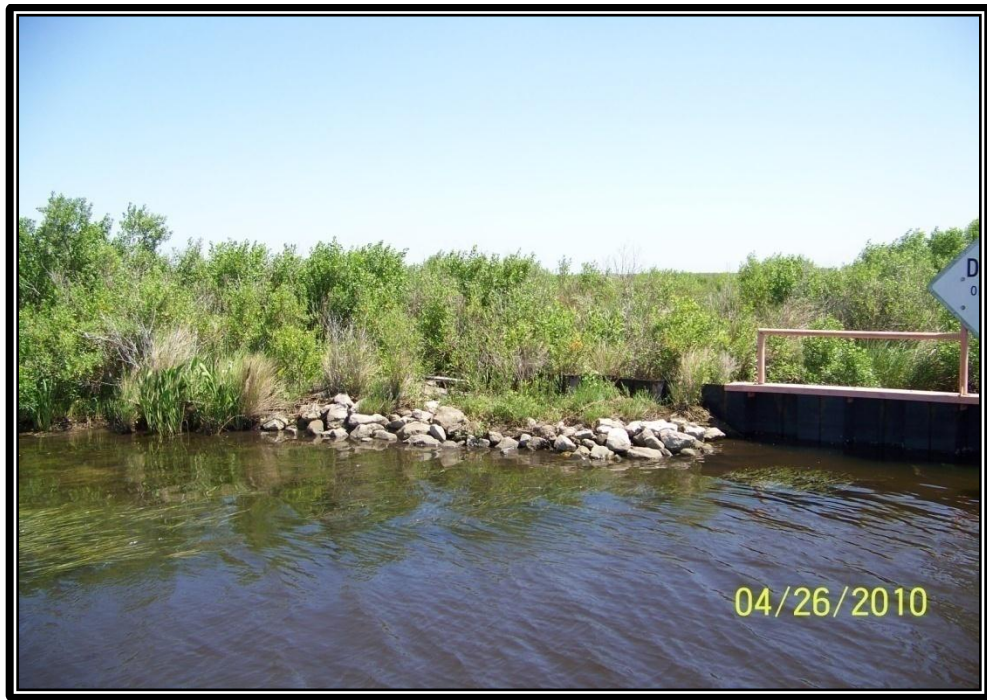
Photo No.38 – view of steel bulkhead and bank tie-in on the north side of Structure No.35.

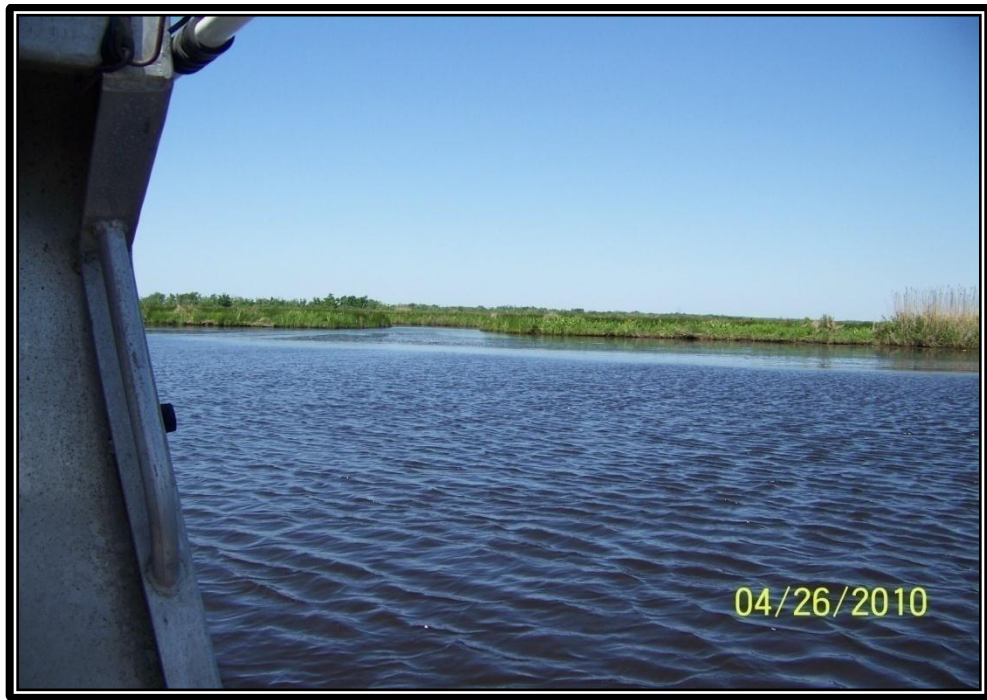
Photo No.40 – Breach No.1 located along the north bank of Breton Canal south of the location canal leading to Structure No.35.

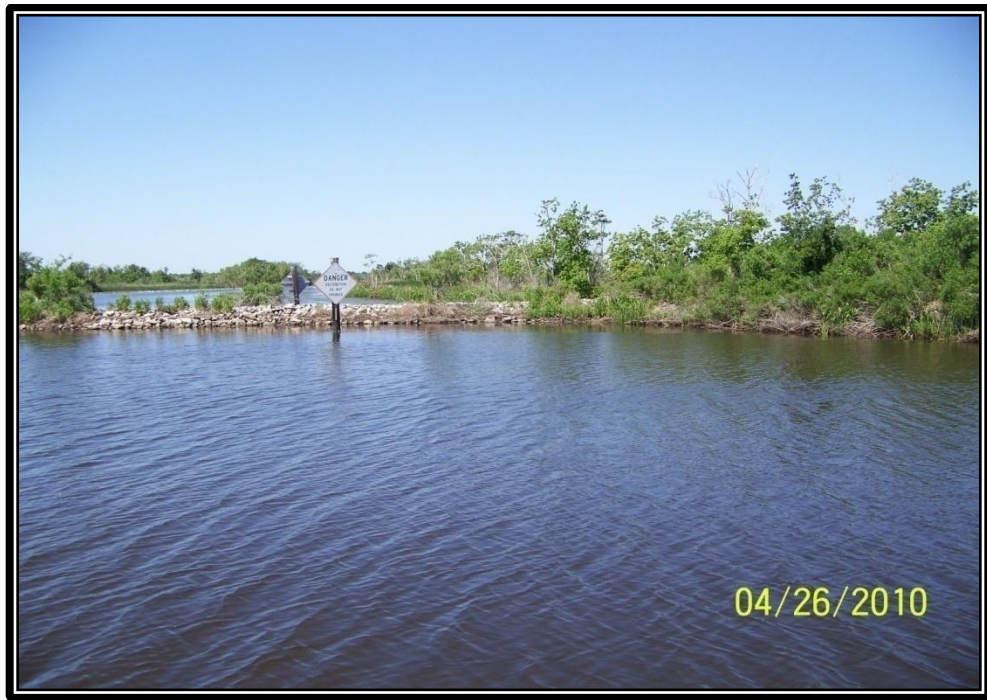
Photo No. 42 – view of rock plug (Structure No.90) looking southeast.

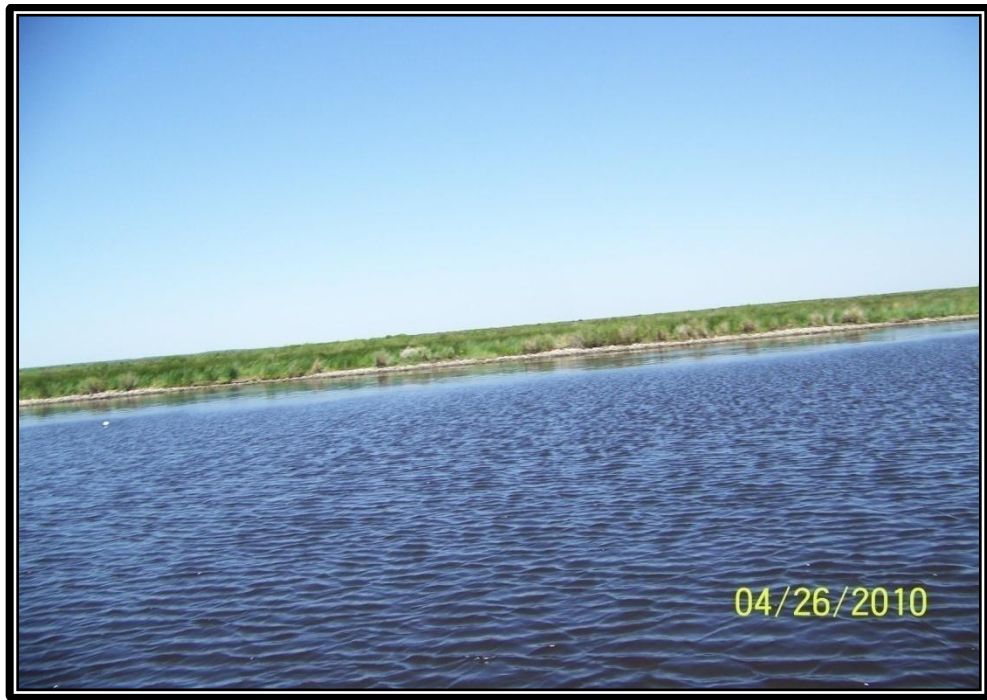
Photo No.44 – view of rock shoreline along the north bank of Breton Canal.

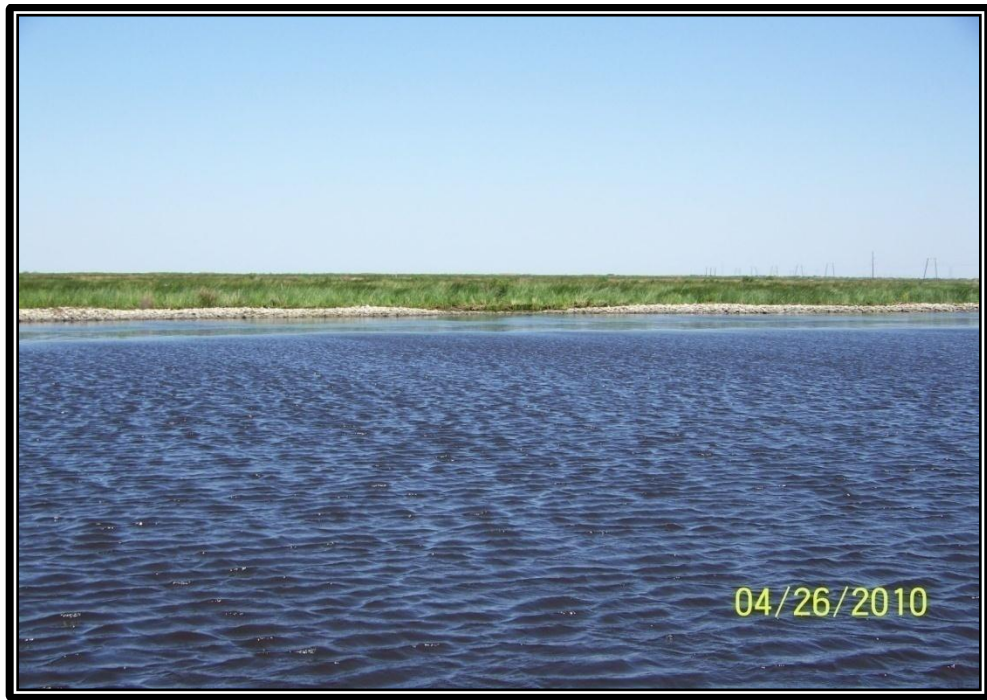
Photo No.46 – view of rock shoreline along the north bank of Breton Canal.

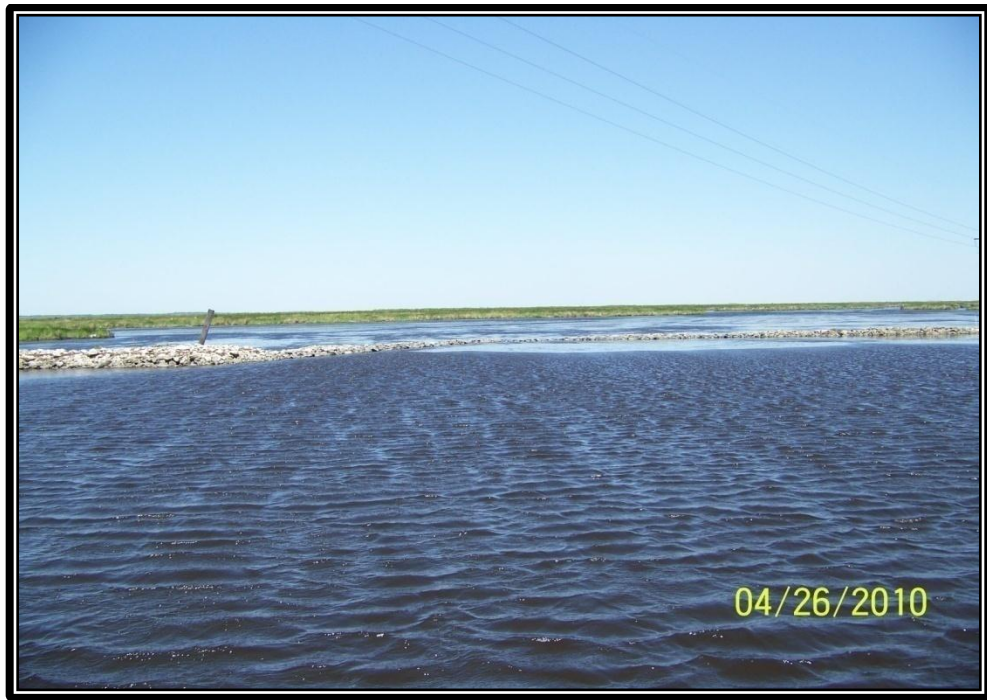
Photo No.48 – view of rock shoreline along the north bank of Breton Canal.

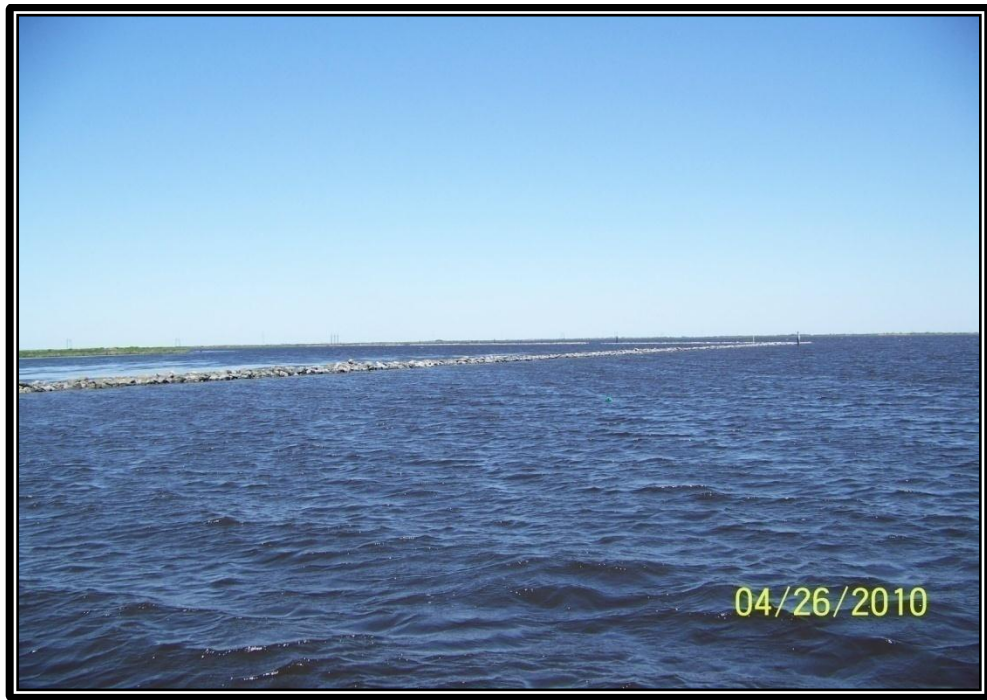
Photo No.50 – view of rock dike along the lake rim of Little Lake near the mouth of Breton Canal.

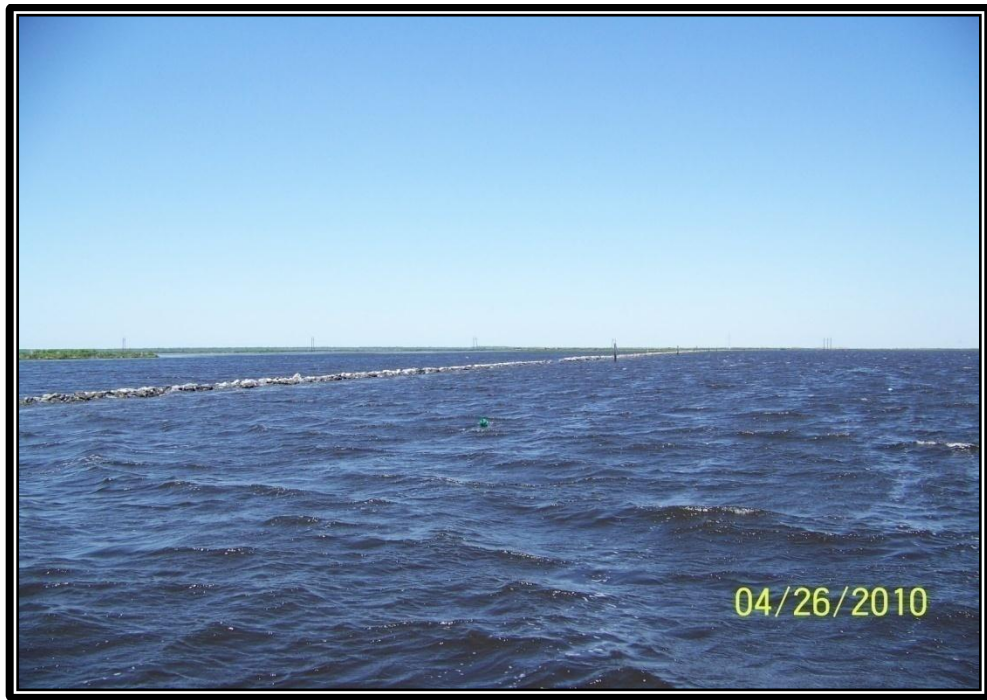
Photo No.52 – view of the rock dike along the lake rim of Little Lake looking north.

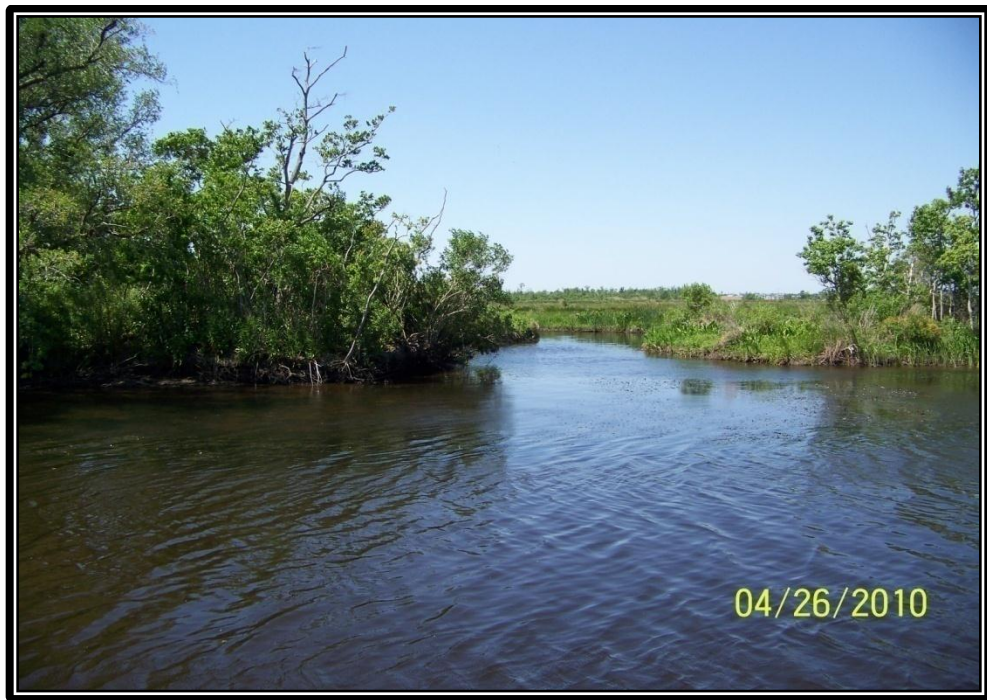
Photo No.56 – Breach No.2 located along the north bank of the first oilfield location canal along Breton Canal across from Breach 3.

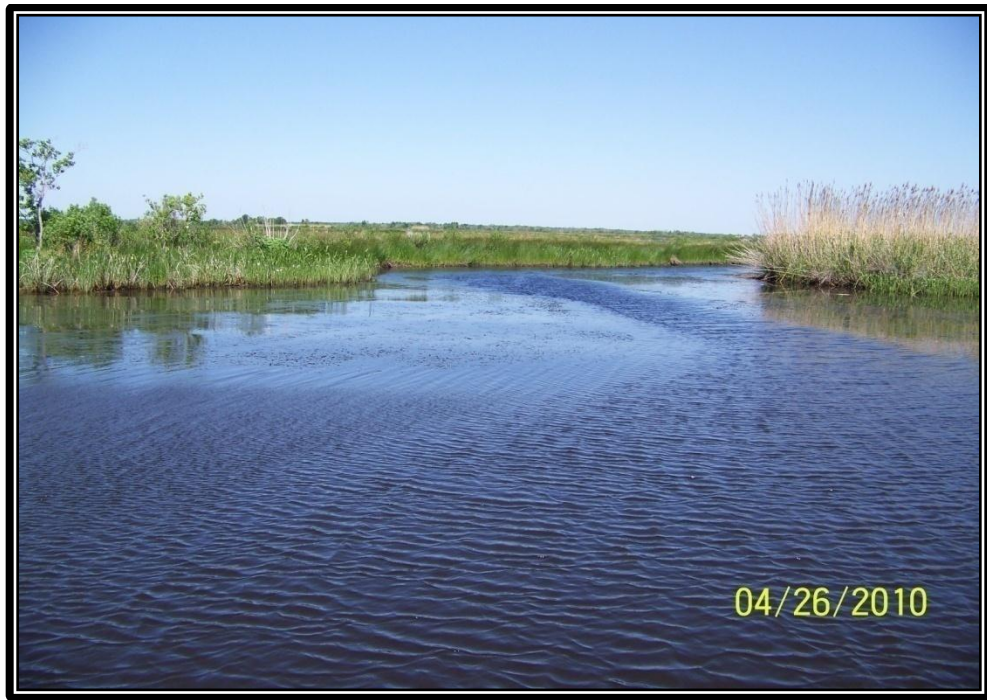
Photo No.58 – Breach No.4 on the west bank of a location canal off of Superior southwest of Structure No.91.
