2011 Operations, Maintenance, and Monitoring Report

Brady Canal Hydrologic Restoration (TE-28)

State Project Number TE-28
Priority Project List 3

December 2011
Terrebonne Parish

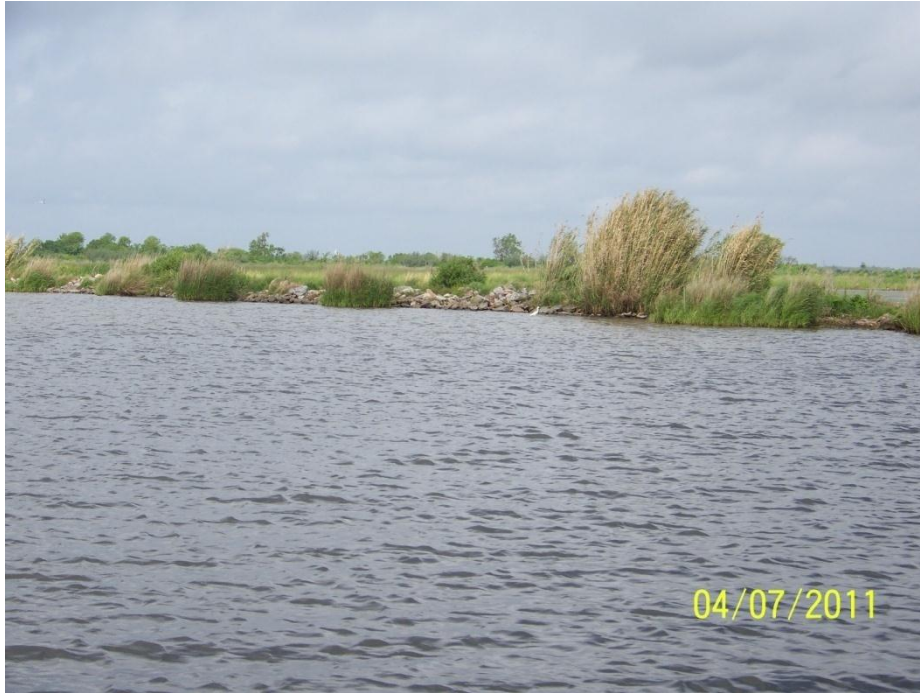
Photo 7: Bayou DeCade Rock Dike and breach closure constructed in 2003, looking north

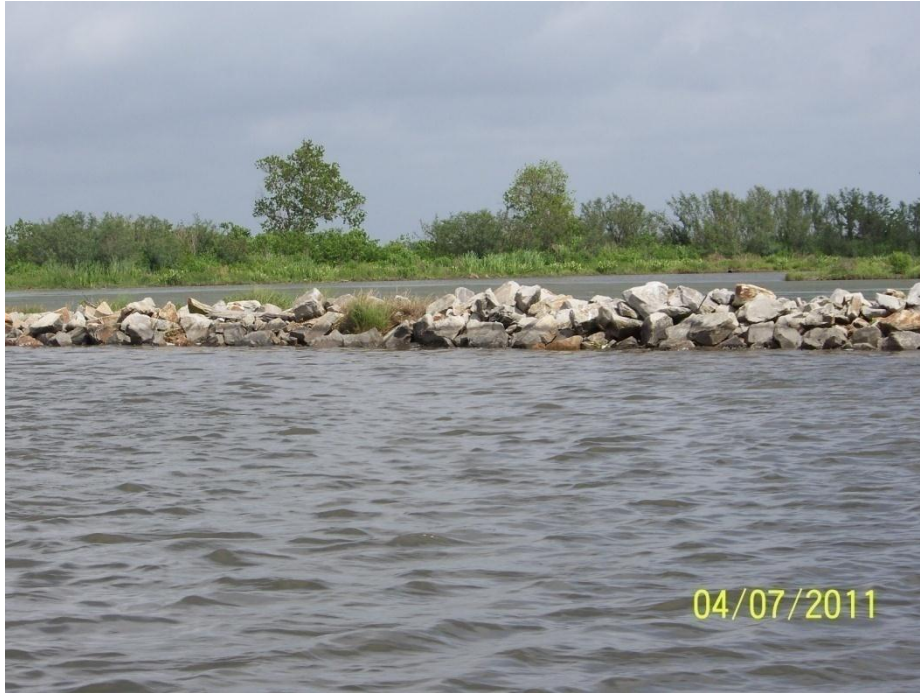
Photo 9: Bayou DeCade Rock Dike and breach closure constructed in 2003, looking north

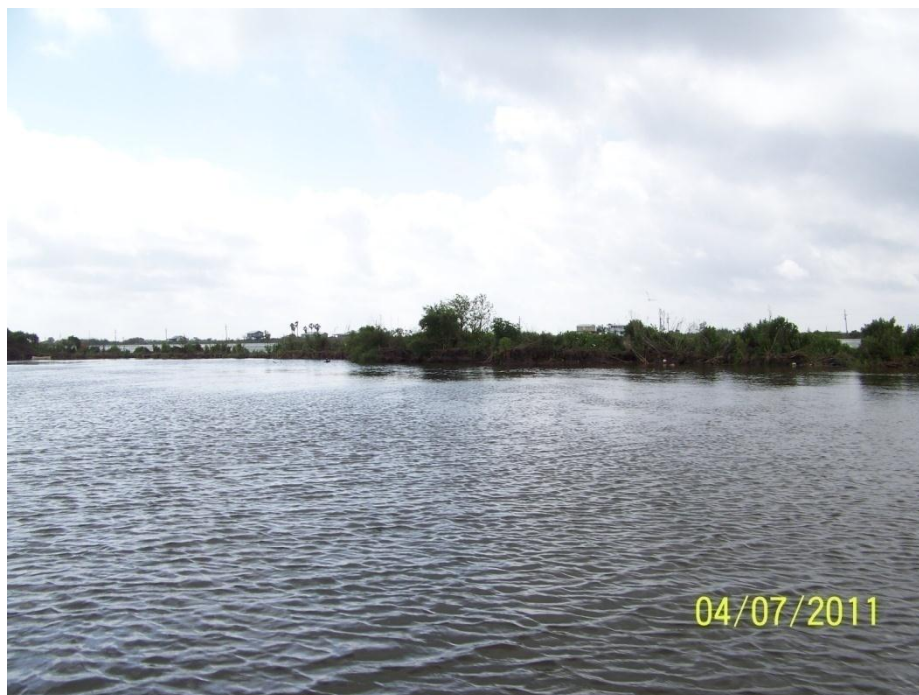
Photo 11: Southeast section of Jug Lake Shoreline looking southeast

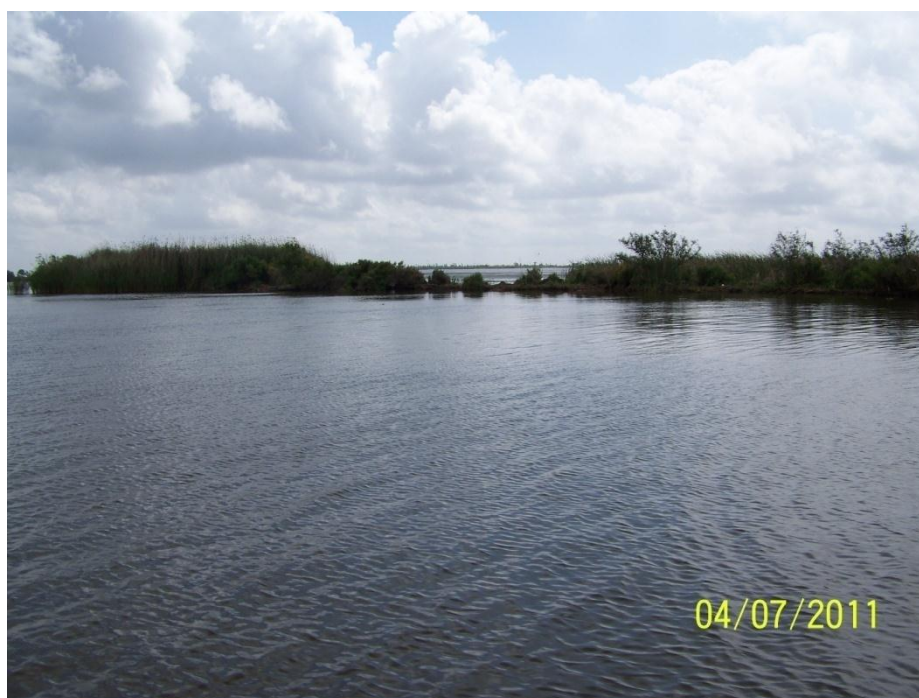
Photo 14: Bankline along southeast side of Jug Lake

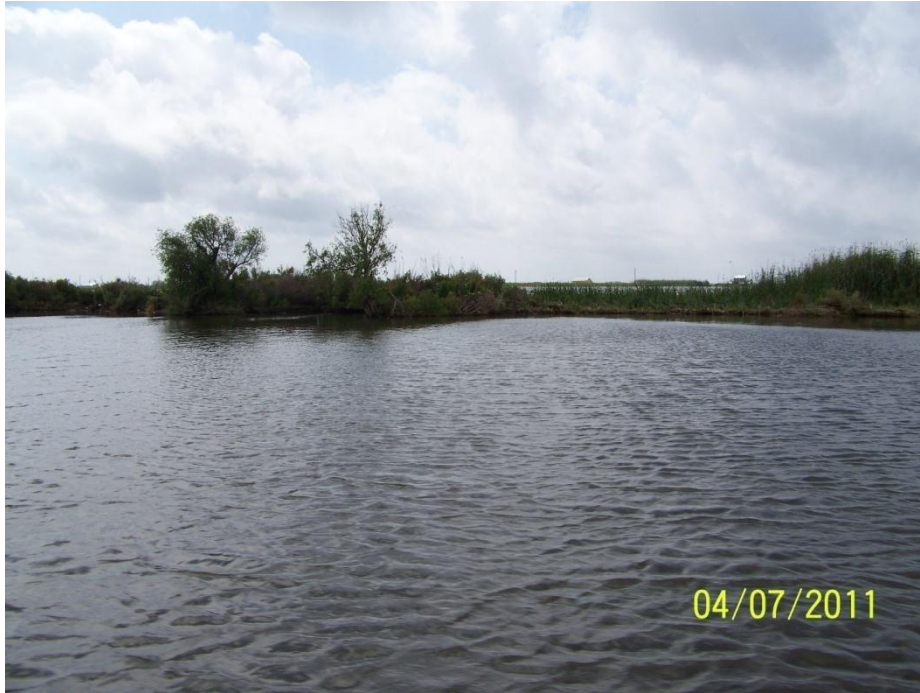
Photo 15: Bankline along southeast side of Jug Lake

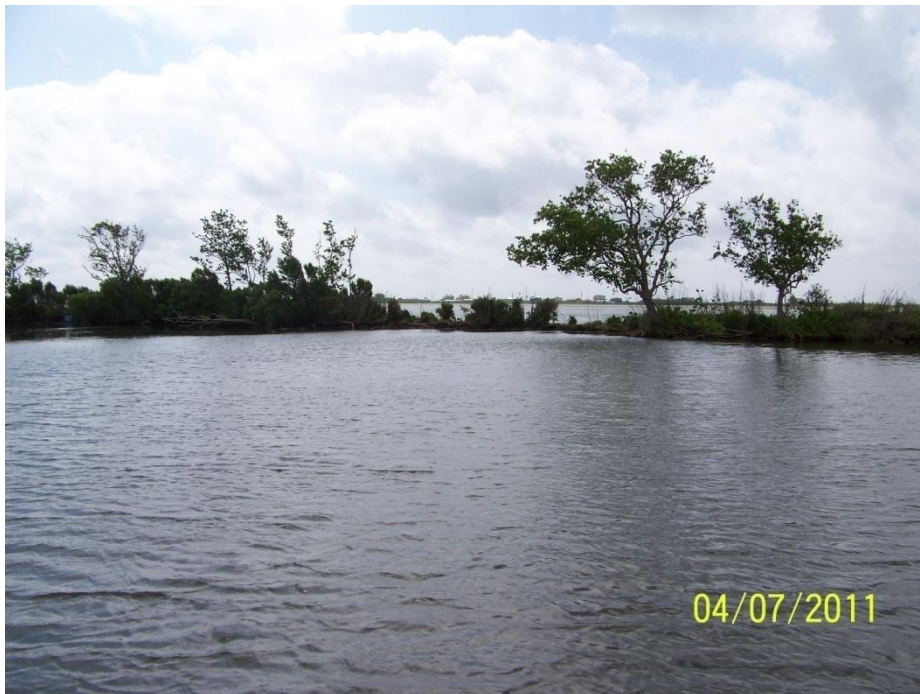
Photo 16: Bankline along southeast side of Jug Lake

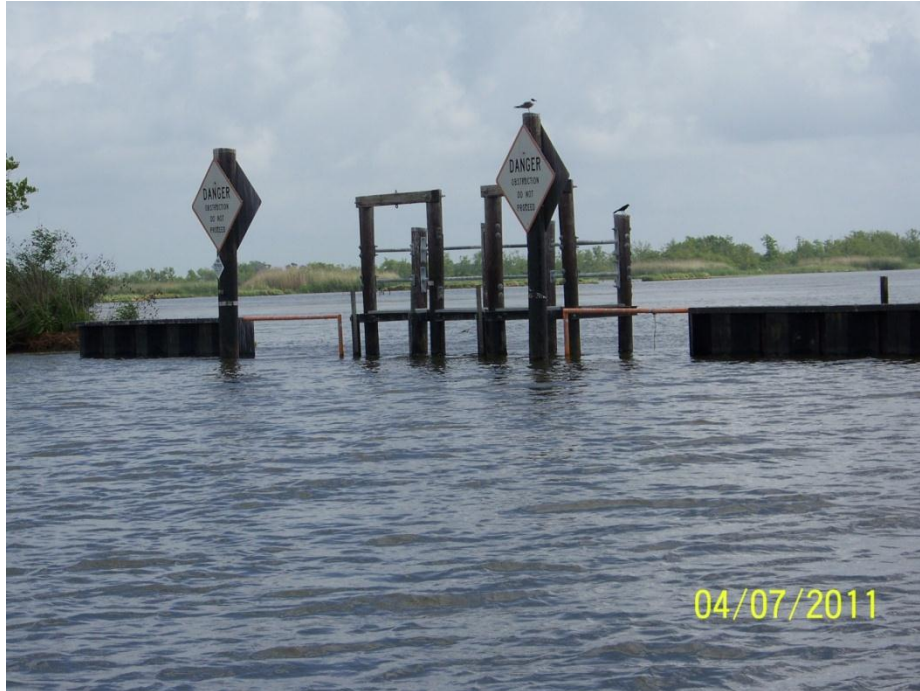
This structure is in overall good condition as there is no visual damage to the steel bulkhead, railings, decking, warning signs or timbers. However, both of the structures earthen tie-ins have now been breached due to erosion. The north tie-in has been repaired several times in the past, but to prevent further erosion of the embankment, both sides require refurbishment and more robust tie-ins. These improvements are part of the 2011 Maintenance Project and include the reconstruction of the tie-ins with borrow material from the lake and then reinforcing approximately 100 linear feet on both sides of the structure with rock riprap. The upgrades are scheduled to be completed later this year (see Appendix A, Photos 20 through 22).

Photo 21: Two bay variable crest Structure 23, looking east

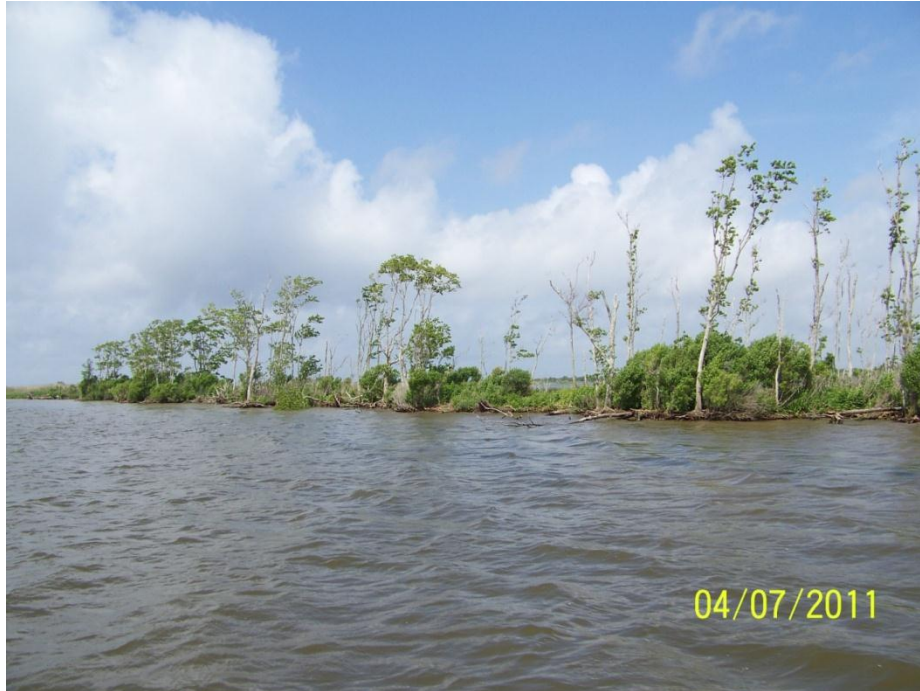
Photo 23: Shoreline along northern bank of Jug Lake, looking northwest

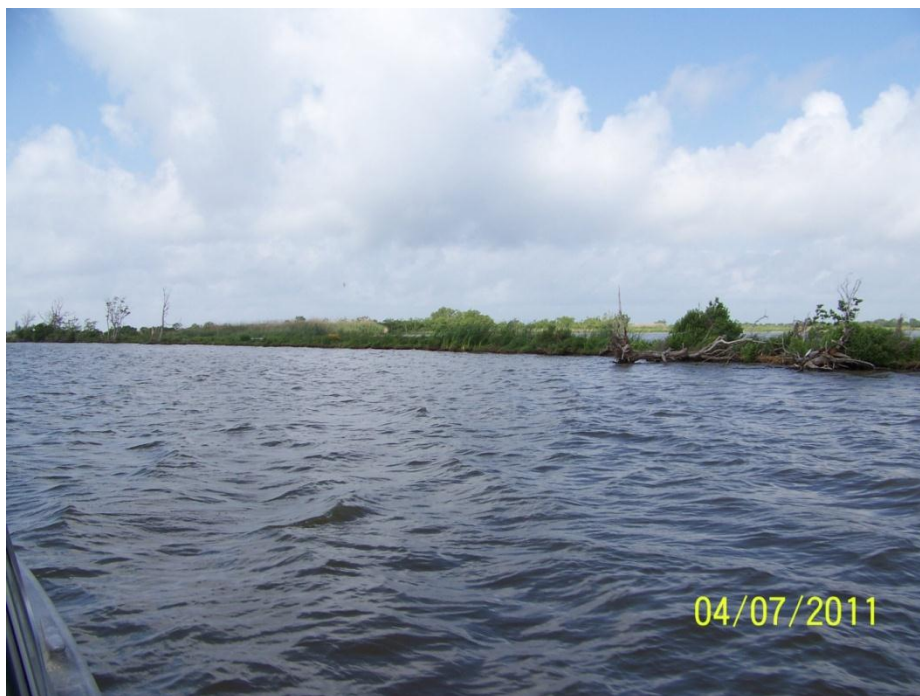
Photo 24: Shoreline along northern bank of Jug Lake, looking northwest

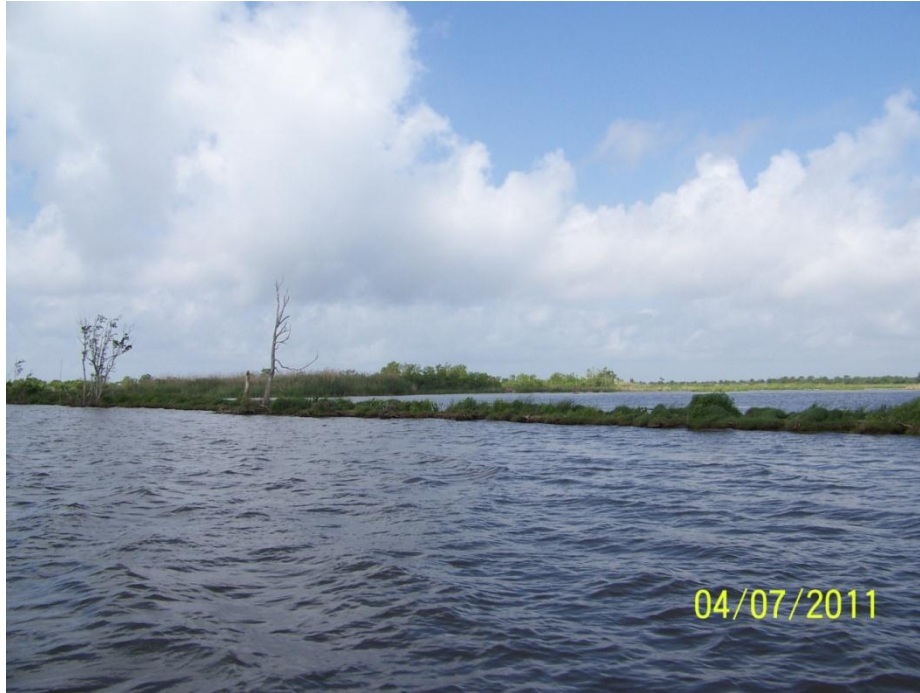
Photo 25: Shoreline along northern bank of Jug Lake, looking northwest

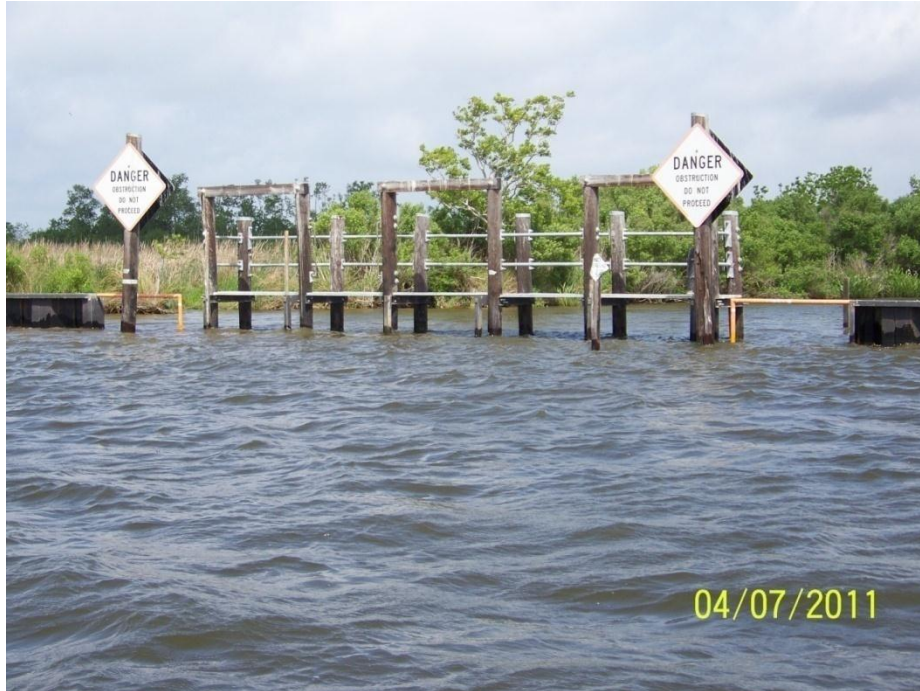
This structure is in overall good condition as there is no visual damage to the steel bulkhead, railings, decking, warning signs or timbers. There is substantial erosion of the earthen tie-ins, exposing the end of the steel bulkhead on both sides of the structure, and causing a breach on the east side of the structure. To prevent further erosion of the embankment, both sides require refurbishment and more robust tie-ins. These improvements are part of the 2011 Maintenance Project and include the reconstruction of the tie-ins with borrow material from the lake and then reinforcing approximately 100 linear feet on both sides of the structure with rock riprap. The upgrades are scheduled to be completed later this year (see Appendix A, Photos 27 through 28).

Photo 27: Three bay variable crested weir Structure 21, looking northwest

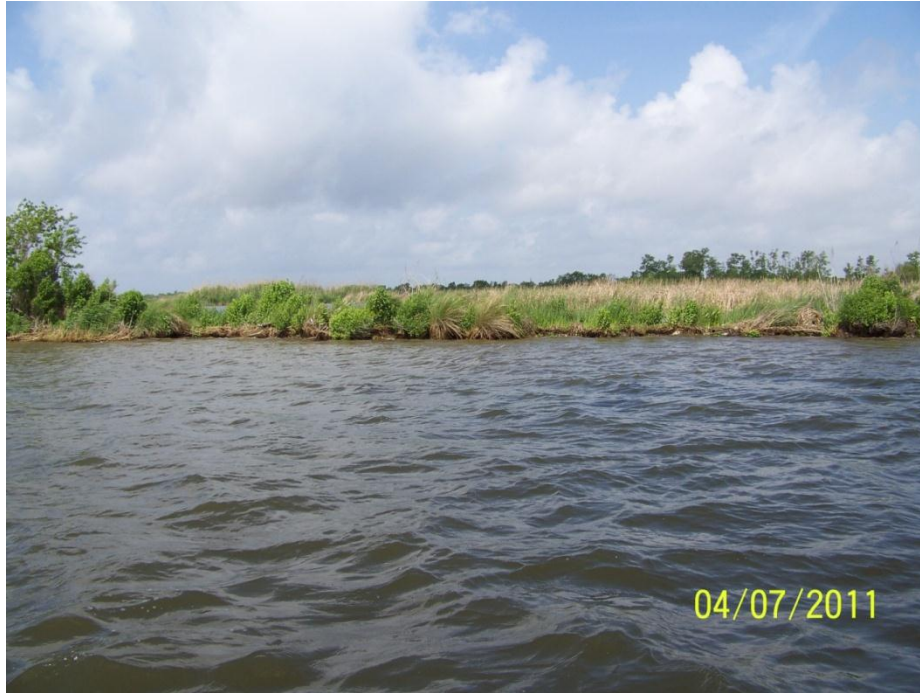
Photo 29: Shoreline along the northwest bank of Jug Lake south of Structure No. 21, looking northwest.

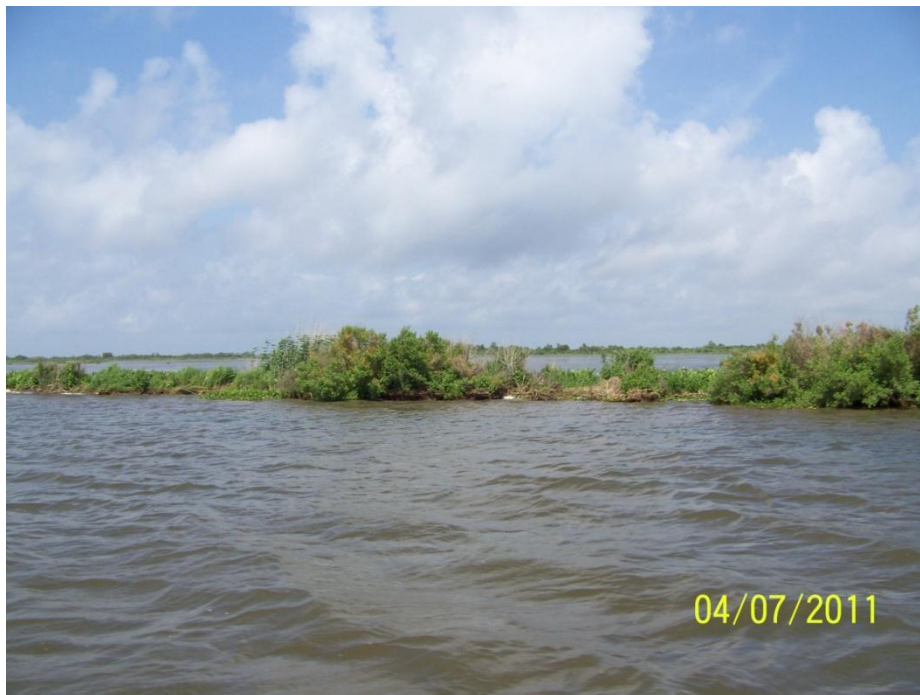
Photo 30: Shoreline along the northwest bank of Jug Lake south of Structure No. 21, looking northwest

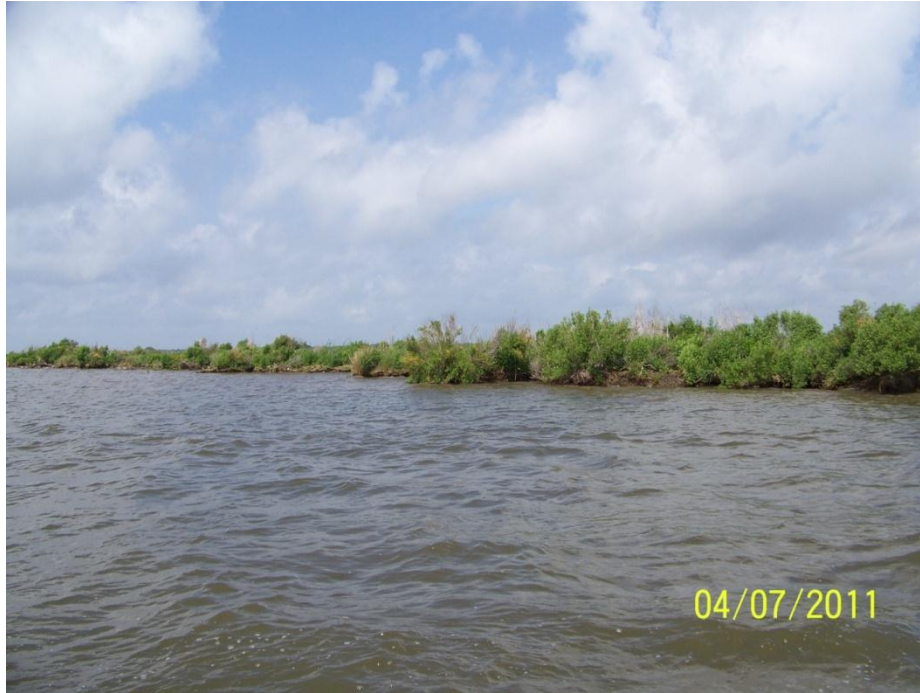
Photo 31: Shoreline along the northwest bank of Jug Lake south of Structure No. 21, looking northwest

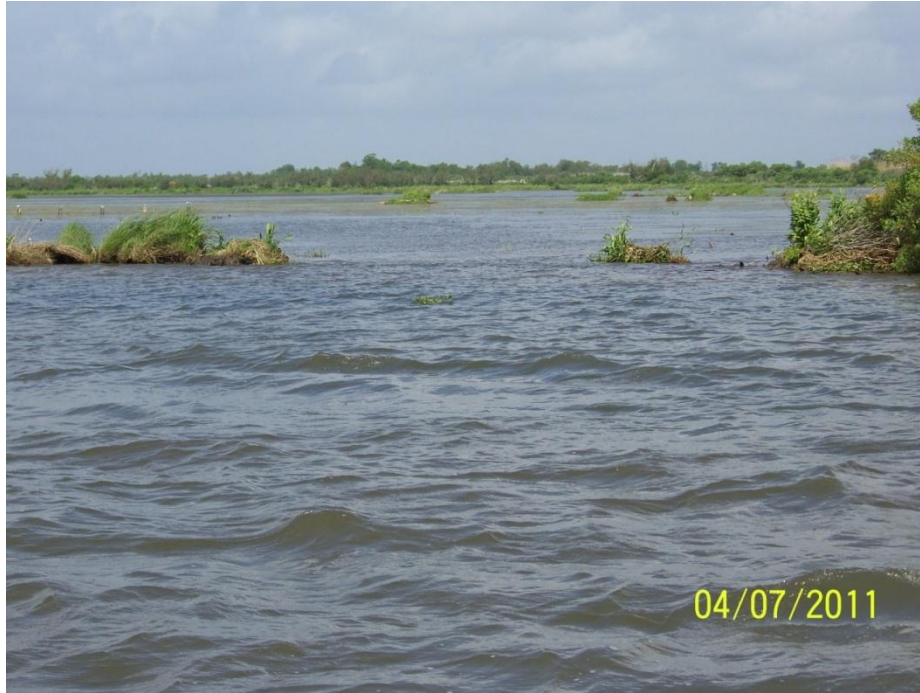
Photo 33: Small breach along the northwest shoreline of Jug Lake located between Structure 20 and Structure 21

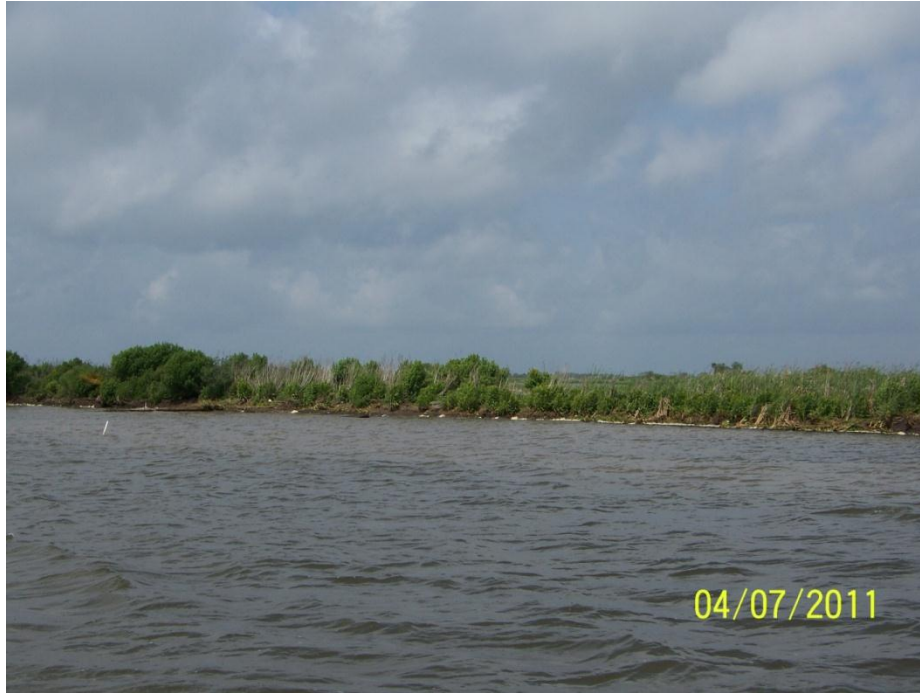
Photo 35: Shoreline along the northwest side of Jug Lake north of Structure 20, looking northwest.

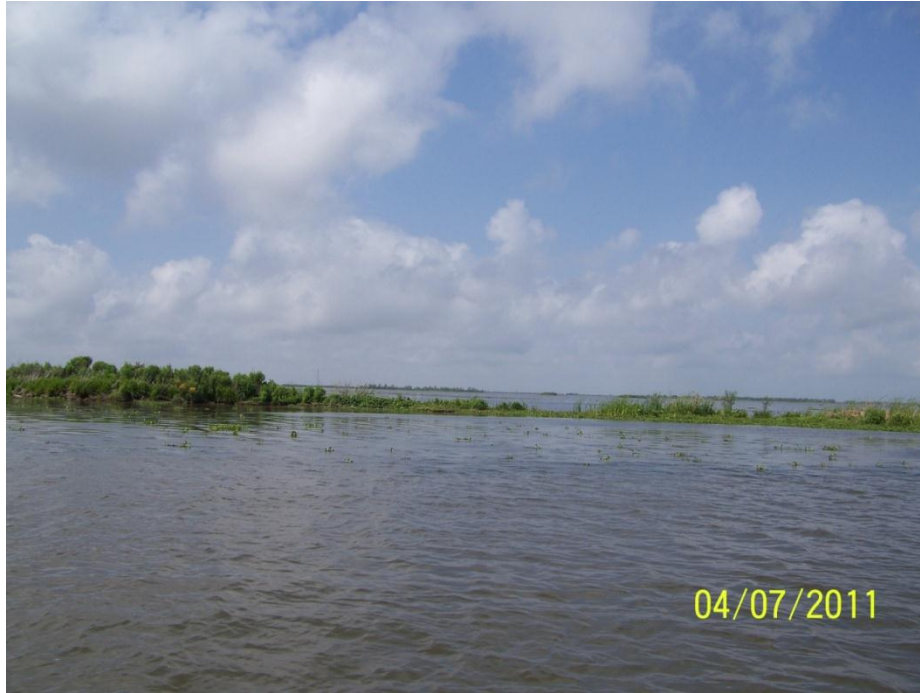
Photo 39: Low bank line along the north bank of Bayou Decade near the entrance to Jug Lake.

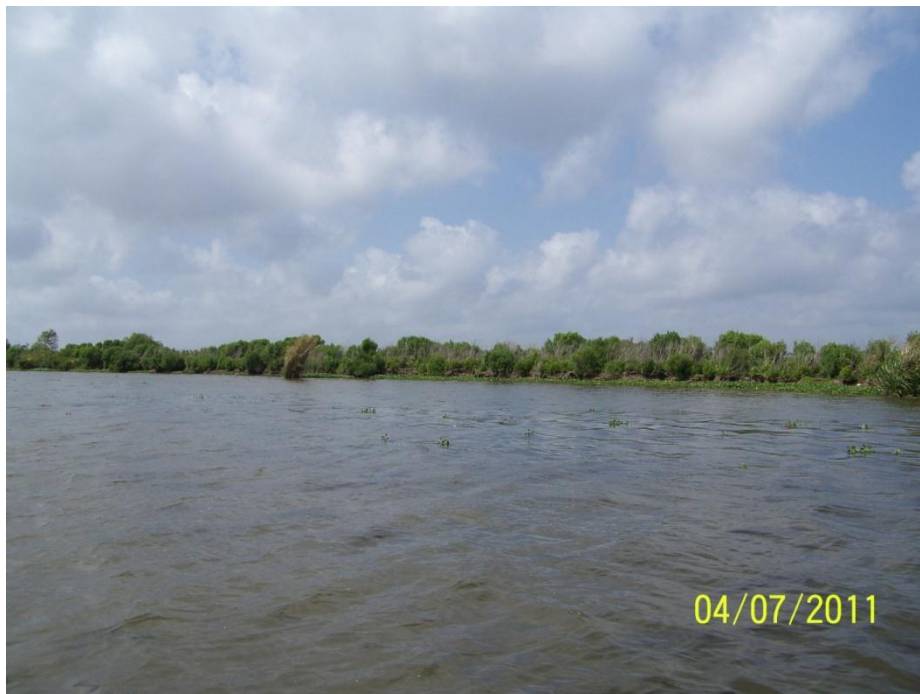
Photo 40: Existing north bankline of Bayou Decade between Jug Lake and Structure No.6

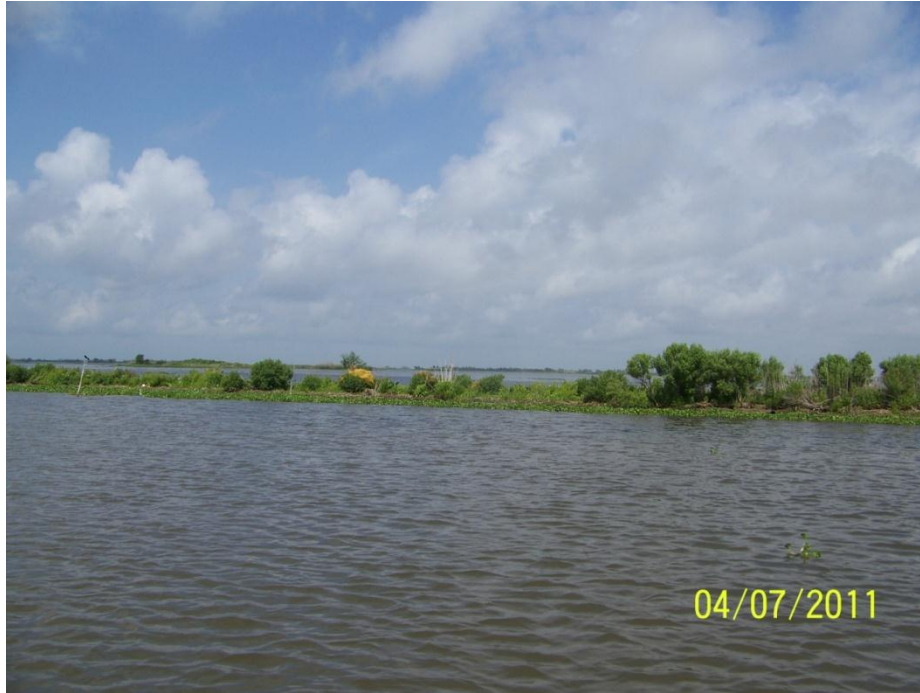
Photo 41: Existing north bankline of Bayou Decade between Jug Lake and Structure No.6

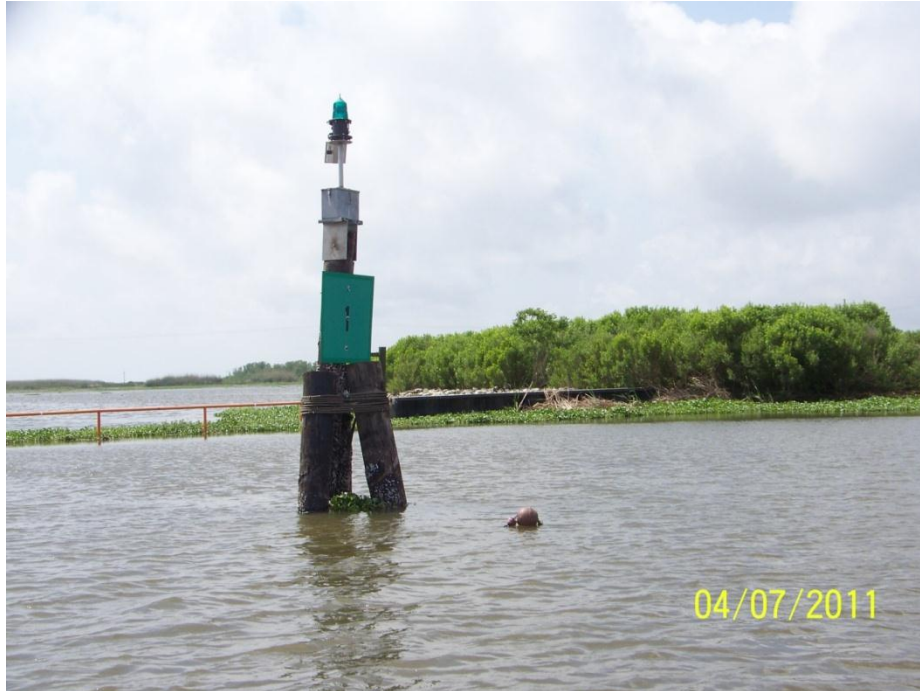
Photo 47: Navigational aids on west side of Structure 6, looking south

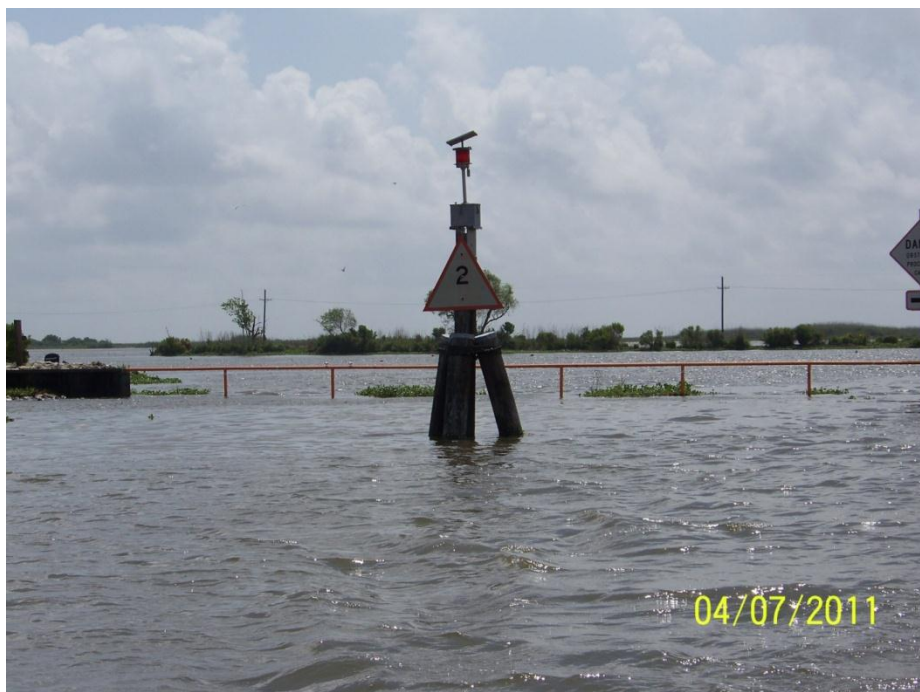
Photo 48: Navigational aids on east side of Structure 6, looking south

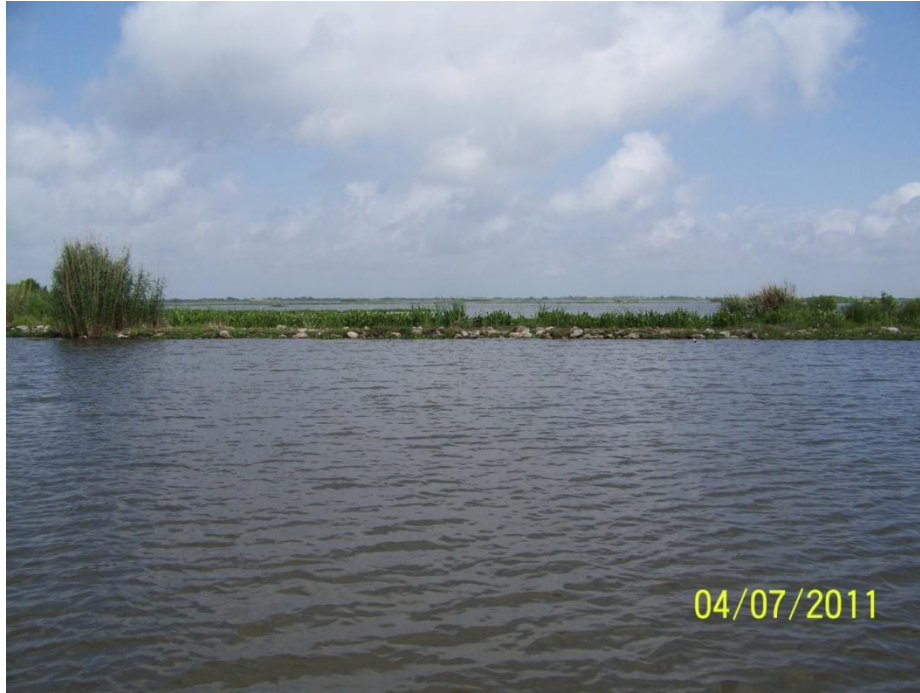
Photo 49: Low area of rock dike along Bayou DeCade north shoreline, located between Structure 6 and 7

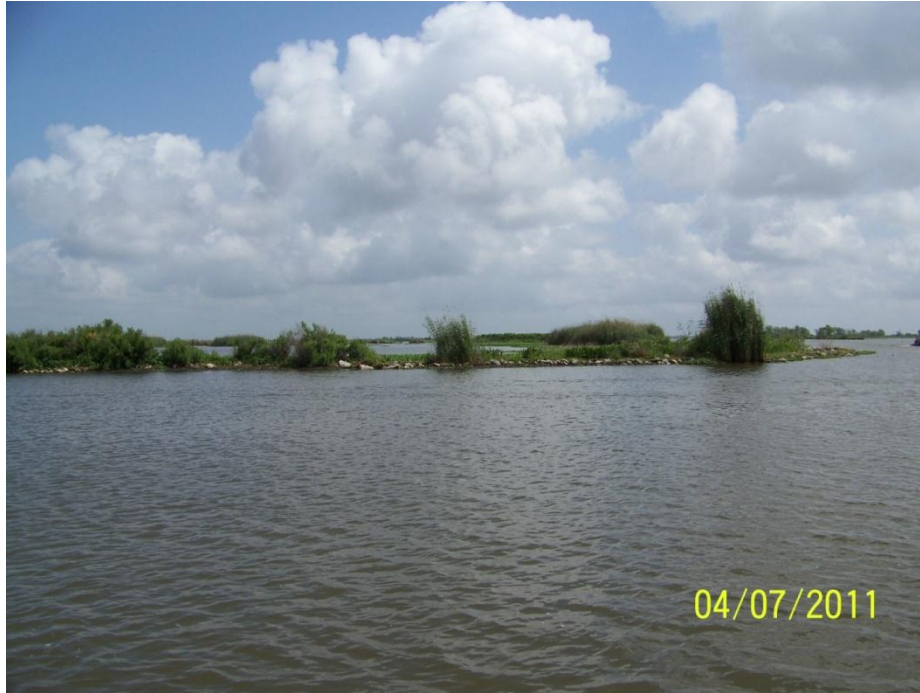
Photo 51: Low area of rock dike along Bayou DeCade north shoreline, located between Structure 6 and 7

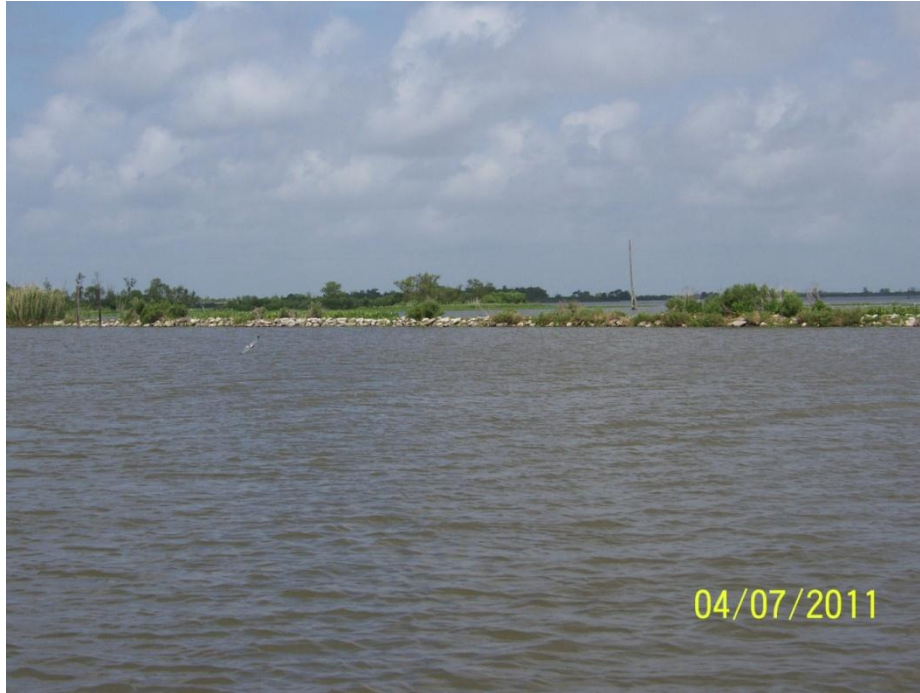
Photo 53: Low area of rock dike along Bayou DeCade north shoreline, located between Structure 6 and 7

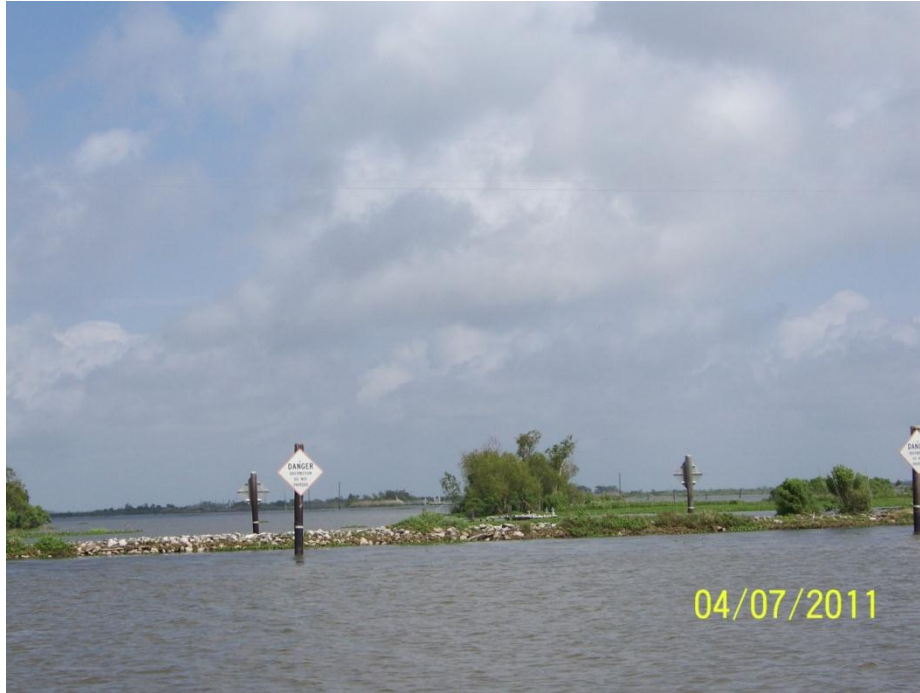
Structure 7 is in overall good condition with no observed settlement of the rock plug or signs of erosion around the tie-ins to the earthen embankment. This structure does not require maintenance at this time therefore there are no recommendations for repair (see Appendix A, Photos 54 and 55).

Photo 55: Structure 7 rock plug located on north bank of Bayou DeCade, looking north

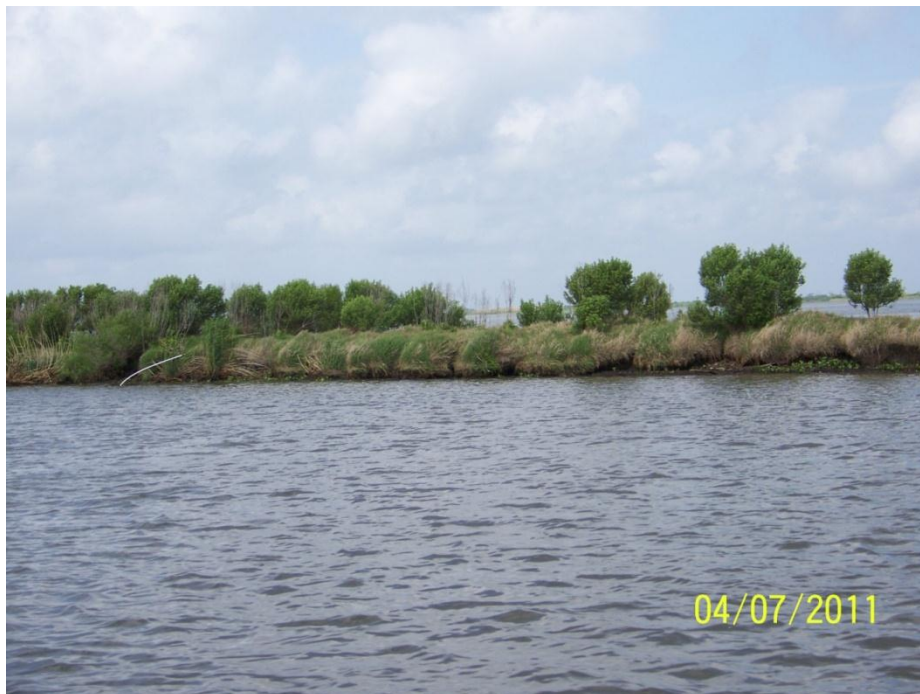
Photo 56: Earthen embankment along north bank of Bayou Decade, looking north

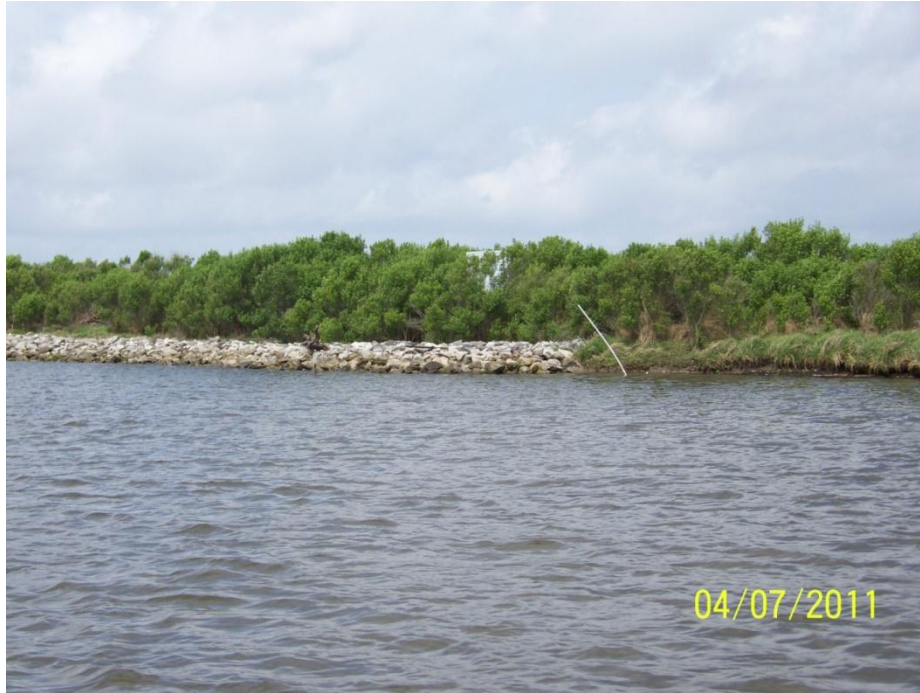
Photo 57: Transition to earthen embankment with rock along north bank of Bayou Decade

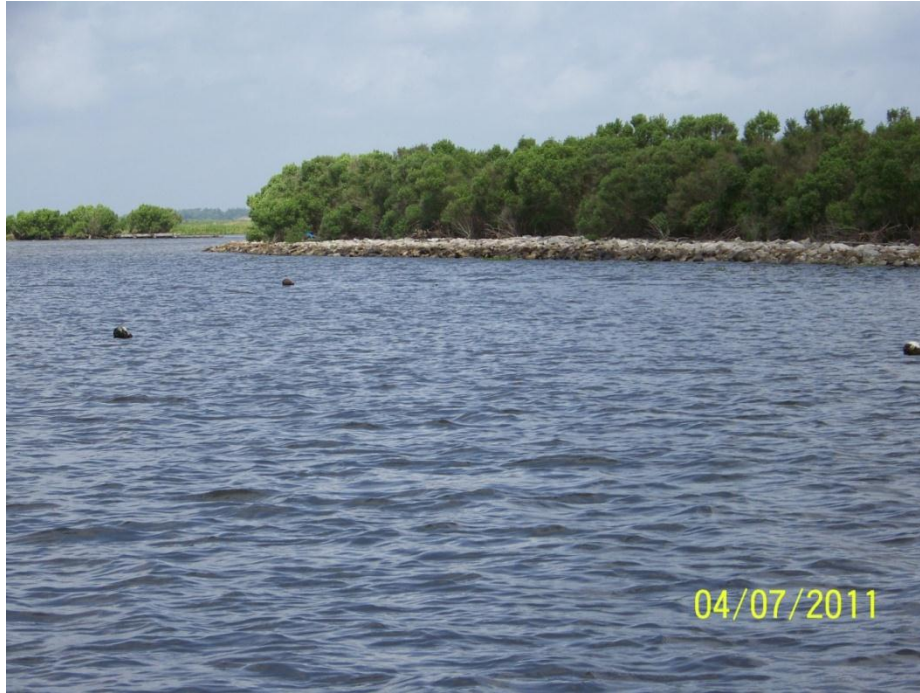
Photo 59: Bayou DeCade and Voss Canal intersection, earthen embankment with rock

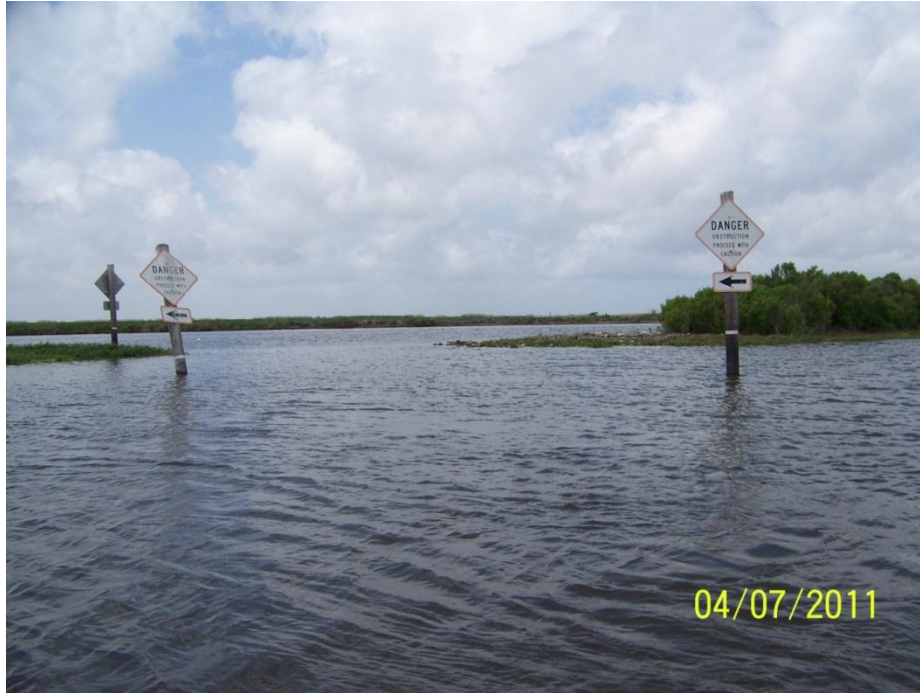
Photo 63: Structure 10 rock armored channel liner along Voss Canal, looking west

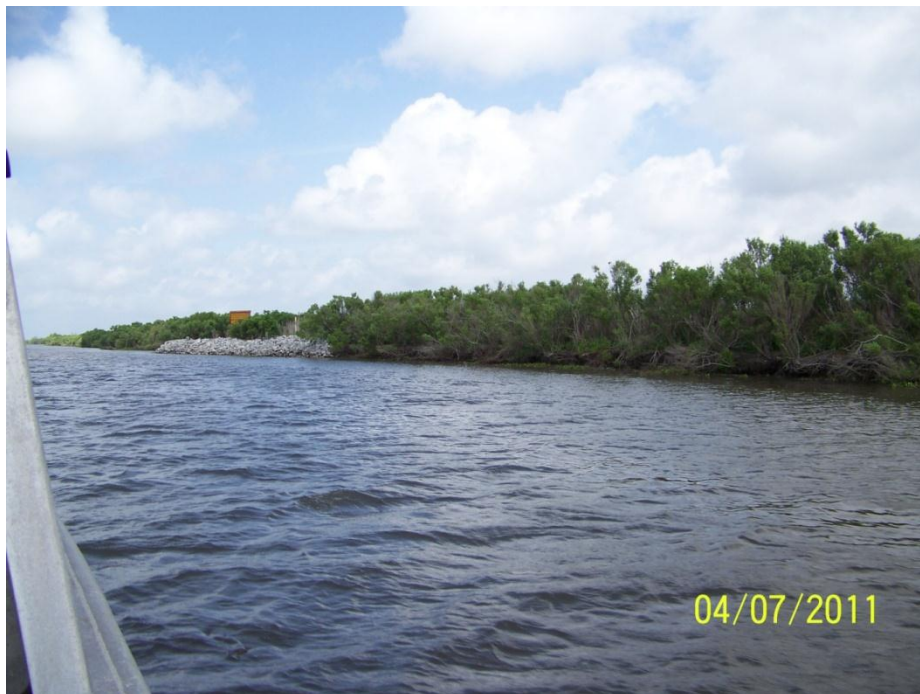
Photo 64: Earthen embankment along east side of Voss Canal between Structure 10 and 14

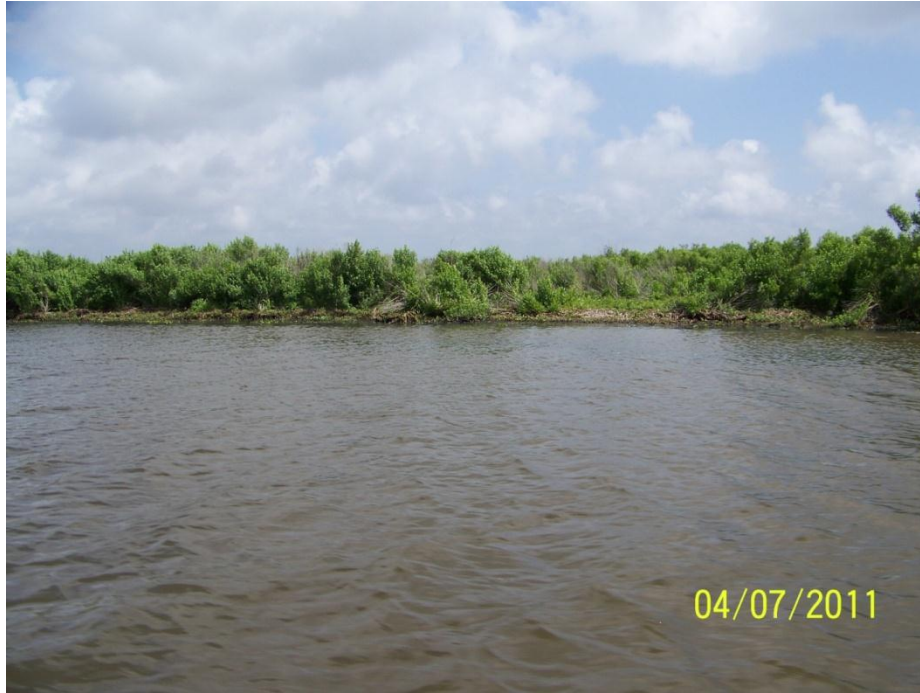
Photo 65: Earthen embankment along east side of Voss Canal between Structure 10 and 14

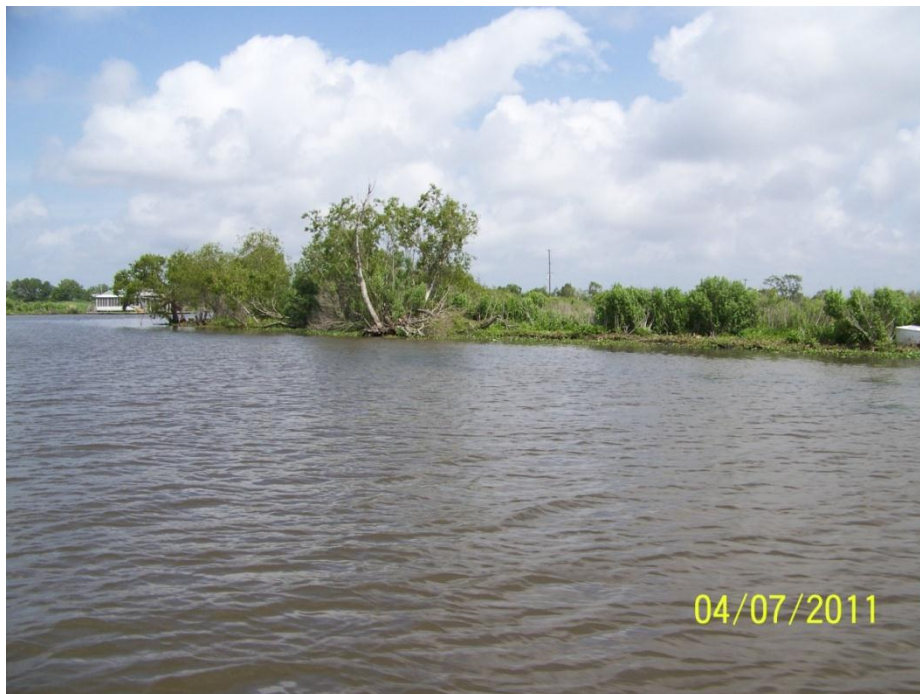
Photo 66: East bank of Voss Canal between Structure 10 and 14

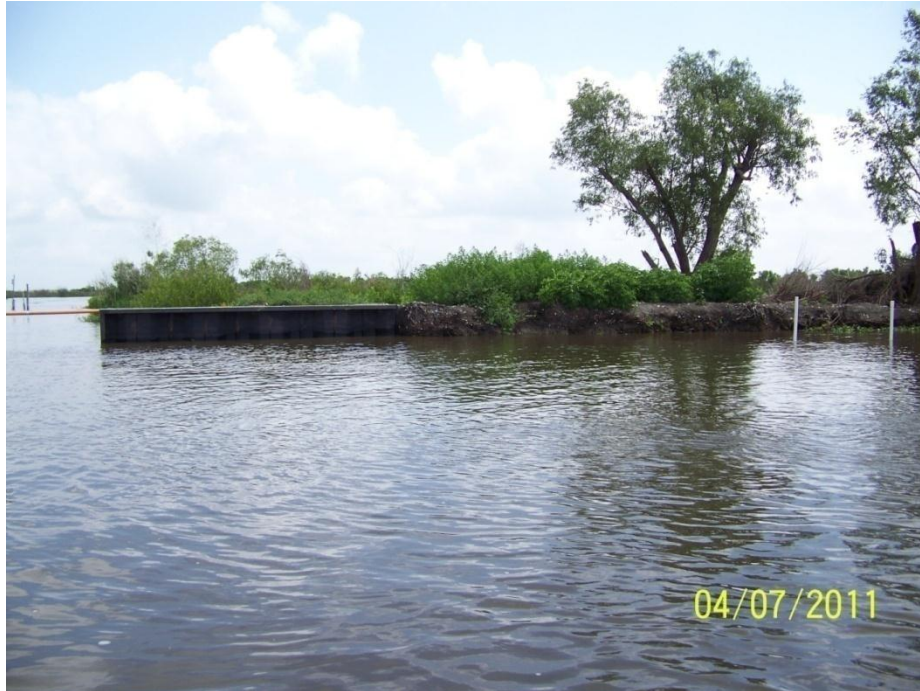
This structure appears to be in overall good condition. There is no apparent damage to the steel bulkhead, railings, platform, or warning signs and their timbers. There is some noticeable erosion around the tie-ins on the west side of the structure, but no more than was noticed in the 2010 annual inspection. Because there was no significant change, there will be no recommendations to restore the tie-ins at this time, but they will continue to be monitored for further erosion on future visits (see Appendix A, Photos 67 through 69).

Photo 67: Bank tie-in on the south side of Structure 14, looking east
