2011 Operations, Maintenance, and Monitoring Report

Brady Canal Hydrologic Restoration (TE-28)

State Project Number TE-28
Priority Project List 3

December 2011
Terrebonne Parish

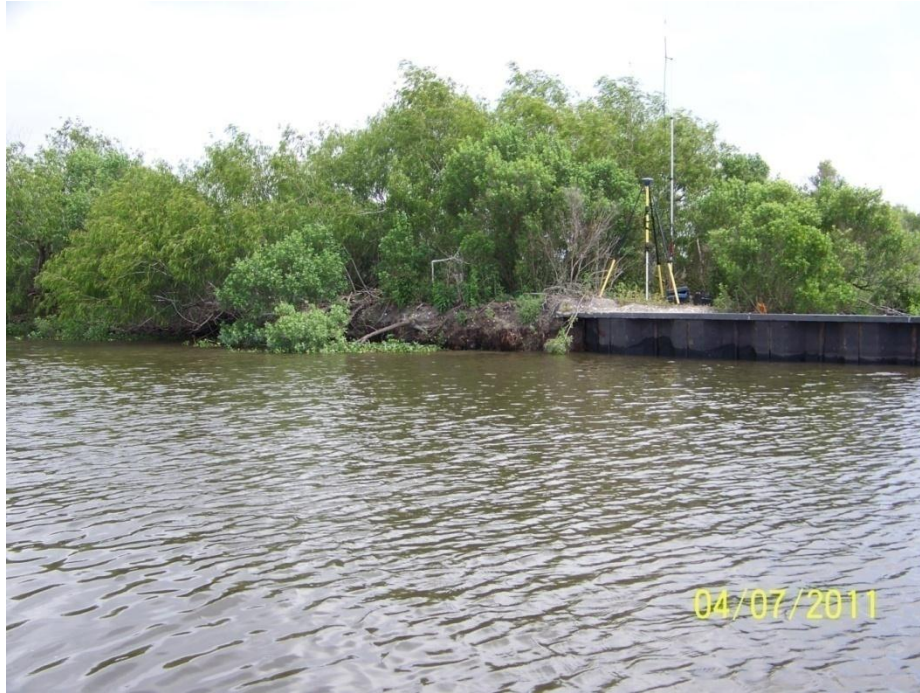
This structure appears to be in overall good condition. There is no apparent damage to the steel bulkhead, railings, platform, or warning signs and their timbers. There is some noticeable erosion around the tie-ins on the west side of the structure, but no more than was noticed in the 2010 annual inspection. Because there was no significant change, there will be no recommendations to restore the tie-ins at this time, but they will continue to be monitored for further erosion on future visits (see Appendix A, Photos 67 through 69).

Photo 69: Bank tie-in on the north side of Structure 14, looking east
